# The Darley Centre

## Management Survey

### Asbestos Report – Copy 1

**Project No:** A-82747

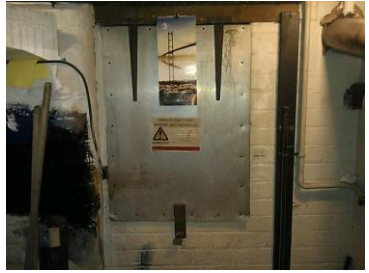
No access has been gained into the following locations:			
Building	Location	Comments	Photograph
The Darley Centre	First Basement Level; Location ID: B03- Undercroft. (Whole location)	No access due to confined space and locked.

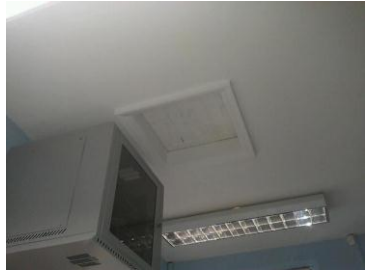
The Darley Centre	First Floor; Location ID: 001- Loft above area G03 (Whole location)	Furniture beneath the hatch.

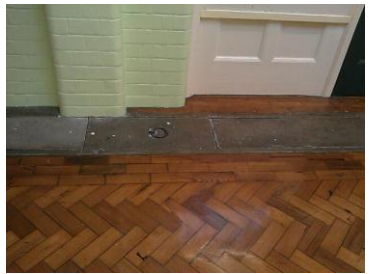
Limited access has been gained into the following locations:			
Building	Location	Comments	Photograph
The Darley Centre	Ground Floor; Location ID: G36-Corridor (Whole Location)	Unable to gain access to floor ducts due to jammed panels

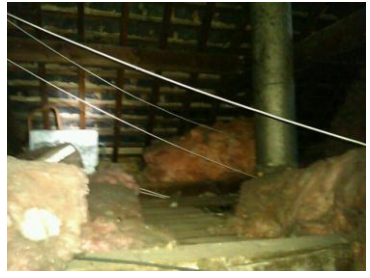
Limited access has been gained into the following locations:			
Building	Location	Comments	Photograph
The Darley Centre	First Floor; Location ID:002-Loft over area G10(Whole location)	MMMF insulation, galvanized tank, slate roof, timber framework

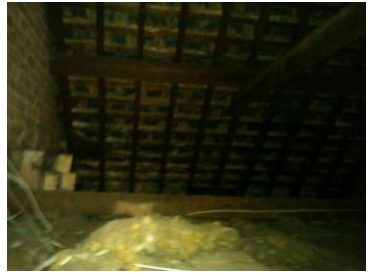
The Darley Centre	First Floor; Location ID:003-Loft over area G01(Whole location)	MMMF insulation, slate roof, timber framework
