YOUR ONESURVEY
HOME REPORT

52 Lanrigg Avenue
Fauldhouse, Bathgate
EH47 9JW

Single Survey

Surveyor Reference	XP080299
Customer	Ms. A Allsopp
Selling address	52 Lanrigg Avenue Fauldhouse, Bathgate EH47 9JW
Date of Inspection	27/08/2024
Prepared by	Robert A Smith, BSc MRICS Bathgate - Allied Surveyors Scotland Ltd

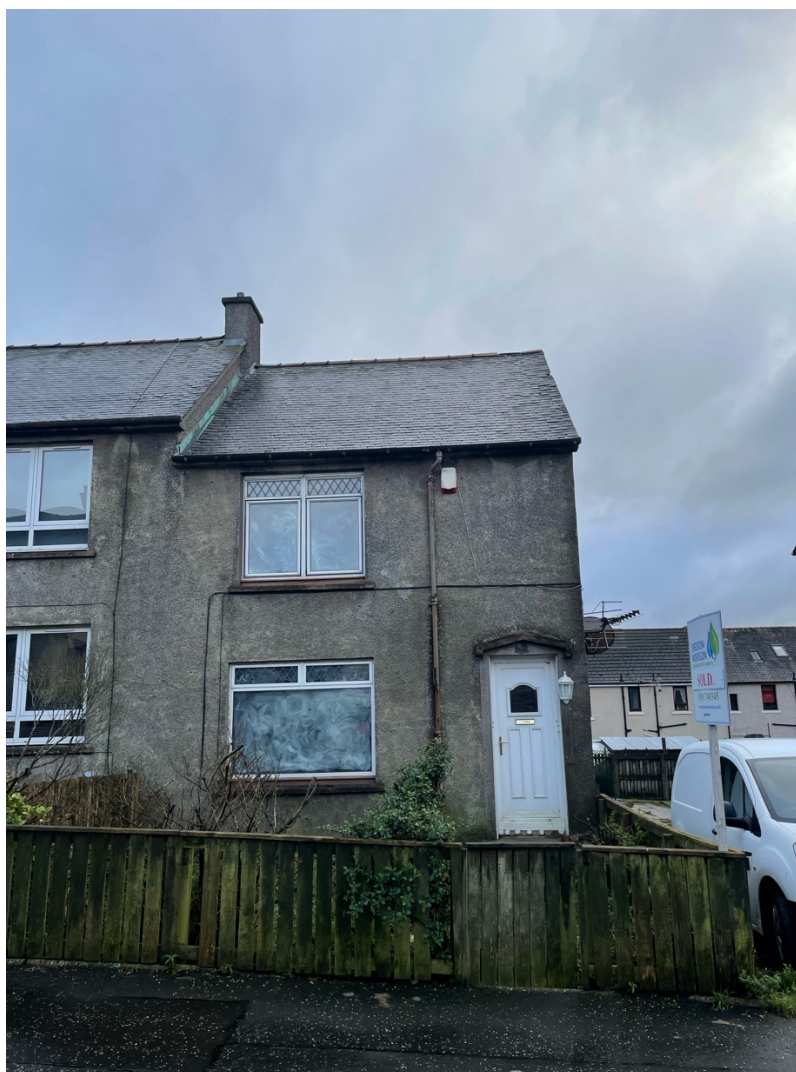
The site is located at 52 Lanrigg Avenue, Fauldhouse, within an area of built-up residential dwellings, and is at the end of a terrace block.

Figure 1 - Property in question.

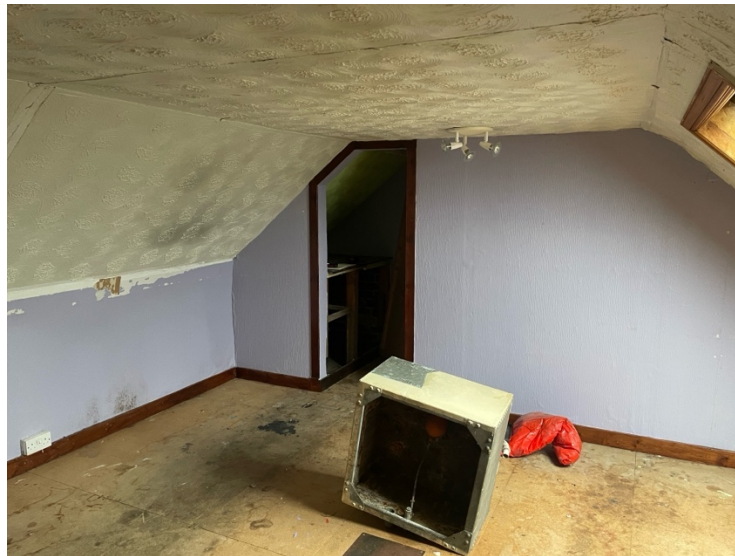
The existing trusses are traditional ridge plate and rafter construction which span from external wall to external wall with the ceiling ties taking no internal support. The trusses are at approximately 450mm c/c with the rafters being 50x135mm, bottom chords being 50x130mm and internal members being 50x75mm. These trusses sizes and spacings are consistent with a truss which has not been designed for habitable load with only insulation and plasterboard permitted to be secured to the bottom chord of the truss, with minimum storage allowance above.

Figure 2 – Current attic space.

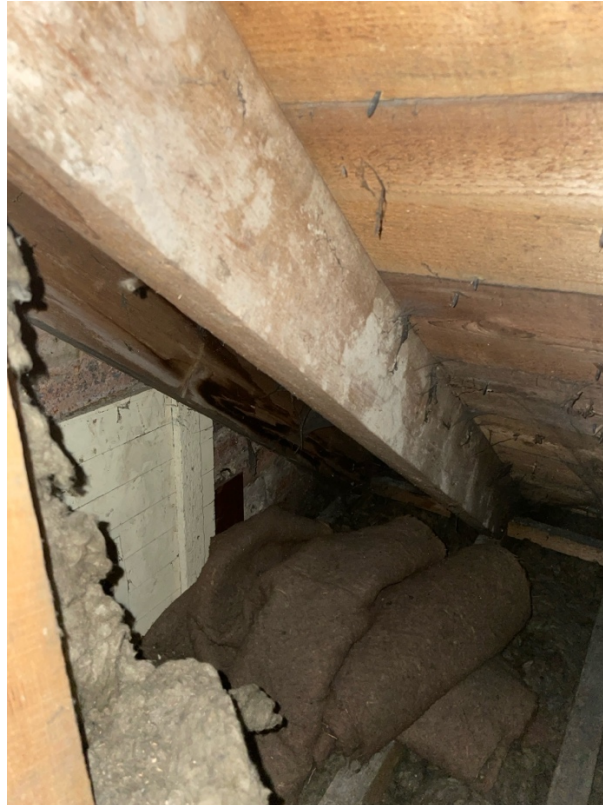
Figure 3 - Eaves space.

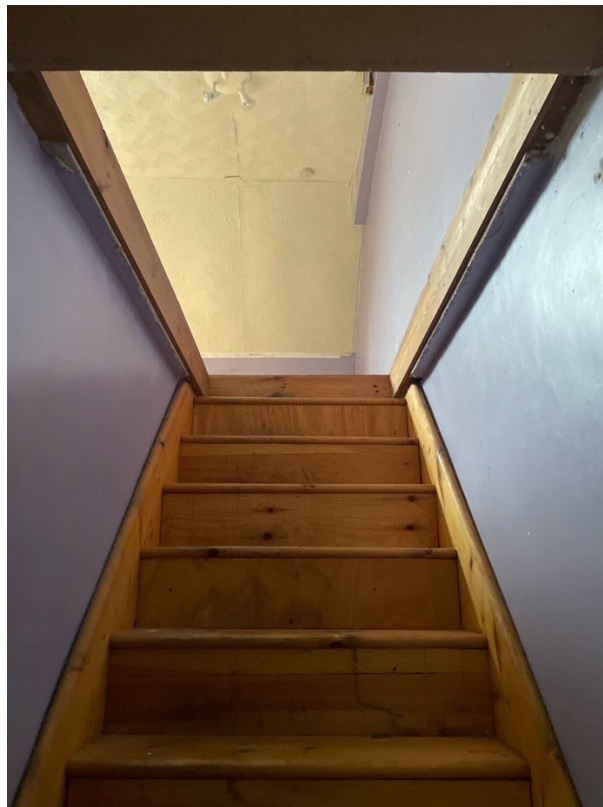
Figure 4 - Stair access.
