Home Report

Single Survey

Property address	Flat 1 Ness House Ness Road Fortrose IV10 8SD
Customer	Emma Cameron
Customer address	Flat 1 Ness House Ness Road Fortrose IV10 8SD
Prepared by	Shepherd Chartered Surveyors
Date of inspection	29/04/2025

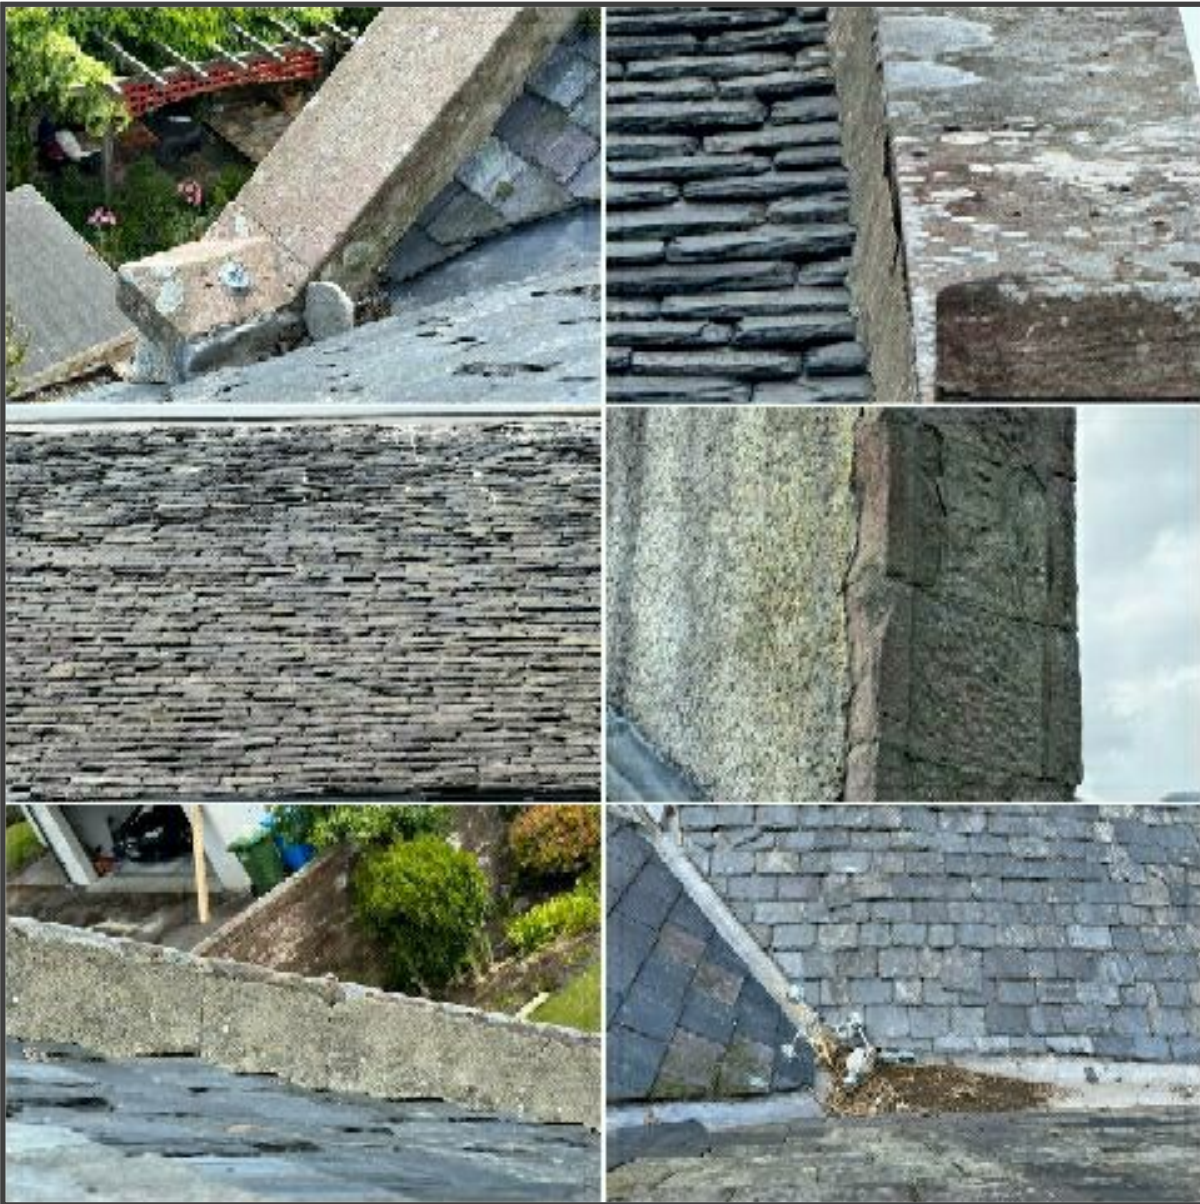
Defective cement work noted to the roof coverings which can lead to water penetration, failure to repair these could result in spoiling of internal wall fabrics and fungal decay to concealed timbers.

Slipped & broken slates were noted to the roof coverings.

We would recommend a competent builder or roofer thoroughly inspect the property's exterior and perform any necessary repairs to ensure the water tight integrity of the building.

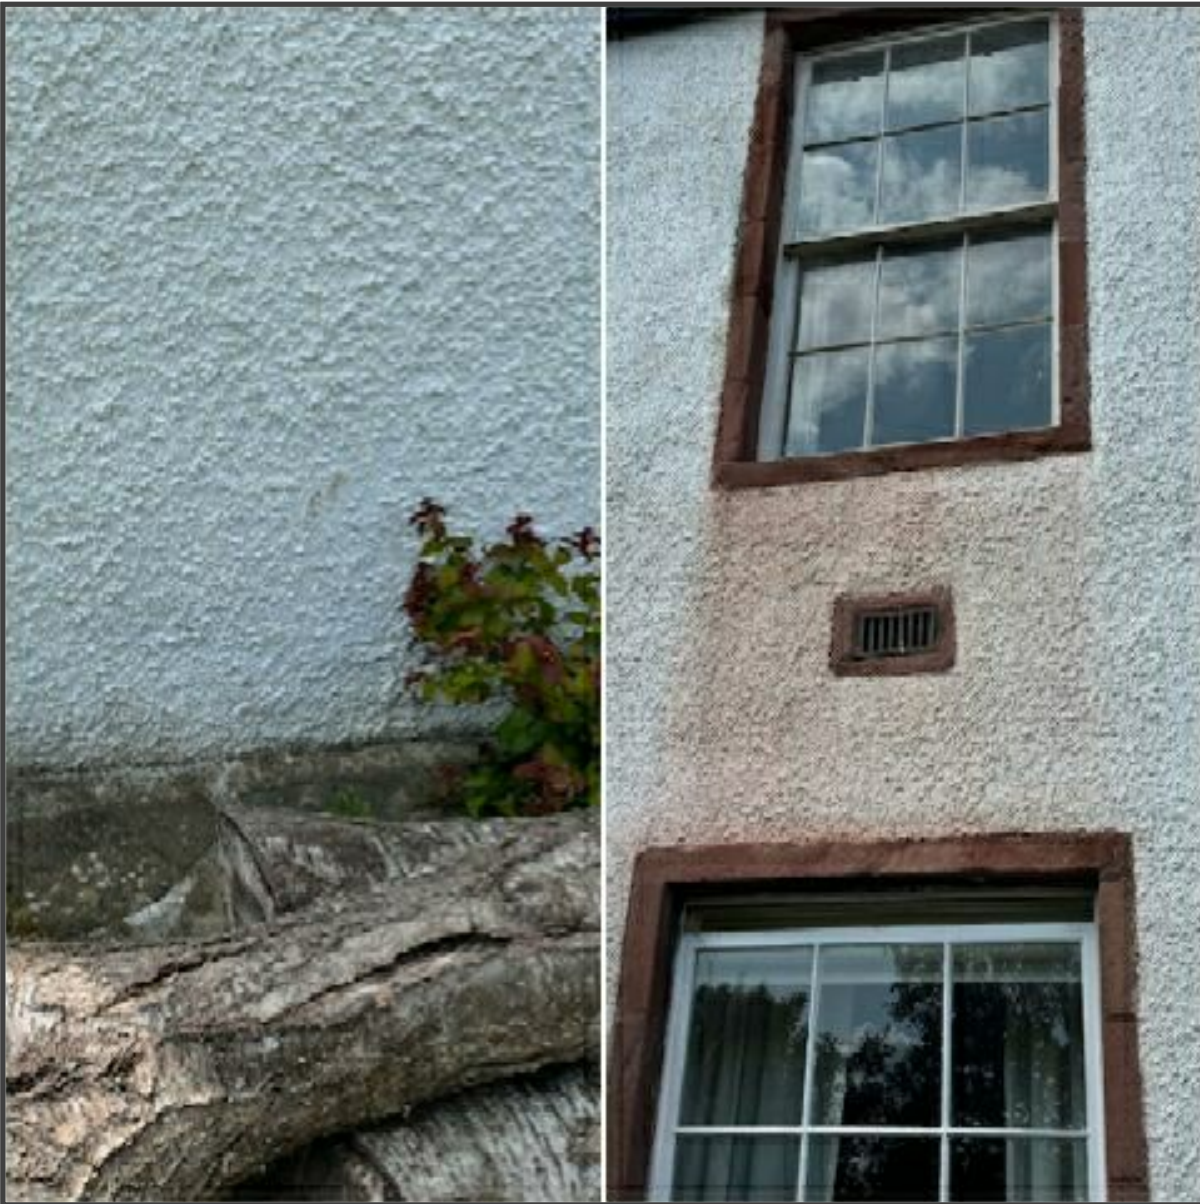
Staining indicative of excessive water running down the render was noted which may lead to water penetration through the walls, failure to repair this could result in spoiling of internal wall fabrics and fungal decay to concealed timbers.

Render is at ground level which if not of waterproof nature, moisture can bridge through the render and into the interior

In conclusion, external render reaching the ground heightens the risk of damp ingress, structural decay, thermal inefficiency, and aesthetic deterioration. Remedial actions, including raising the render above DPC levels where exists, improving drainage systems, and maintaining the integrity of the DPC where exists, are essential to protect the building against moisture-related issues and preserve its long-term sustainability.

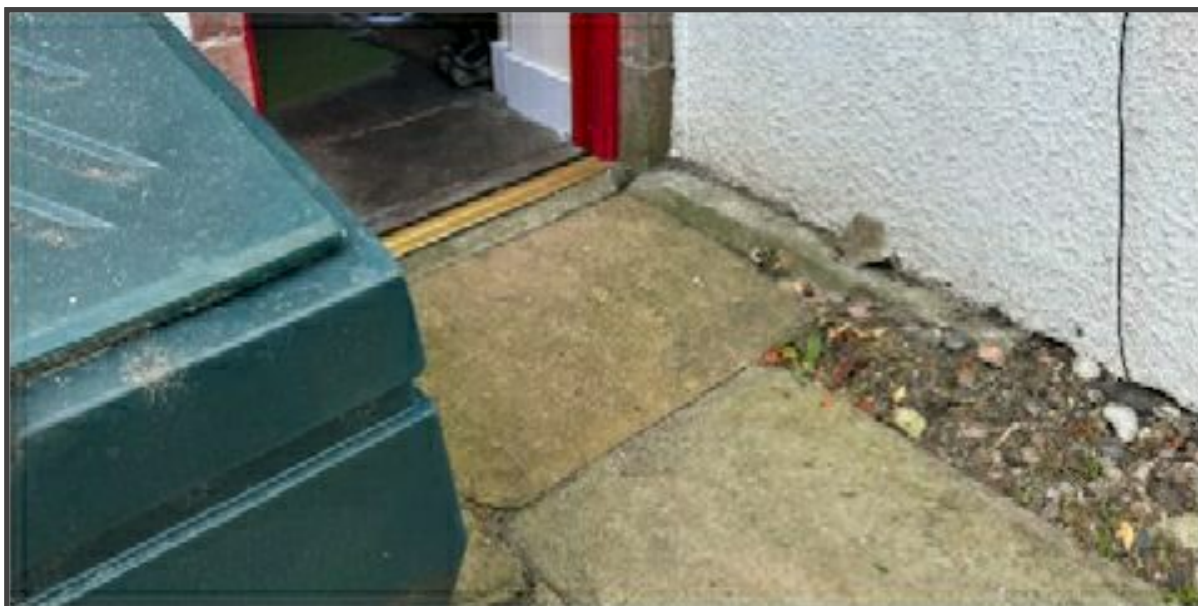
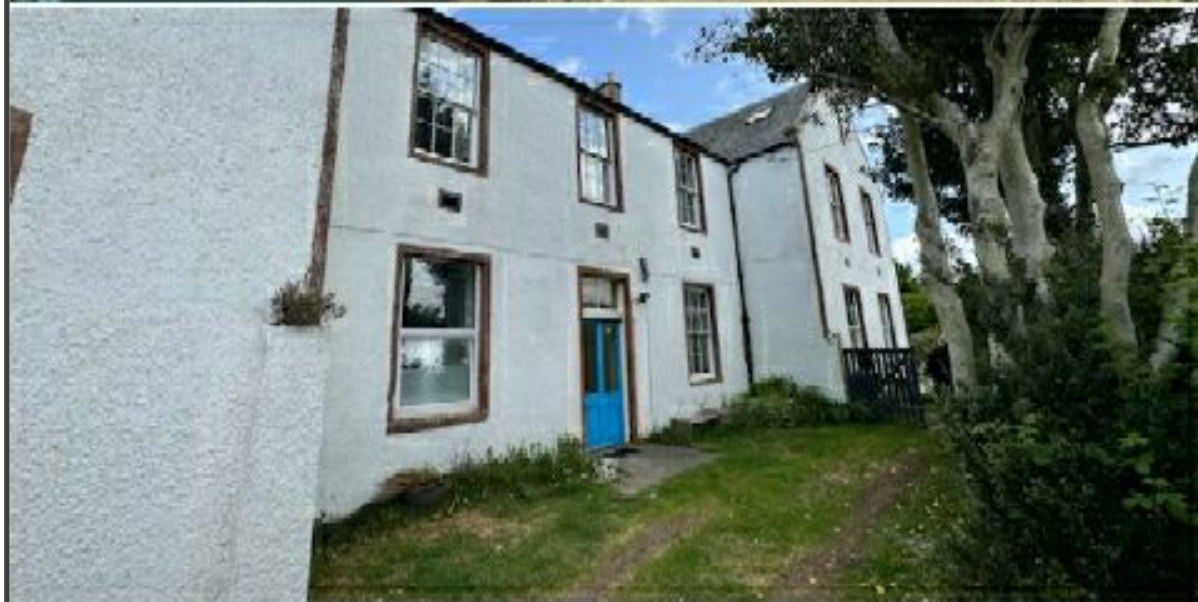
External ground level was high in areas in relation to internal floor level which may lead to water penetration.

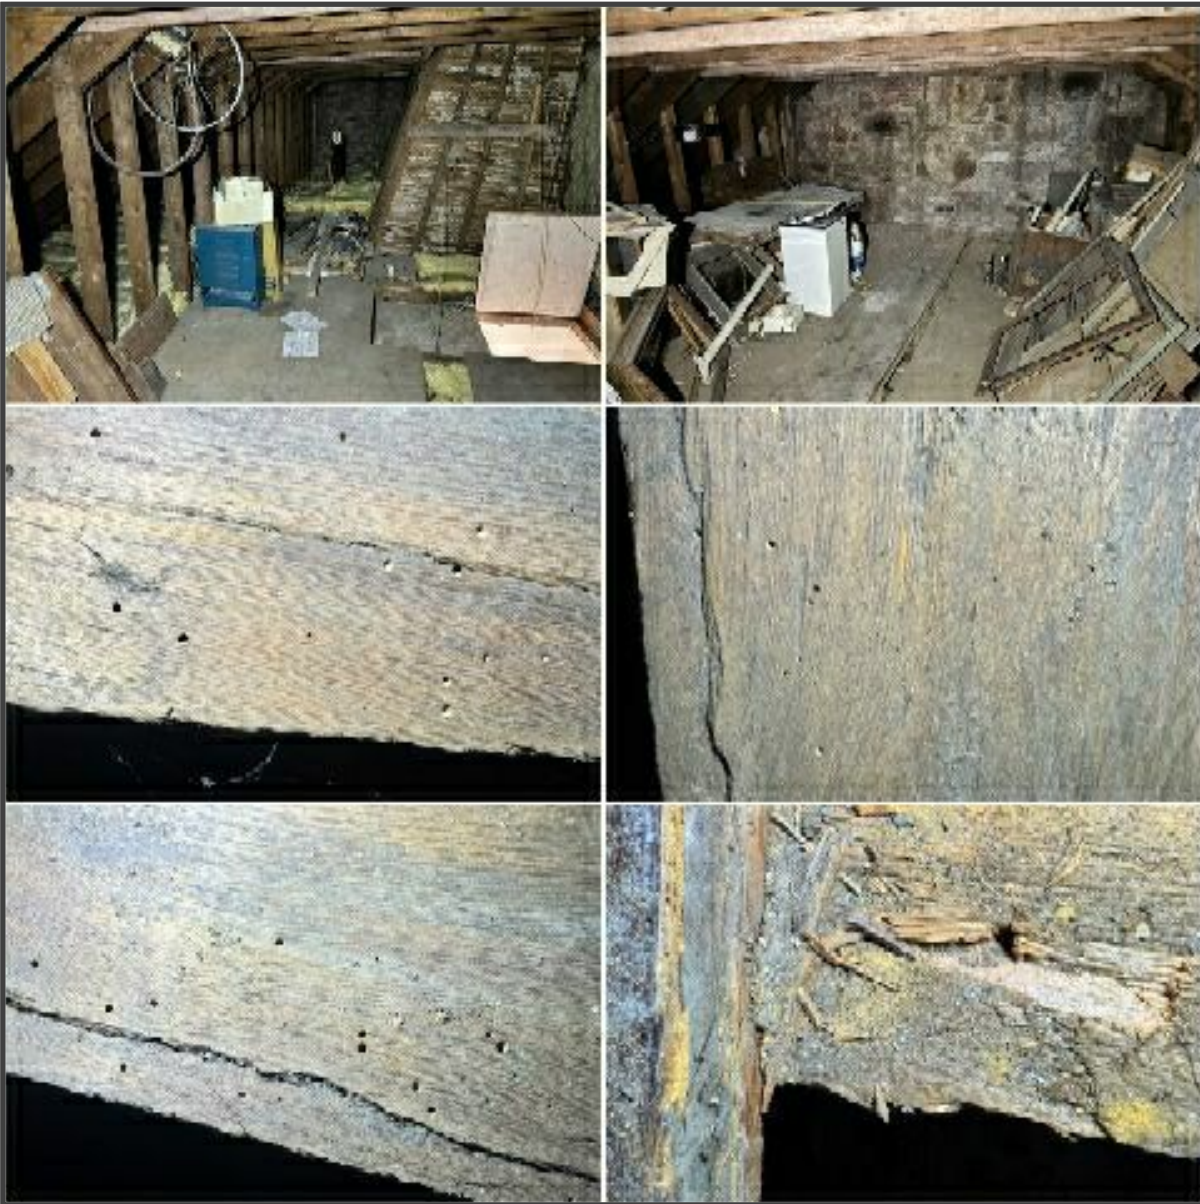
Evidence of an infestation by the common furniture beetle (*Anobium Punctatum*) was found to be present.

This wood-boring insect is responsible for about 75% of all woodworm damage in this country and will attack softwood and hardwood.

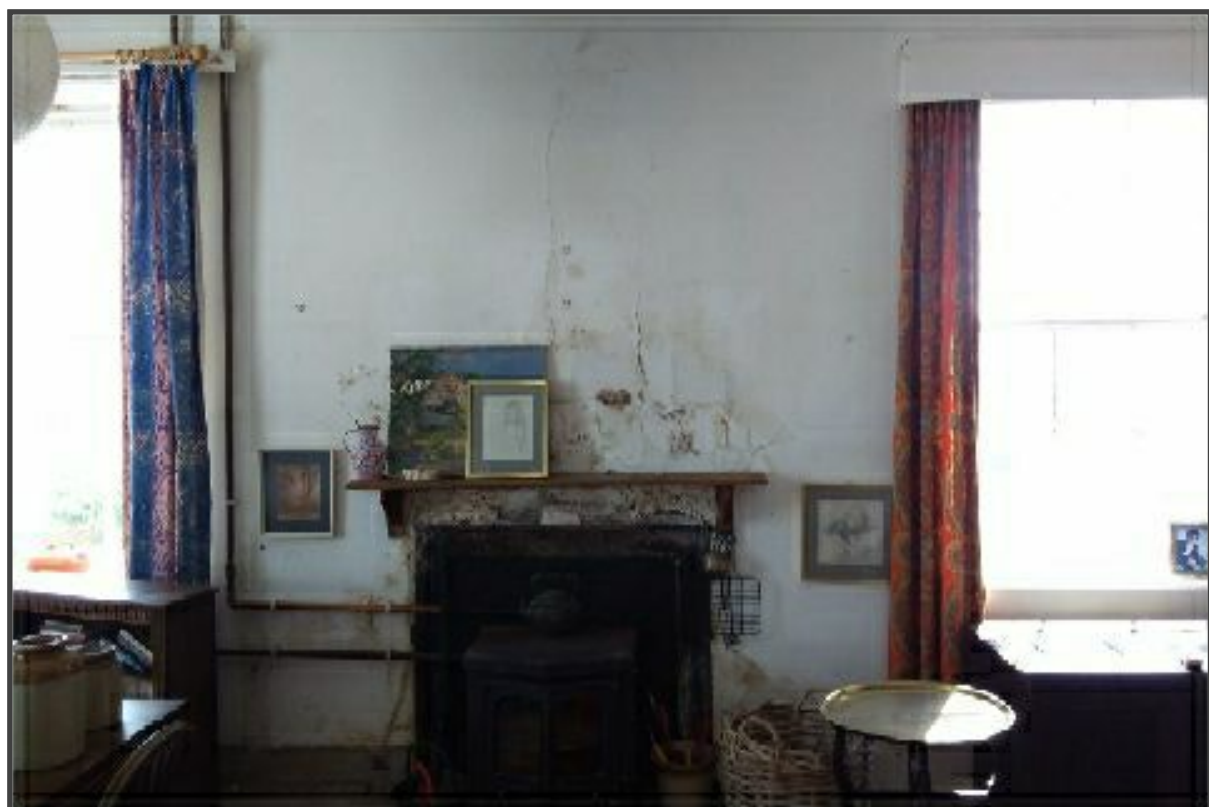
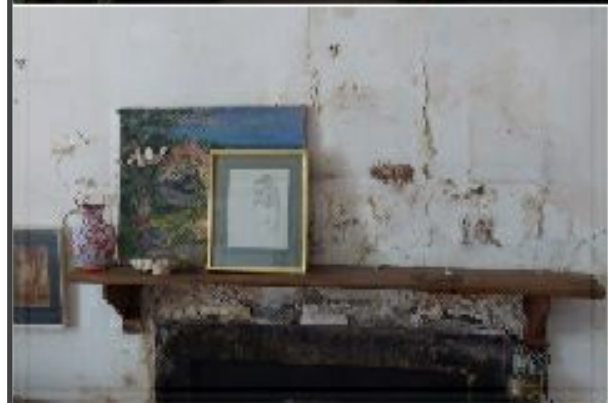
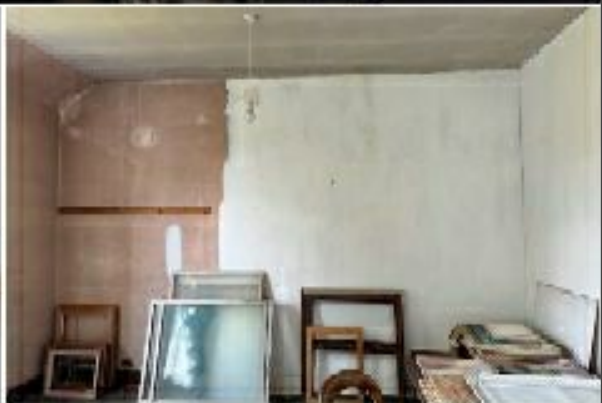
Our inspection of the internal ceiling & wall surfaces of the property was carried out by a visual inspection and by the use of an electrical conductivity meter; As highlighted in the first three sets of collage photos above, this indicated penetrating damp to be present in the ceiling of the Hallway & the walls of the Lounge, Kitchen and rear left Bedroom designated for treatment on our enclosed sketch plan.

Damp staining was noted to areas of ceiling plaster and wall surfaces throughout the property as can be seen in the fourth set of collage photos above, when tested these areas were found to be dry and appeared historic (plaster repairs works may be required to these areas by the clients own contractor prior to any decoration being carried out).

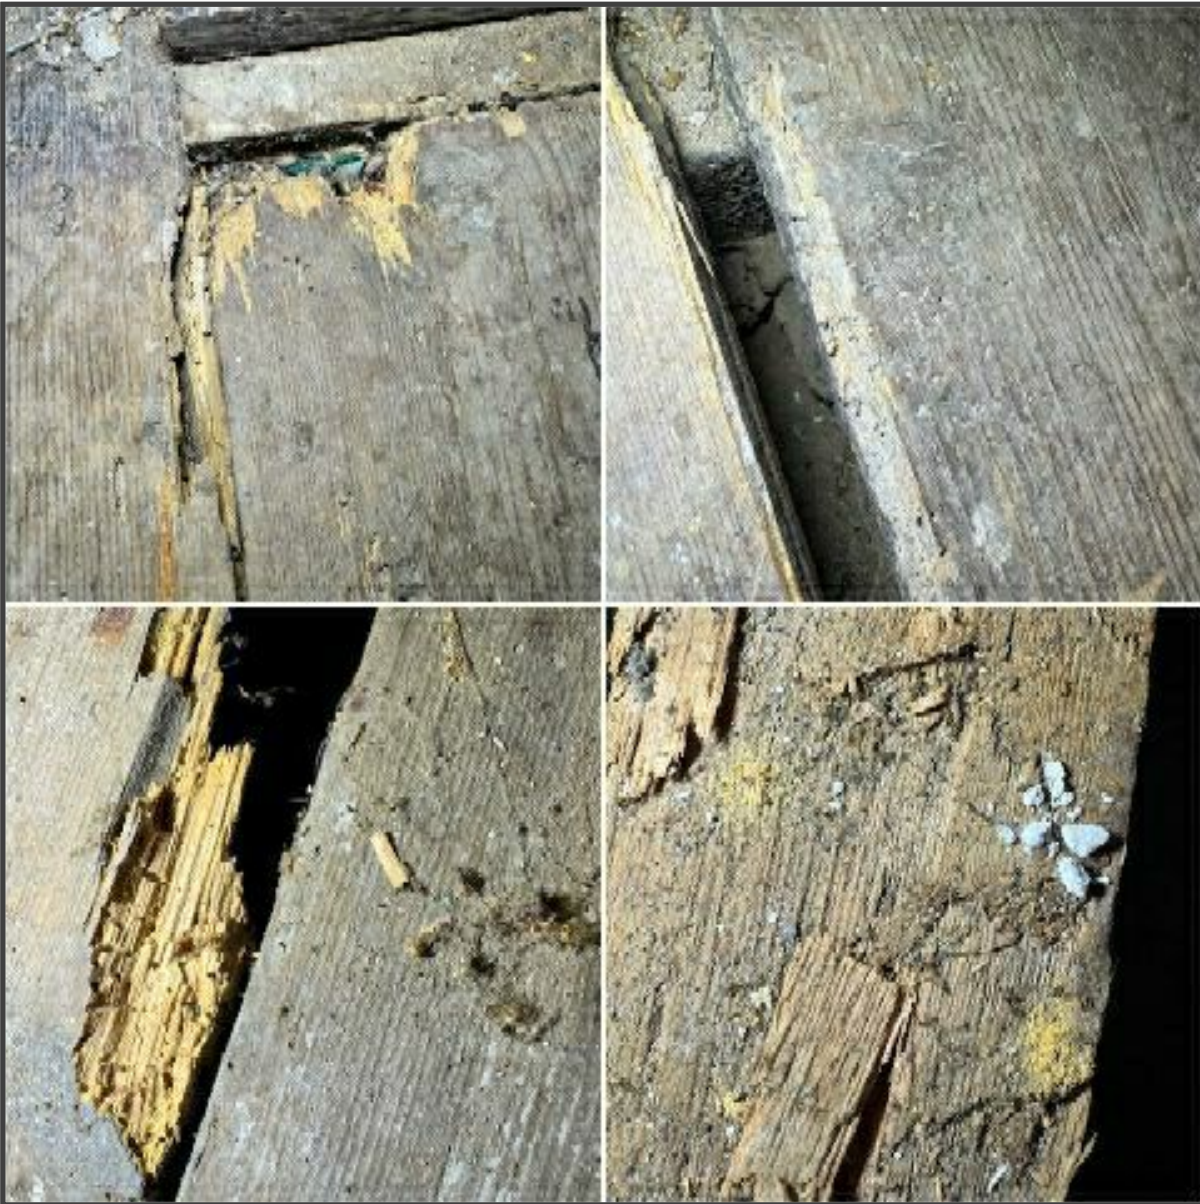
Evidence of an infestation by the common furniture beetle (*Anobium Punctatum*) was found to be present.

This wood-boring insect is responsible for about 75% of all woodworm damage in this country and will attack softwood and hardwood.
