Asbestos-Containing Building Material

Refurbishment Survey Report

Project 3618AS1059

6 Station Road, Port Talbot.

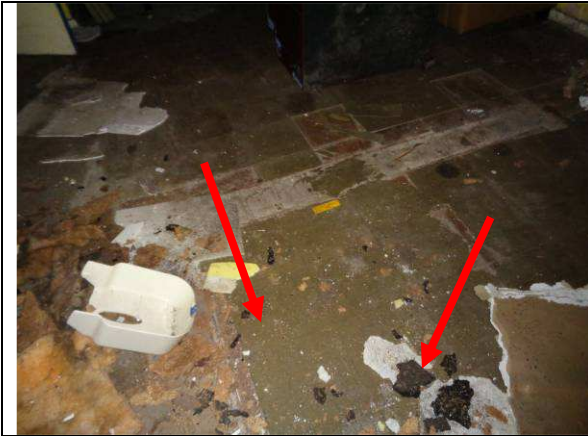
3618AS1059-006 & 013

Recommendation	Last date ACM inspected	Last date ACM modified	Note	Licensed work?
A			NGAR5 780-3	3618AS10 59-006	2nd Floor	Club - Lounge, sink room - Floors	Adhesive	Bitumen adhesive & paints	Positive asbestos sample	30SM	NA	2	0	1	4	NA	NA	Remove	28/08/15			NNLW
A			NGAR5 780-5	3618AS10 59-010	External	Rear roof - Roof coverings	Roof slates	Cement - Fully comp flat sheet, tiles, slates & boards	Positive asbestos sample	120SM	NA	0	1	1	3	NA	NA	Remove	28/08/15			No*
