## **SURVEY REPORT**

**Property:** 39 Loudoun Road  
Newmilns  
KA16 9HJ

**Ref No:** 11635

Property Description: Terraced House

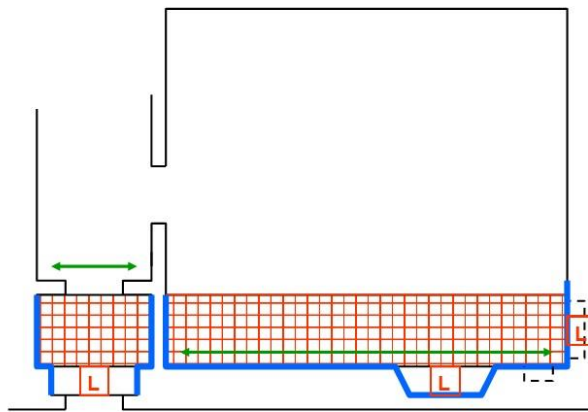
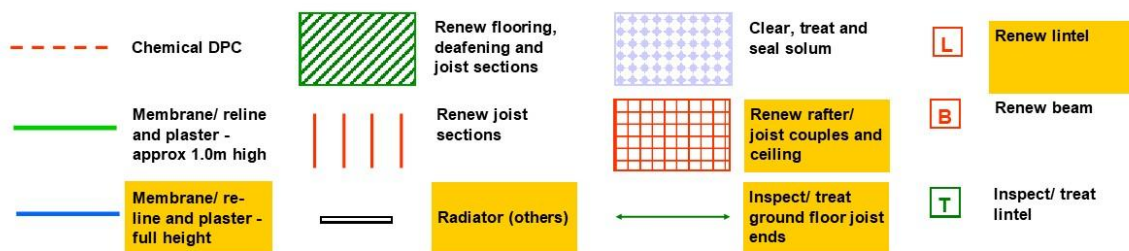
### Part Ground Floor Plan—Front

Moisture ingress has occurred along the front elevation due to external defects to roof, rainwater goods and stonework which all require to be attended to by others.

This, together with decay noted to timbers around alcove and gas meter recess and significant deflection to ceiling along front elevation leads us to strongly suspect substantial decay will be affecting concealed structural timbers.

Carefully strip out and remove wall linings to areas and heights as indicated and clear all accumulated debris behind.

Carefully hack off and remove existing wall plaster to areas and heights as indicated.

Completely strip out and remove alcove.

Carefully strip out and remove ceiling linings along front elevation.

Shore and support roof structure and carefully cut out and remove all joist end, rafter ends and associated wallplate along front elevation.

Shore and support masonry as necessary and remove timber lintels as indicated.
