# Renovation of 17 Green Walk SK8 4BN

| Project name | 17 Green Walk SK8 4BN |
| Address | 17 Green Walk, Gatley, Cheadle, Storbritannia |
| Conducted by | Farhad Hamahusseini, 15.11.2024 21:34:55 |

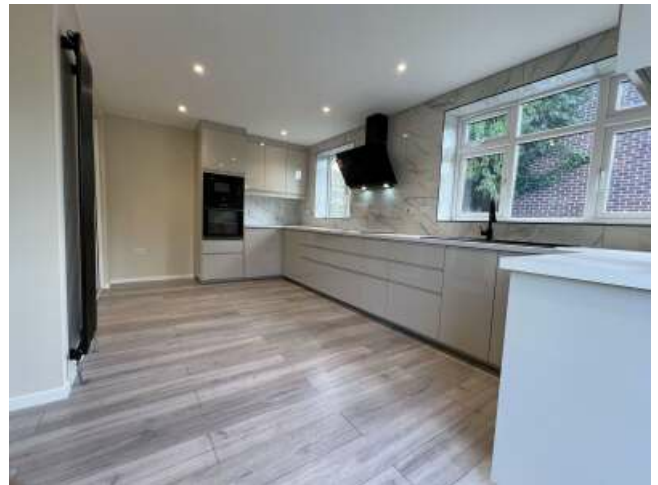
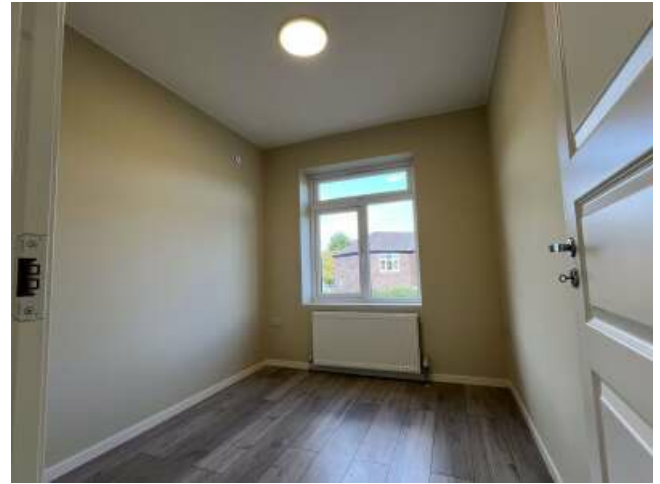
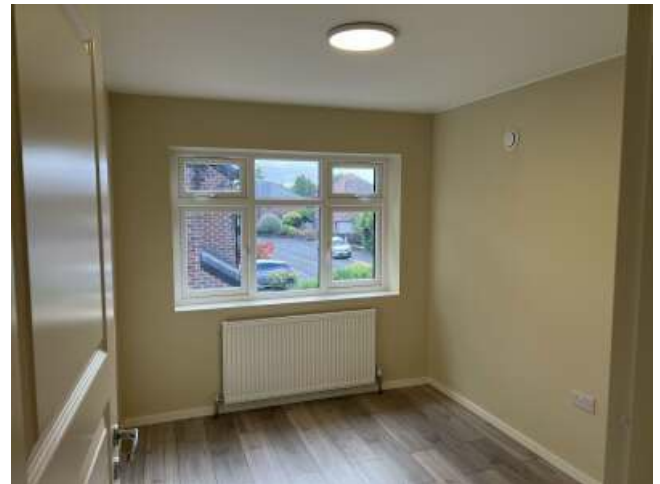
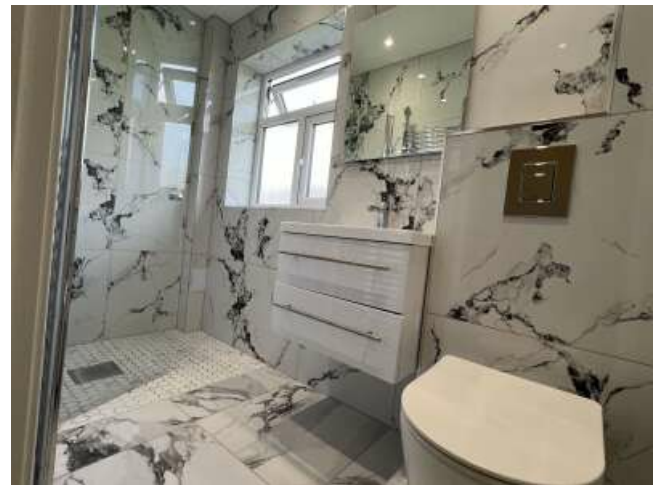
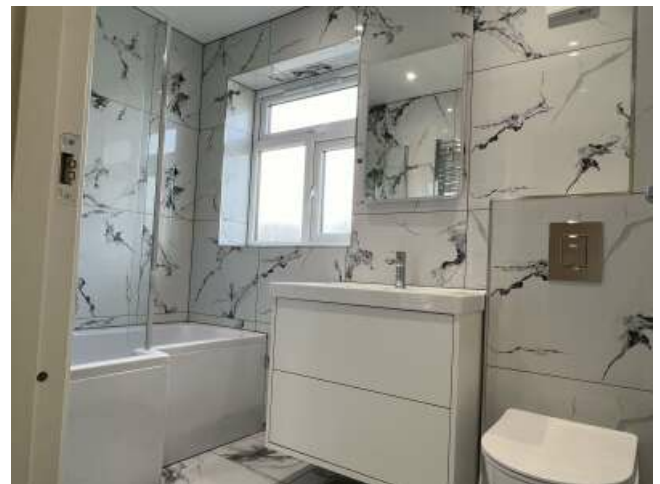
| Pictures of the house's new interior | The pictures show the completed renovation of the interior of the house, including the living room, hallway, porch, bedroom, and kitchen. | ✓ |

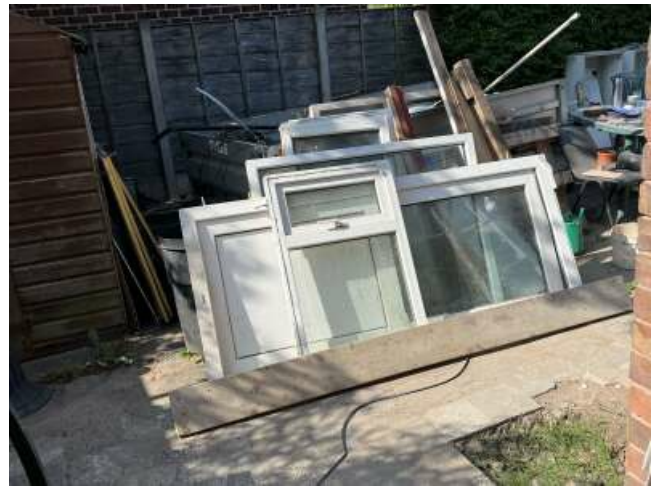
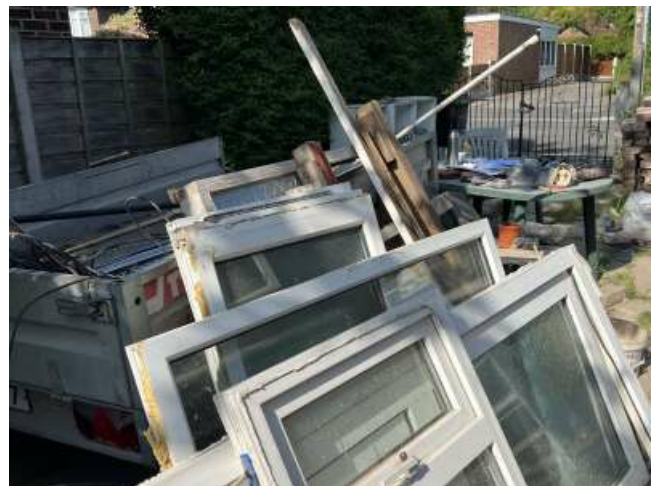
| Demolition | Demolition of plastering, ceiling plasterboard, and windows. | ✓ |

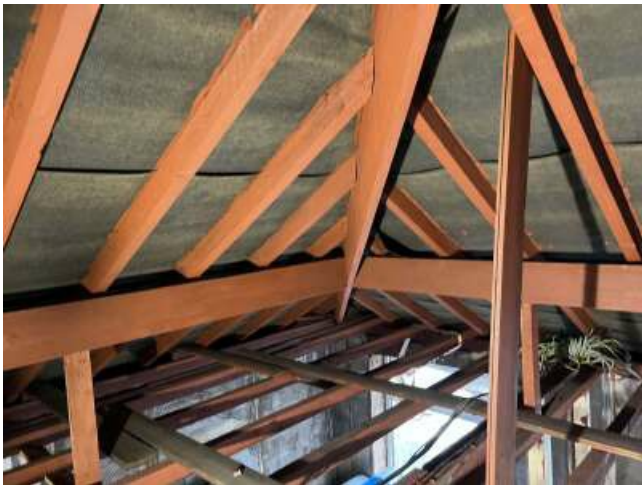
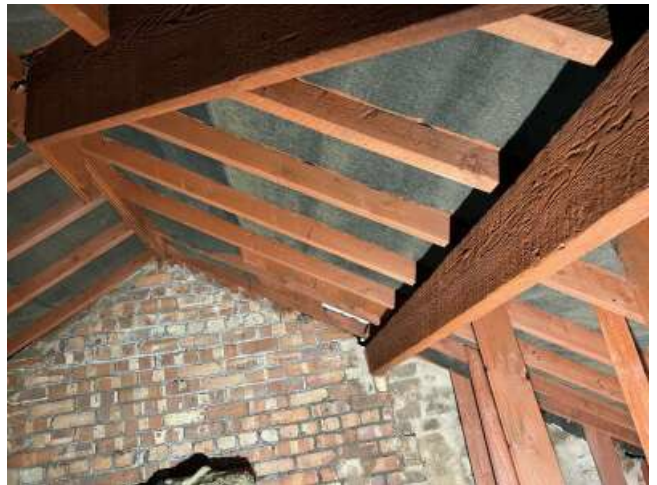
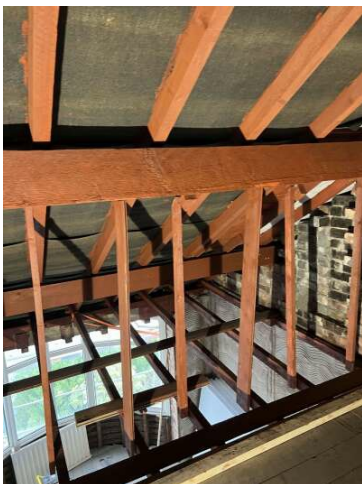
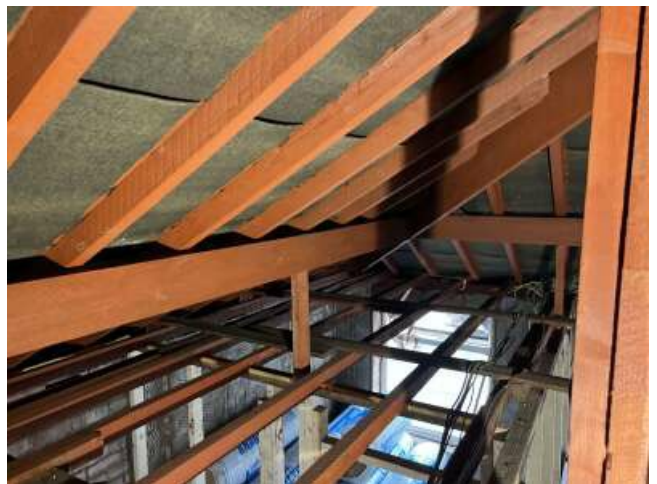
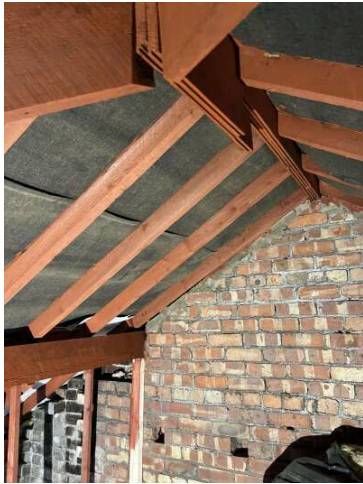
| Cleaning | Cleaning and painting of ceiling structure. | ✓ |

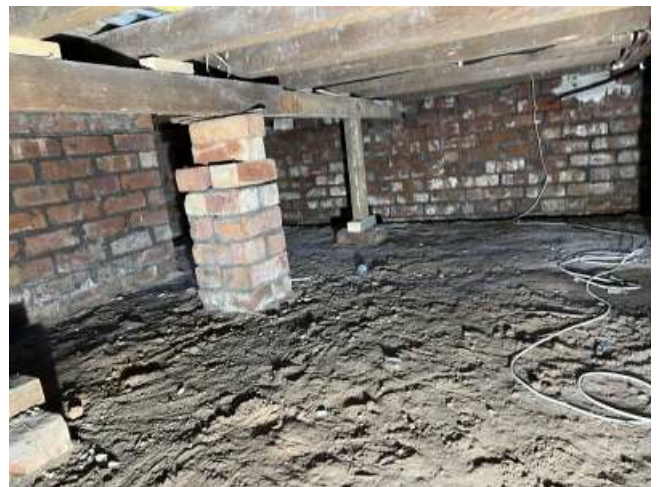
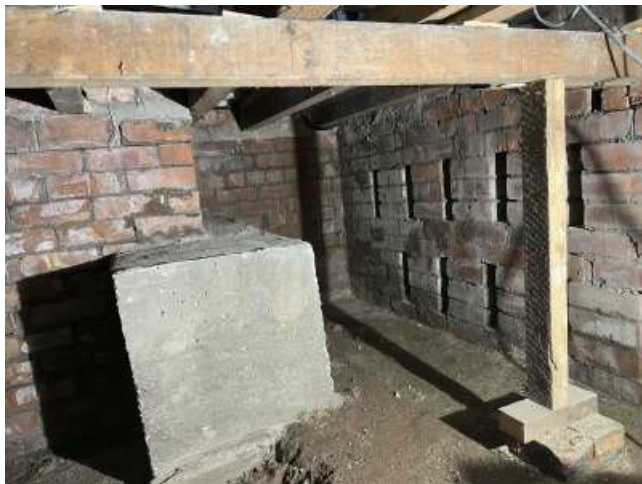
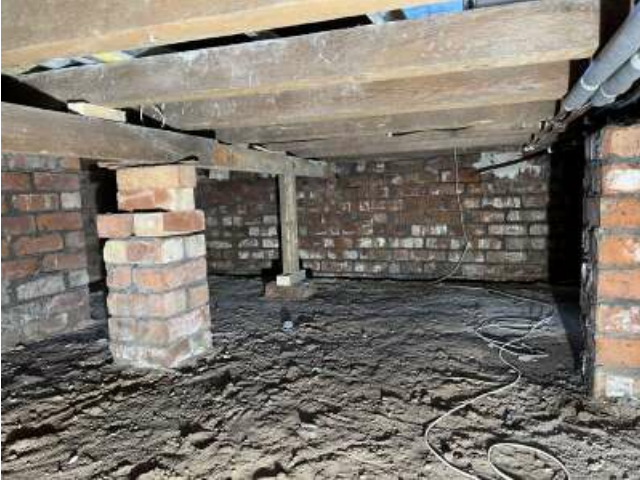
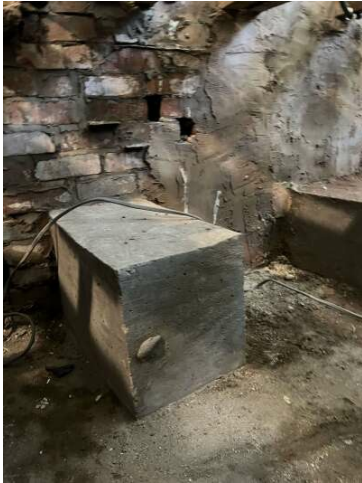
| Reinforcement of walls beneath foundations | The pictures show the crawl space basement, including the cleaning and reinforcement of the concrete beam under the foundation. | ✓ |

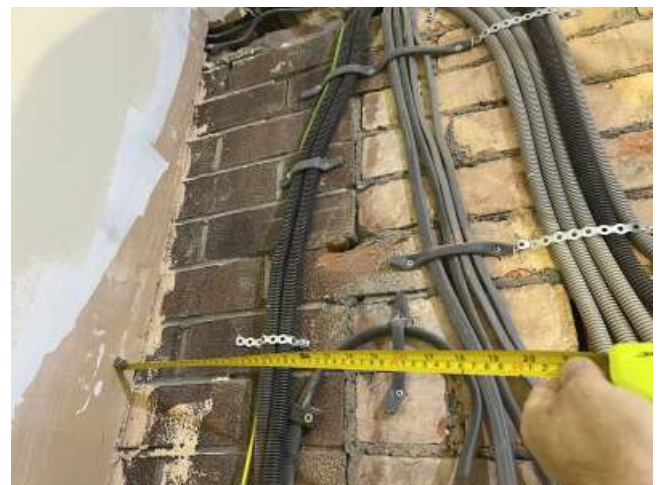
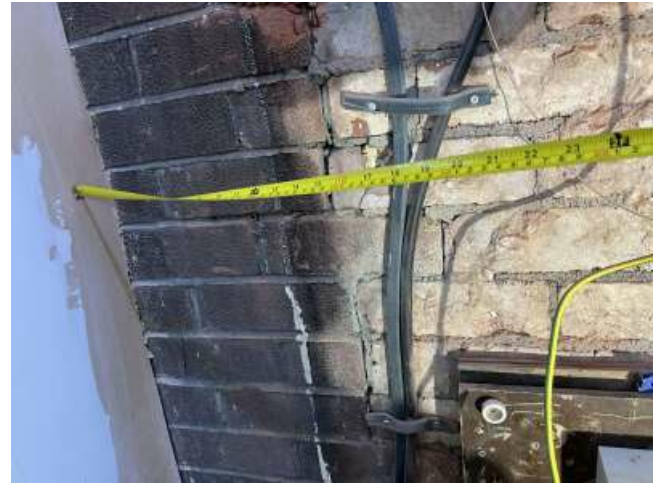
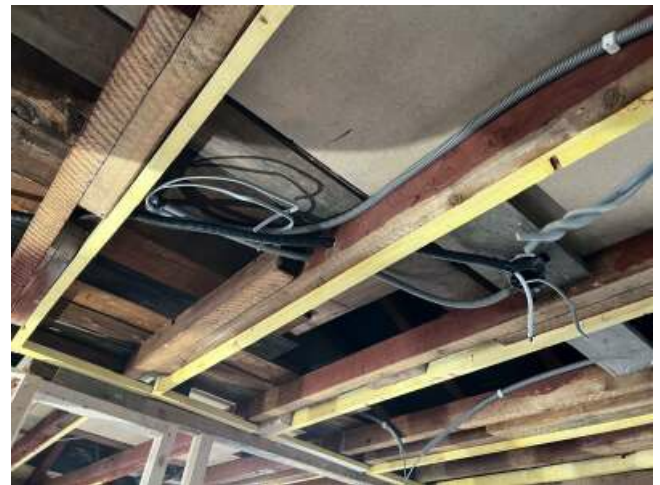
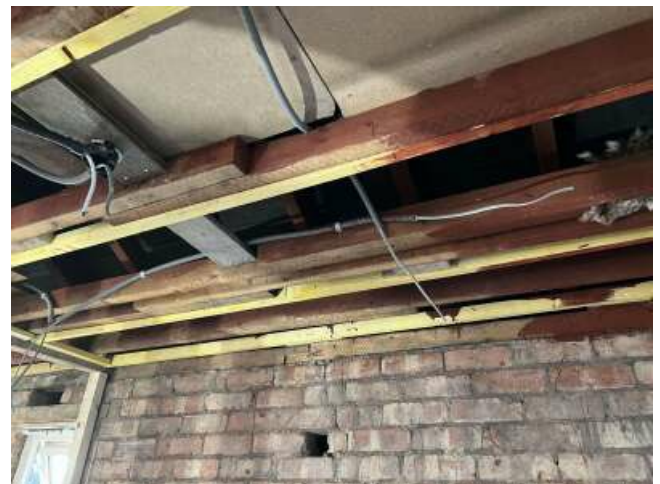
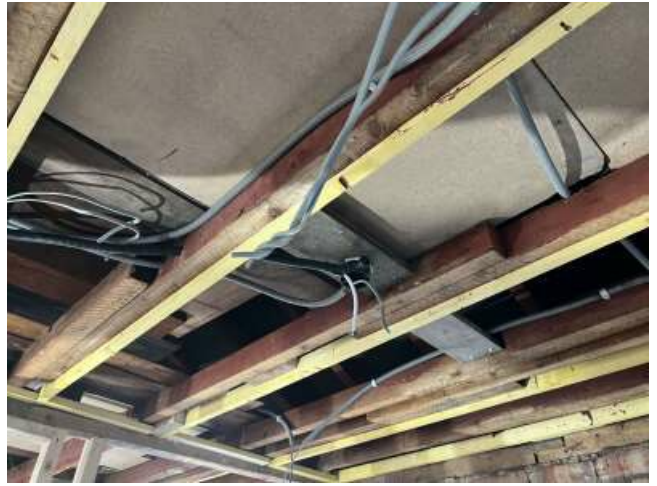
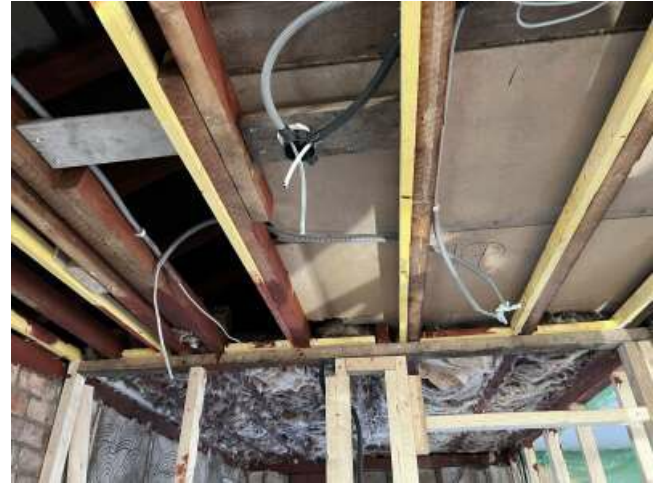
## Electrical

| Electrical work | | |
|---|---|---|
| Electrical | New electrical wiring to living room, bedroom 1, 2, 3, and 4. New electrical cables and wall boxes for kitchen, hallway, porch, and exterior. New cable for electric car. New fuse box. | ✓ |

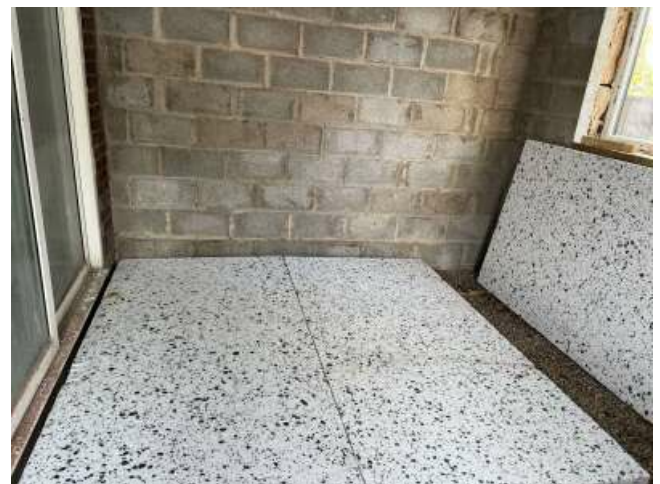
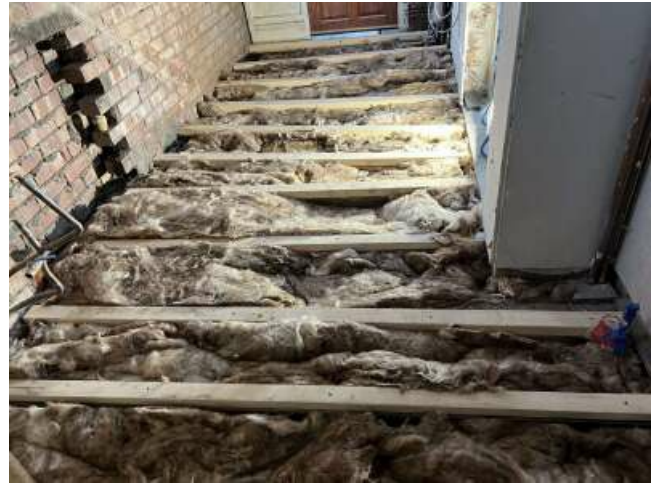
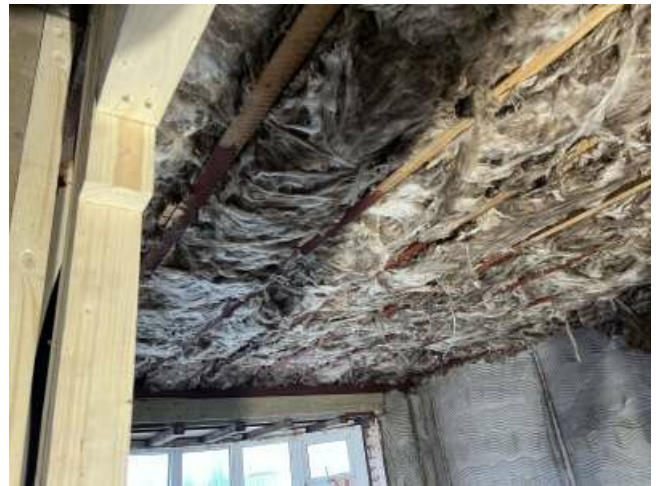
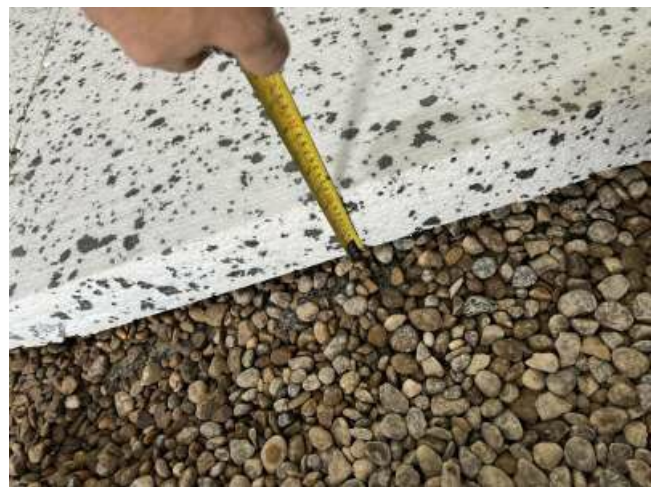
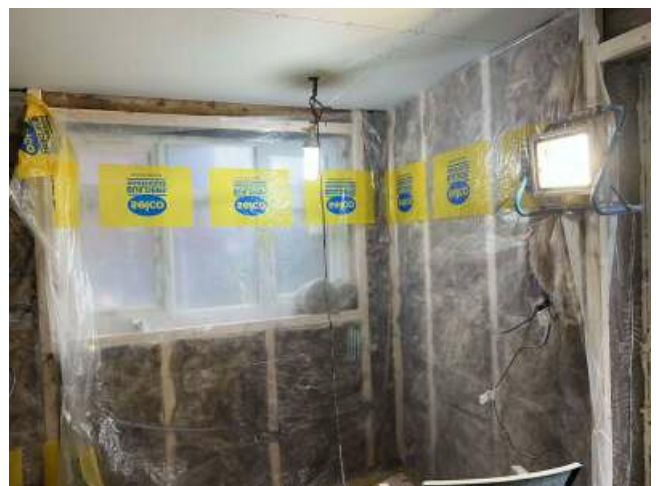
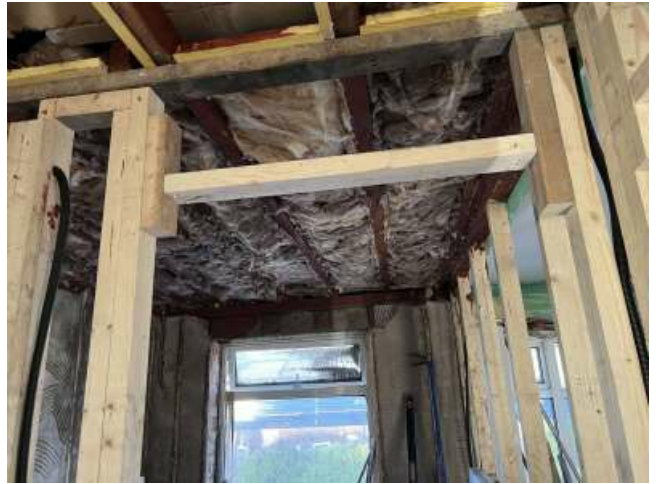
## Insulation

| Insulation | | |
|---|---|---|
| Insulation | Insulation of attic with 300mm insulation, insulation of interior walls in floor 2 with 100mm insulation, insulation of floor 2 ceiling with 200mm insulation. Insulation of floor in floor 1 with 200mm. Insulation of exterior walls with 150mm. Insulation of floor in extension with 100mm. Insulation in ceiling of extension with 300mm. | ✓ |

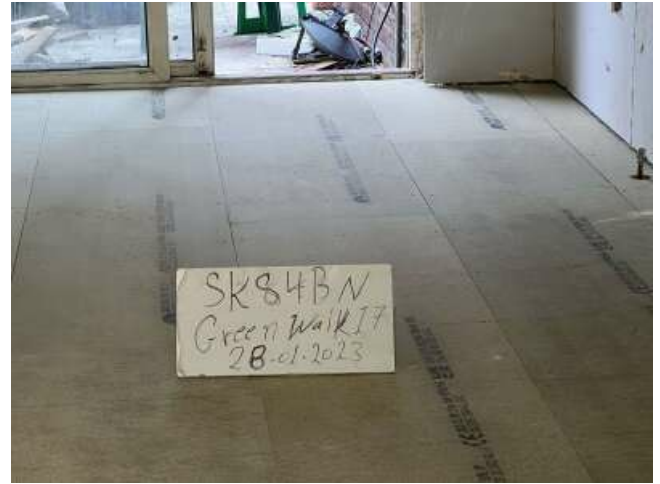
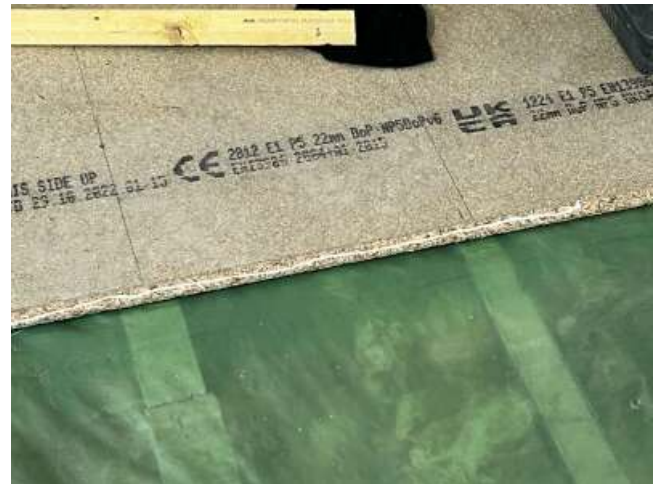
| Floorboard installation | | |
|---|--|---|
| Installation of 22mm chipboard in first floor | | ✓ |

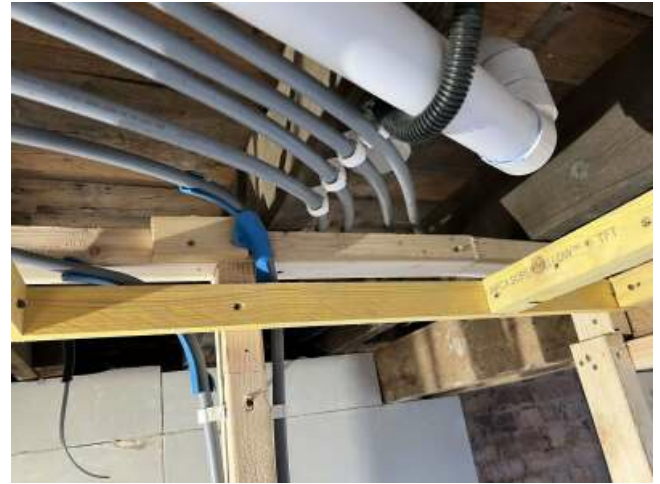
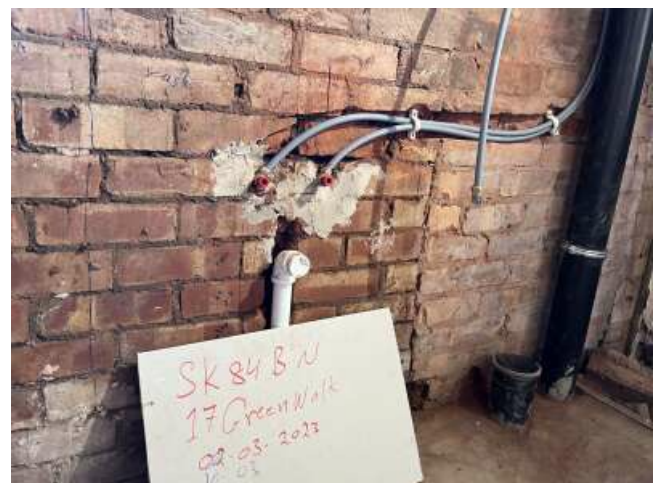
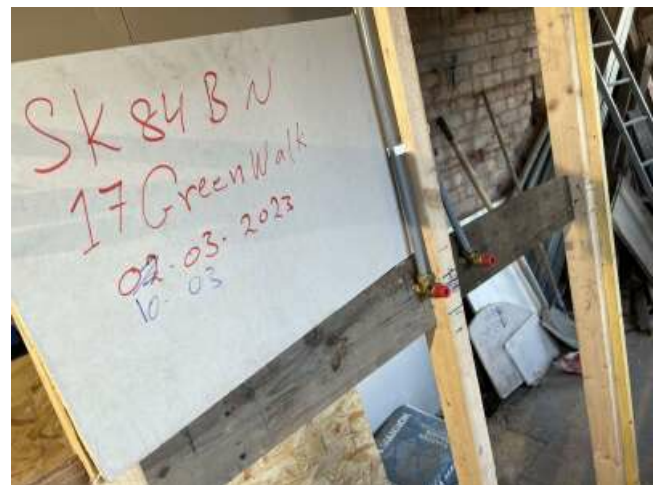
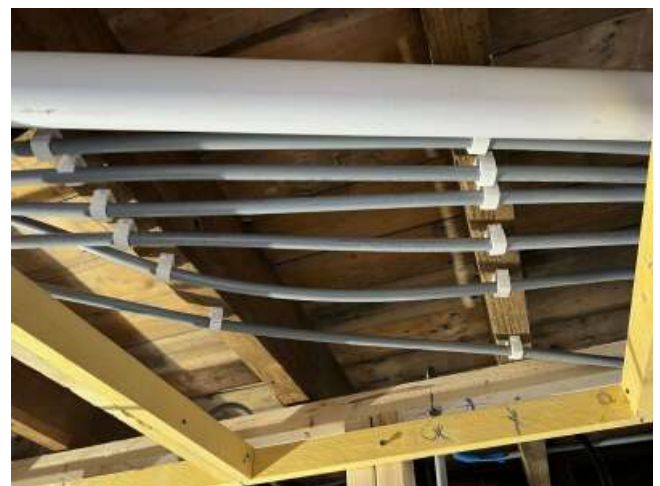
| Interior plumbing work | | |
|---|---|---|
| Plumbing work | All interior pipes are new. New drainage and sewer pipes to the bathroom on floor 1, kitchen, and bathroom on floor 2, as well as new drainage and sewer pipes in the laundry room under the stairs. | ✓ |

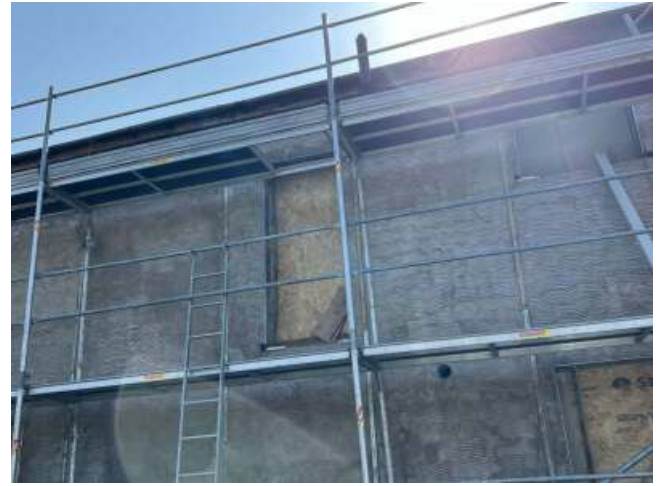
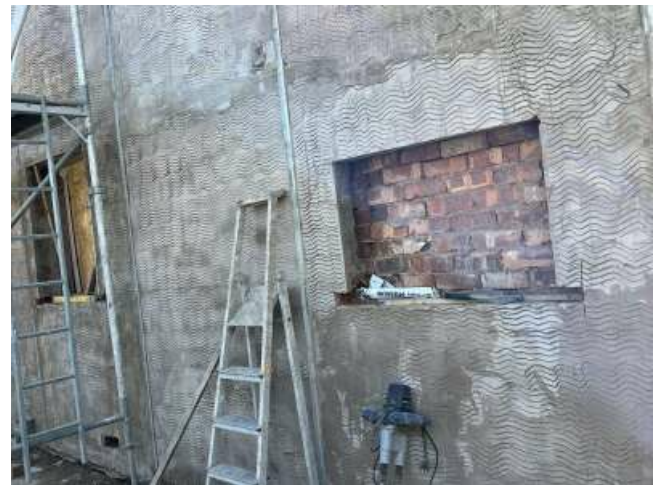
Exterior rendering ✓

| Exterior rendering | Exterior rendering of all exterior walls. After rendering, a white sand-based silicone facade finish will be applied to protect against moisture. | |

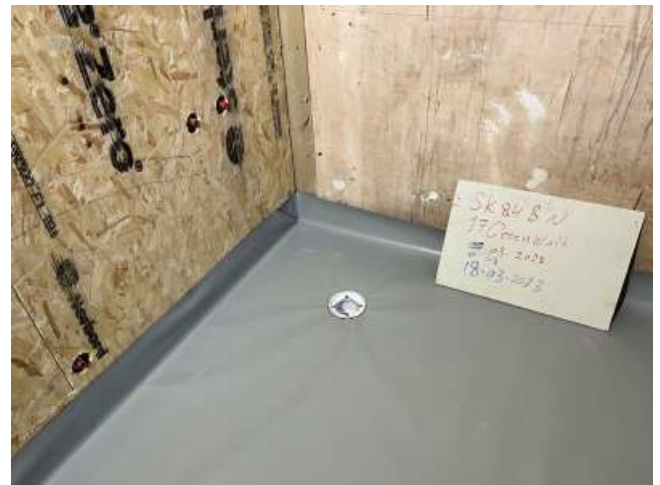
| Installation of Protan G 1.6 welding membrane | Installation of Protan G 1.6 welded membrane on bathroom floors to ensure 100% waterproofing in all bathrooms on floors 1 and 2, and in the laundry room under the stairs. This type of membrane is sourced from Norway and is specifically designed for wet rooms. It is resistant to mold and mildew, which cannot thrive on this material. This membrane is not available in the UK, and this project is the only one using this type of membrane. Full testing of the bathroom floors has been conducted by filling the entire bathroom floor with approximately 10 cm of water for 48 hours without any leakage. | |

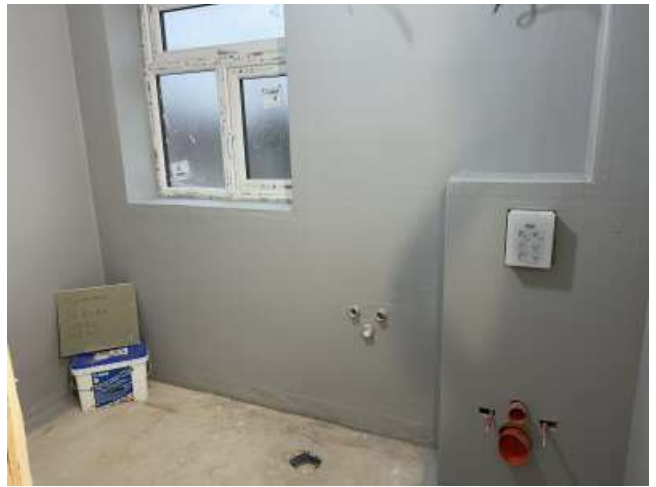
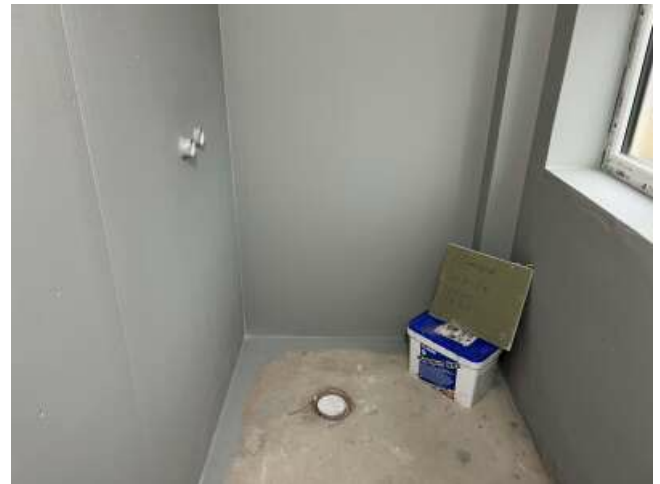
| Installation of Mapei Waterproofing membrane | <p>For the walls, MAPEI Mapegum WPS has been used, applied in three coats to ensure complete waterproofing. All walls are fully sealed, making it impossible for water damage to occur from the walls or floor. The area behind built-in toilets is also waterproofed with Mapegum WPS, as shown in the pictures.</p> <p>Warning: The bathroom floor must not be drilled or punctured, as it contains underfloor heating cables, and puncturing the floor would damage the welding membrane. The walls must also not be drilled or punctured due to water pipes and electrical cables inside the walls. If you need to hang or attach something to the walls, please refer to the provided pictures to identify safe areas for fixing anything. However, the floor must never be drilled or punctured. If the floor is drilled or punctured, it could damage the heating cables and compromise the waterproofing. Extreme caution is required.</p> | ✓ |

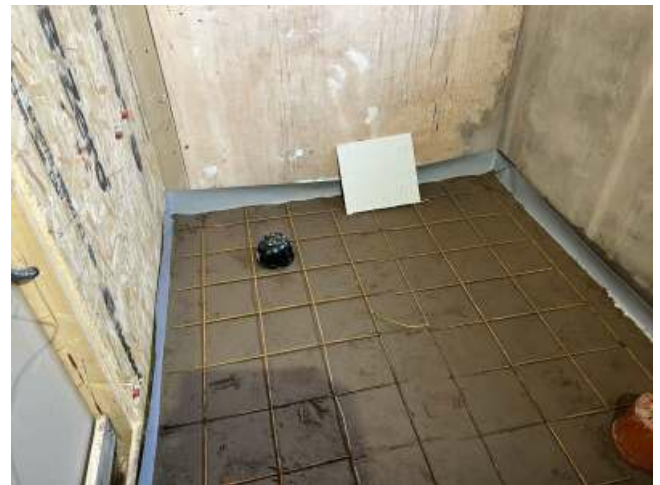
| Bathroom work | | |
|---|---|---|
| Floor installation | <p>The bathroom floor is constructed with lightweight concrete sloping toward the drain, with a grounding mesh for the electrical wiring. The floor is insulated in the first layer, followed by the installation of a welding membrane, and then the tiling is applied.</p> <p>Warning: The bathroom floor must not be drilled or punctured, as it contains underfloor heating cables, and puncturing the floor would damage the welding membrane. The walls must also not be drilled or punctured due to water pipes and electrical cables inside the walls. If you need to hang or attach something to the walls, please refer to the provided pictures to identify safe areas for fixing anything. However, the floor must never be drilled or punctured. If the floor is drilled or punctured, it could damage the heating cables and compromise the waterproofing. Extreme caution is required.</p> | ✓ |

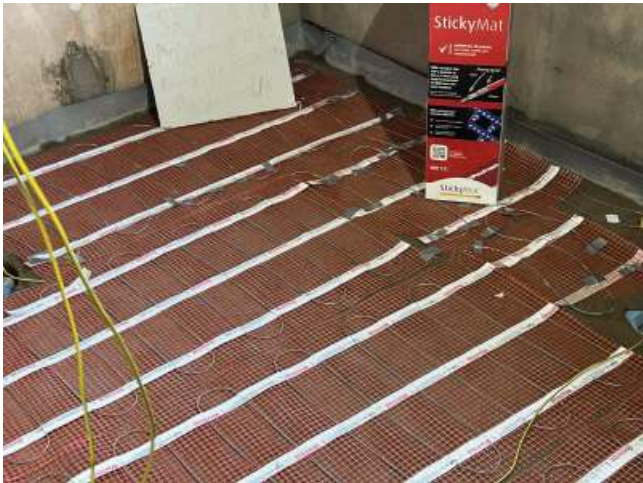
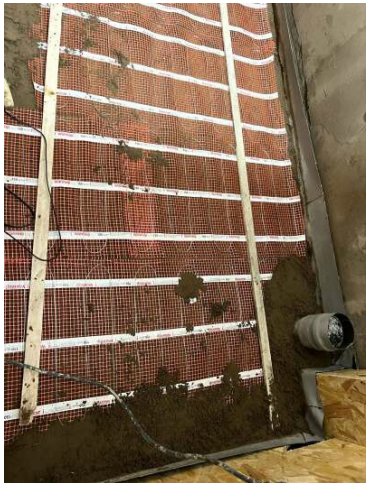
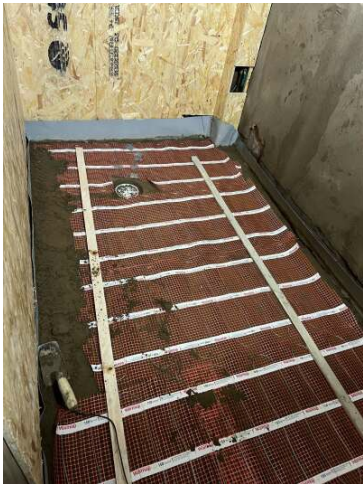
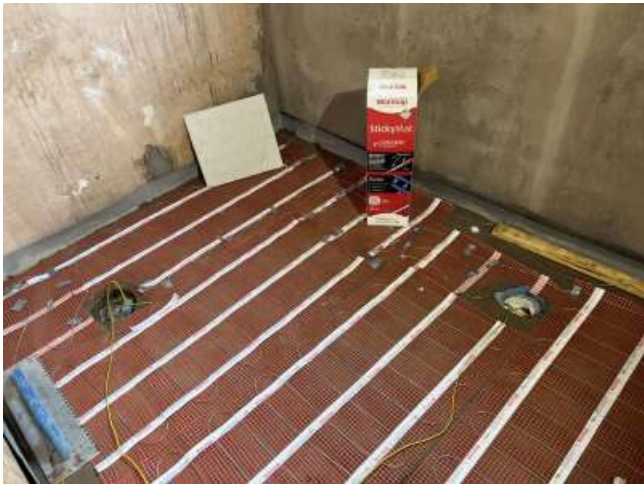
| Bathroom work | | |
|---|---|---|
| Installation of underfloor heating | <p>Bathroom work includes sealing from floor to ceiling, with underfloor heating installed in the bathroom floors on both the 1st and 2nd floors.</p> <p>Warning: The bathroom floor must not be drilled or punctured, as it contains underfloor heating cables, and puncturing the floor would damage the welding membrane. The walls must also not be drilled or punctured due to water pipes and electrical cables inside the walls. If you need to hang or attach something to the walls, please refer to the provided pictures to identify safe areas for fixing anything. However, the floor must never be drilled or punctured. If the floor is drilled or punctured, it could damage the heating cables and compromise the waterproofing. Extreme caution is required.</p> | ✓ |

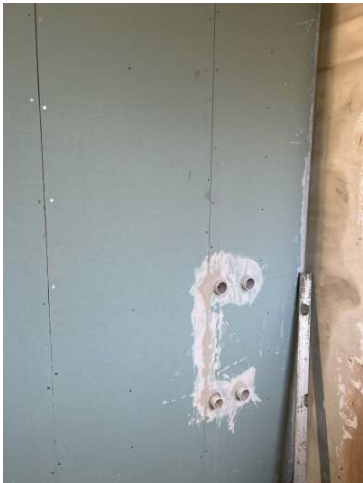
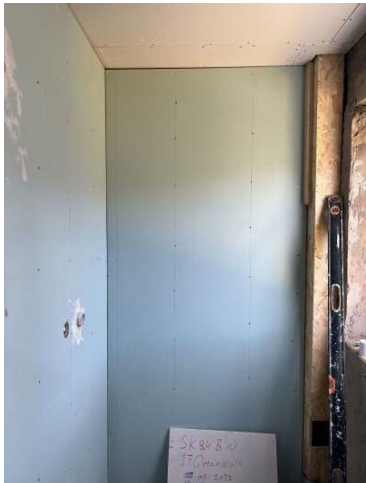
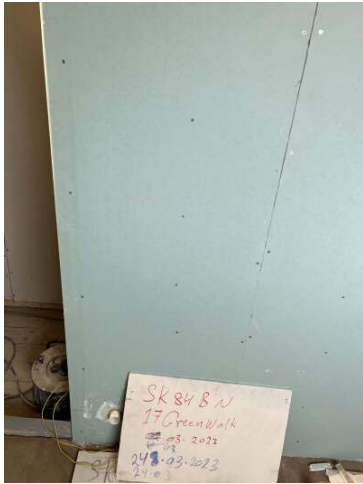
| Installation of OSB boards and moisture-resistant plasterboards on walls and roof | The walls are constructed with a 12mm OSB board layer, followed by a 12.5mm plasterboard layer that is moisture-resistant and suitable for bathrooms in the UK. Mapegum WPS has been applied over the walls to ensure 100% waterproofing. | ✓ |

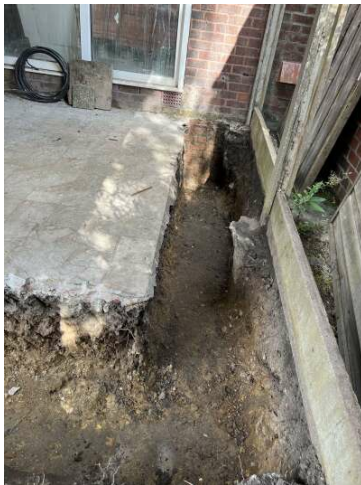
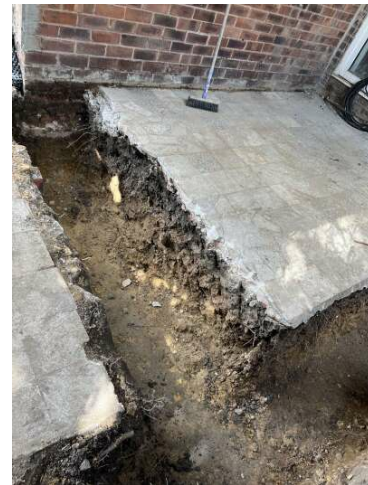
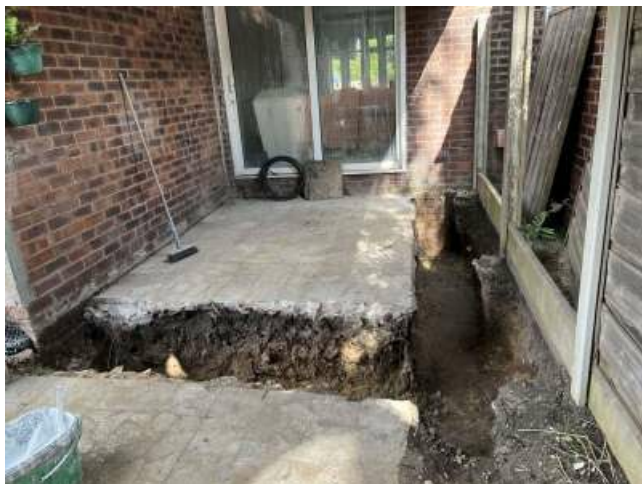
## Excavation

| Excavation | New extension to expand the kitchen. Excavation more than 1 meter deep for foundation work, compacted and filled with stone material. | ✓ |

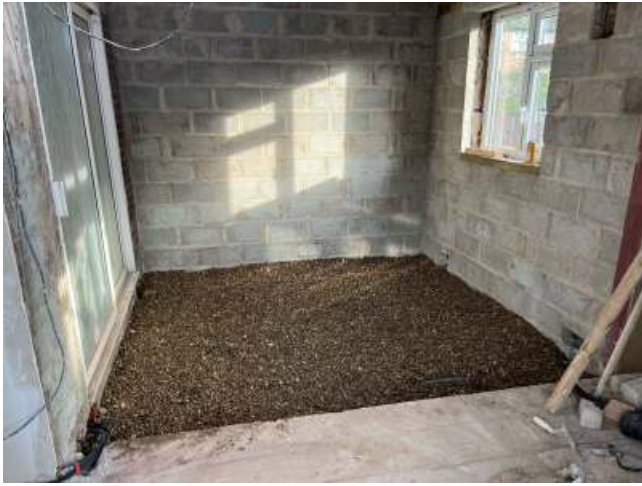
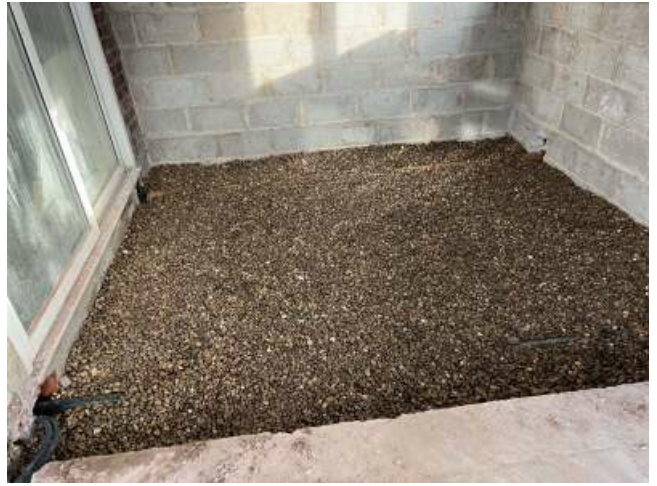
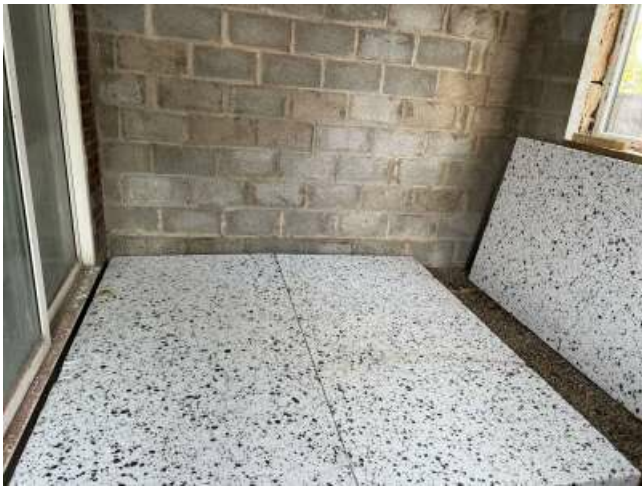
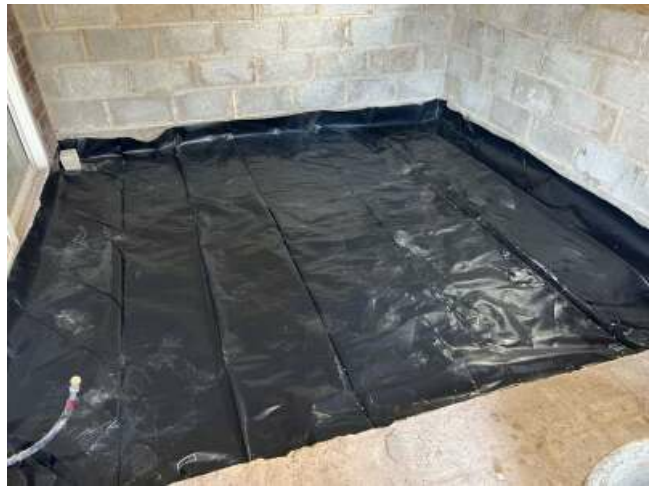
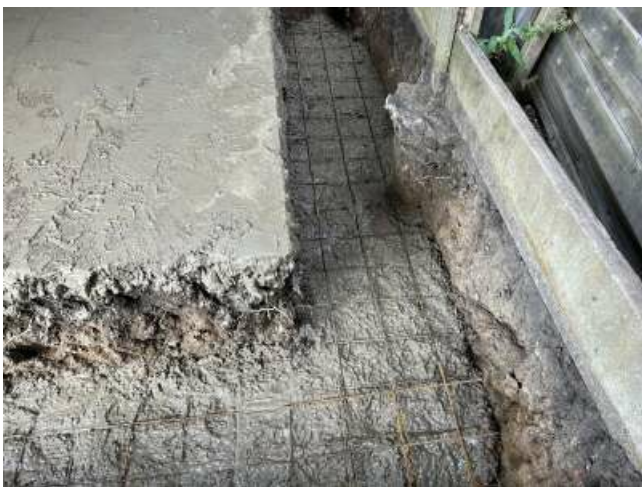
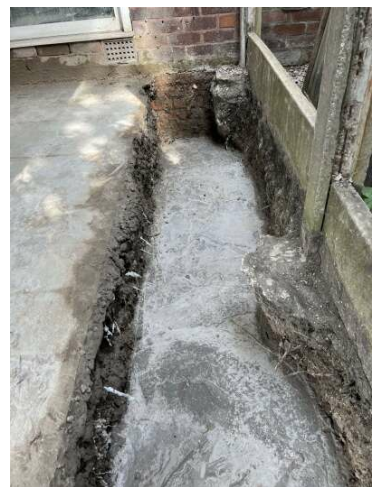
## Foundation work

| Foundation work | A vapor barrier plastic is laid, followed by reinforcement with steel rebar mesh. Concrete is poured with a thickness of 400mm. The interior floor is filled with stone material, followed by 100mm Isopor insulation. A vapor barrier membrane is installed for the floor, with a 100mm thick concrete layer on top. | ✓ |

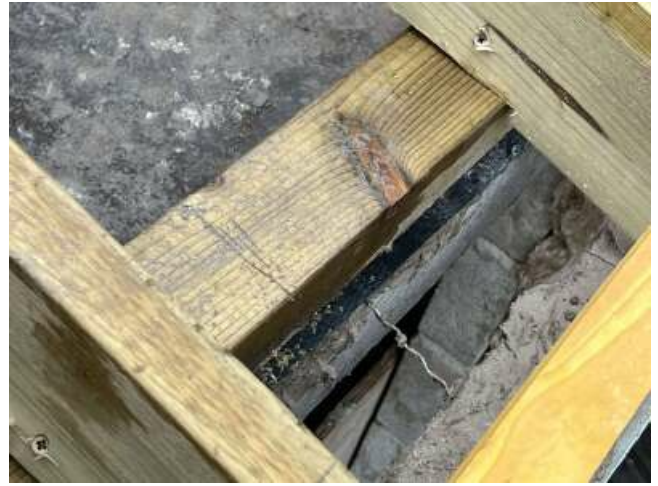
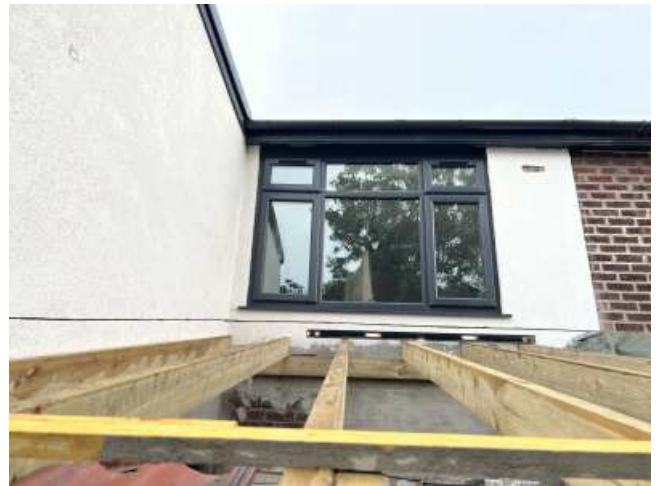
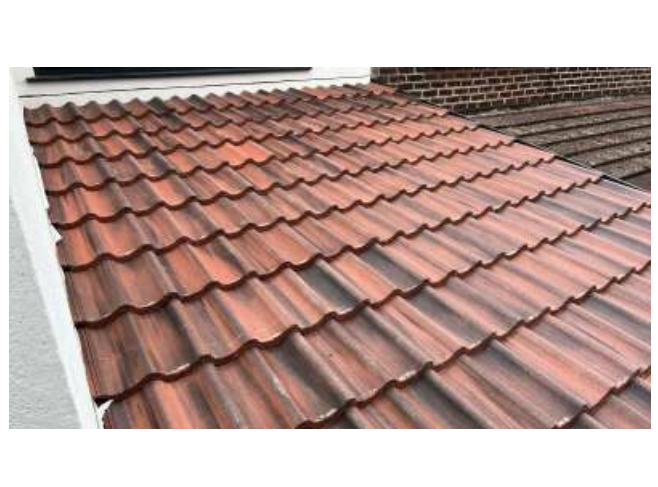
| Roof insulation work | The roof has 300mm insulation with ceiling beams spaced at C/C 400mm, covered with roof tiles. | ✓ |

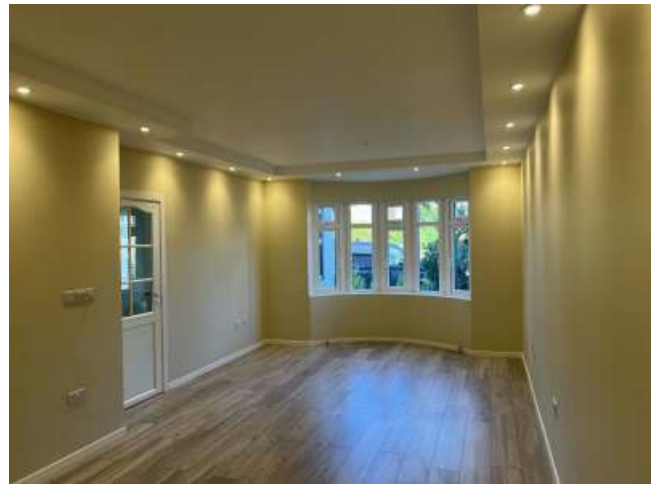
| Skimming both walls and ceilings and painting work for the whole house | Skimming over all plasterboard on both walls and ceiling. Painting the entire ceiling in white and the walls in a beige color. | ✓ |

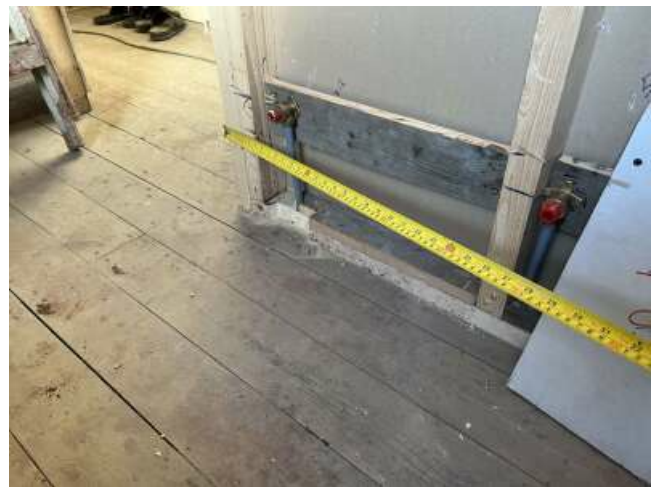
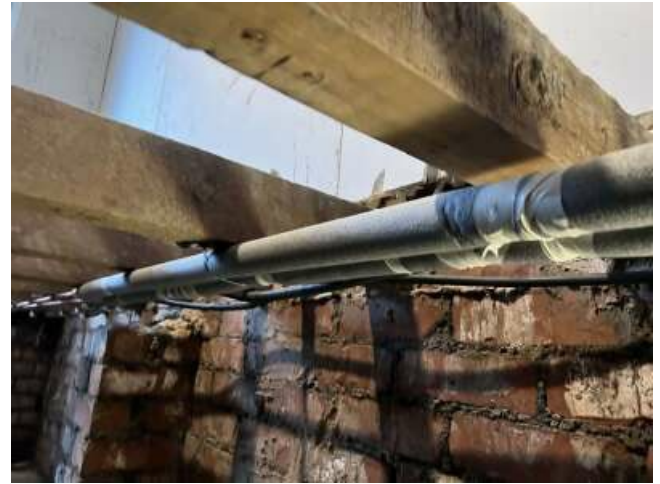
| Delivery and installation of radiators in all bedrooms, hallway, living room, and kitchen | | ✓ |
