ASBESTOS MANAGEMENT SURVEY REPORT

AKTRION FACILITIES SERVICES LTD

Hilti - 1 Trafford Wharf Road, Trafford Park, Manchester, M17 1BY

124255-275877

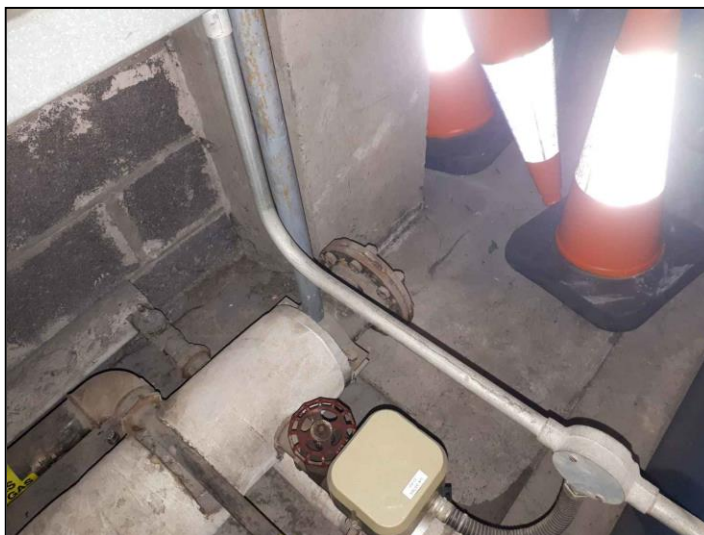
Material Risk:	5
Asbestos Type:	1 - Chrysotile
Product Type:	2 - AIB, Millboard, gaskets, paper etc
Extent of Damage:	1 - Low damage
Surface Treatment:	1 - Enclosed sprays and lagging, AIB, AC sheets etc
Priority Risk:	2
Normal Occupant Activity:	0 - Rare Disturbance
Likelihood of Disturbance:	1 - Low Likelihood of Disturbance
Human Exposure Potential:	0 - Very Low Human Exposure Potential
Maintenance Activity :	1 - Low Risk Maintenance Activity

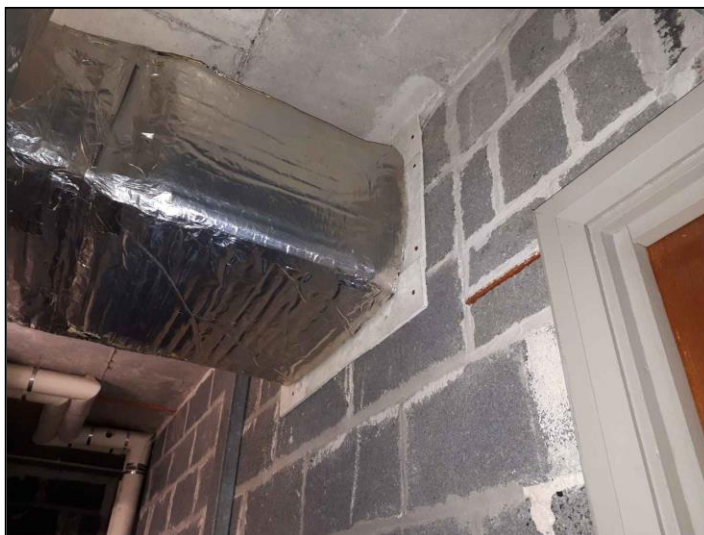
Material Risk: N/A
Asbestos Type: 0 - No asbestos detected

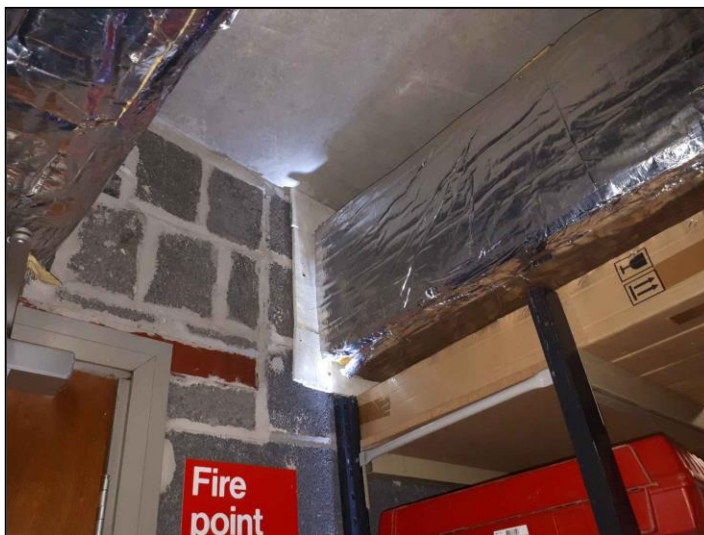
Material Risk: N/A
Asbestos Type: 0 - No asbestos detected

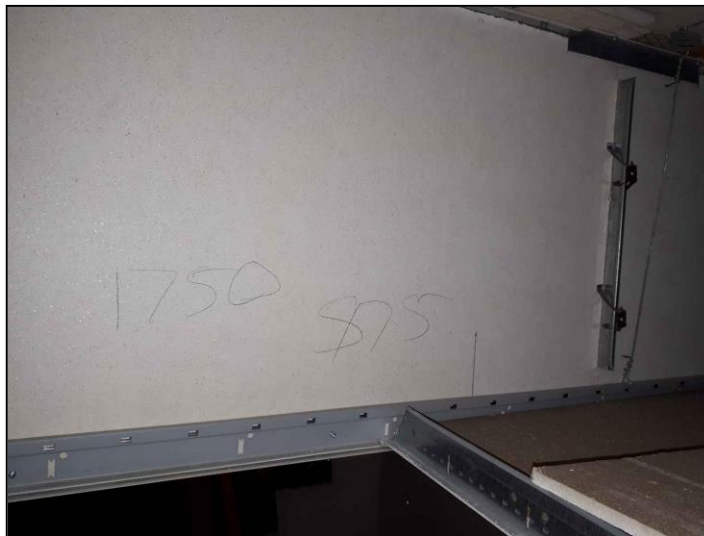
Material Risk: N/A

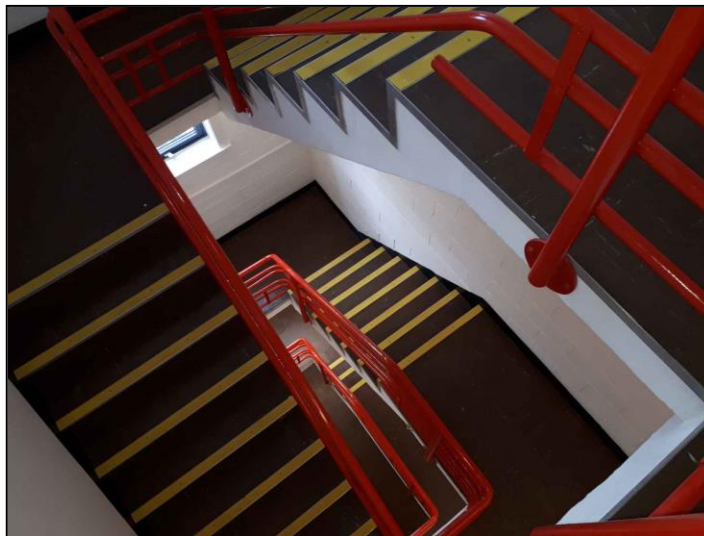
Material Risk:	3
Asbestos Type:	1 - Chrysotile
Product Type:	1 - Asbestos composites, decorative finishes, AC
Extent of Damage:	1 - Low damage
Surface Treatment:	0 - Composite materials containing asbestos (reinforced plastics, vinyl, etc)
Priority Risk:	6
Normal Occupant Activity:	1 - Low Disturbance
Likelihood of Disturbance:	2 - Medium Likelihood of Disturbance
Human Exposure Potential:	2 - Medium Human Exposure Potential
Maintenance Activity :	1 - Low Risk Maintenance Activity

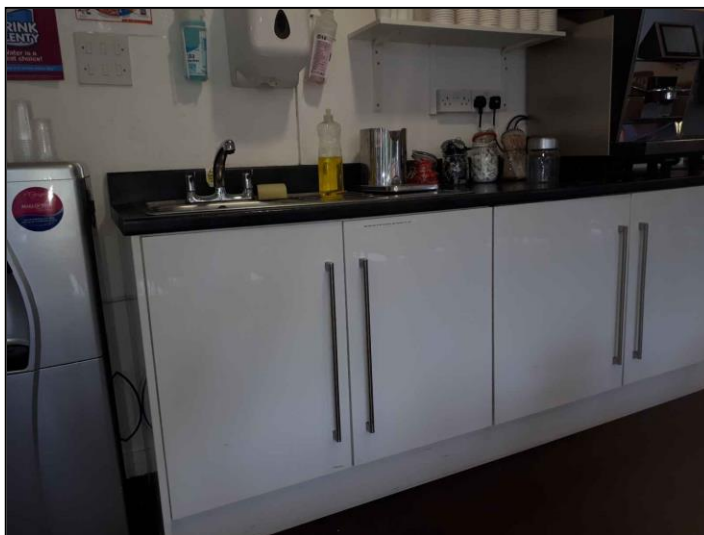
Client:	Aktrion Facilities Services Ltd	Area No:	039
		Floor:	First
Site Address:	Hilti - 1 Trafford Wharf Road, Trafford Park, Manchester, M17 1BY	Area Description:	Canteen
Building:	001	Material Description:	Sink Pad
Building Address:	As Above	Survey Report Reference:	124255-275877-001

Material Risk: N/A
Asbestos Type: 0 - No asbestos detected

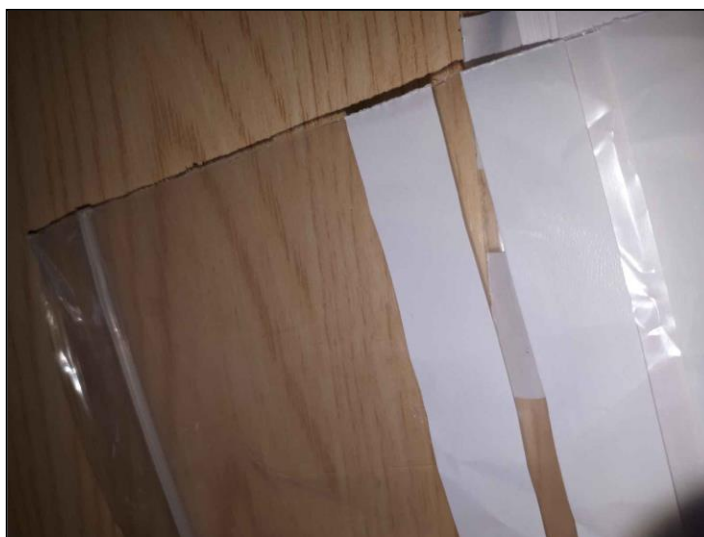
Material Risk:	3
Asbestos Type:	1 - Chrysotile
Product Type:	1 - Asbestos composites, decorative finishes, AC
Extent of Damage:	1 - Low damage
Surface Treatment:	0 - Composite materials containing asbestos (reinforced plastics, vinyl, etc)
Priority Risk:	5
Normal Occupant Activity:	1 - Low Disturbance
Likelihood of Disturbance:	1 - Low Likelihood of Disturbance
Human Exposure Potential:	2 - Medium Human Exposure Potential
Maintenance Activity :	1 - Low Risk Maintenance Activity

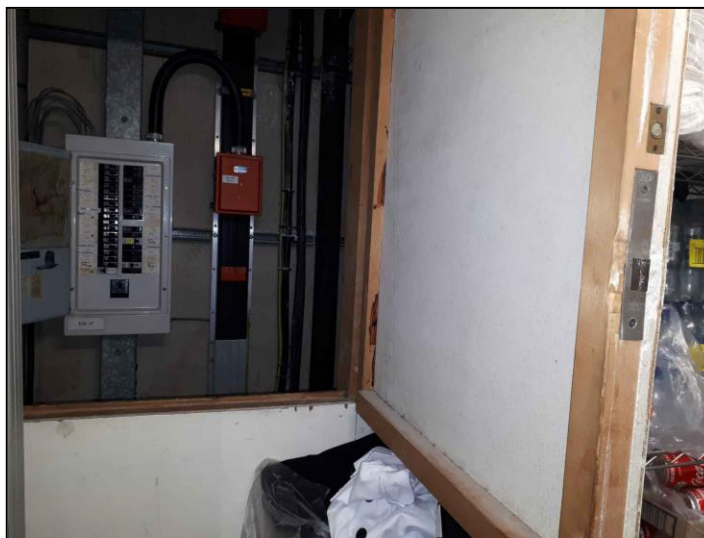
Material Risk: N/A

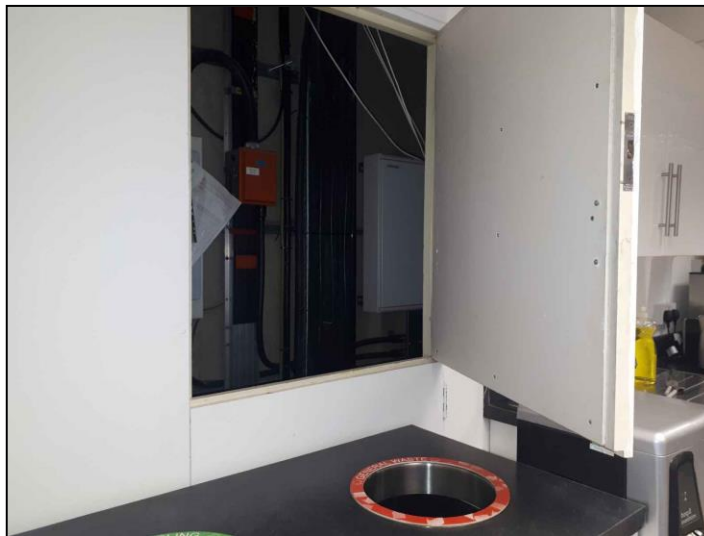
Material Risk: N/A

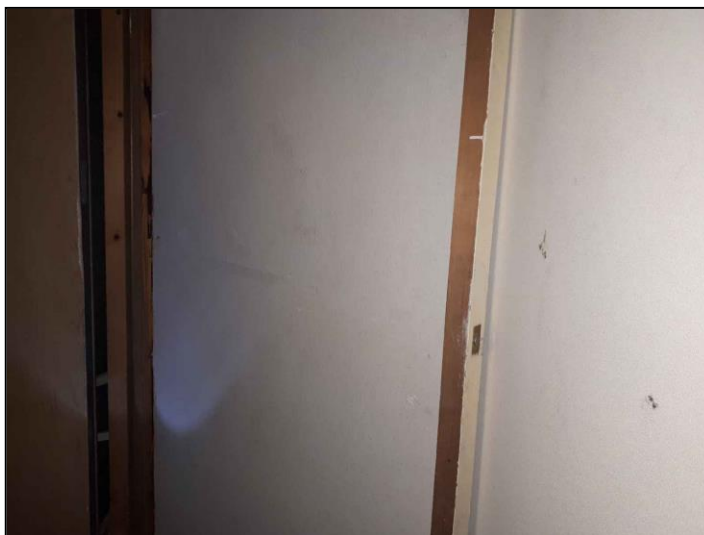
Material Risk: N/A

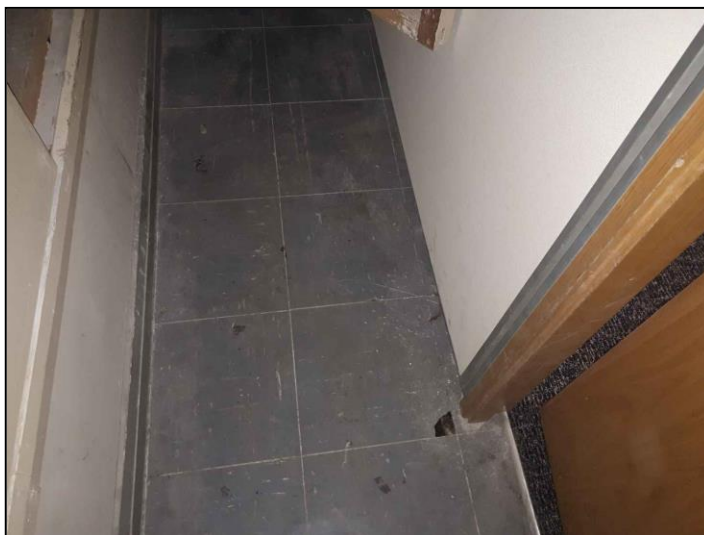
Material Risk:	3
Asbestos Type:	1 - Chrysotile
Product Type:	1 - Asbestos composites, decorative finishes, AC
Extent of Damage:	1 - Low damage
Surface Treatment:	0 - Composite materials containing asbestos (reinforced plastics, vinyl, etc)
Priority Risk:	2
Normal Occupant Activity:	0 - Rare Disturbance
Likelihood of Disturbance:	1 - Low Likelihood of Disturbance
Human Exposure Potential:	0 - Very Low Human Exposure Potential
Maintenance Activity :	1 - Low Risk Maintenance Activity

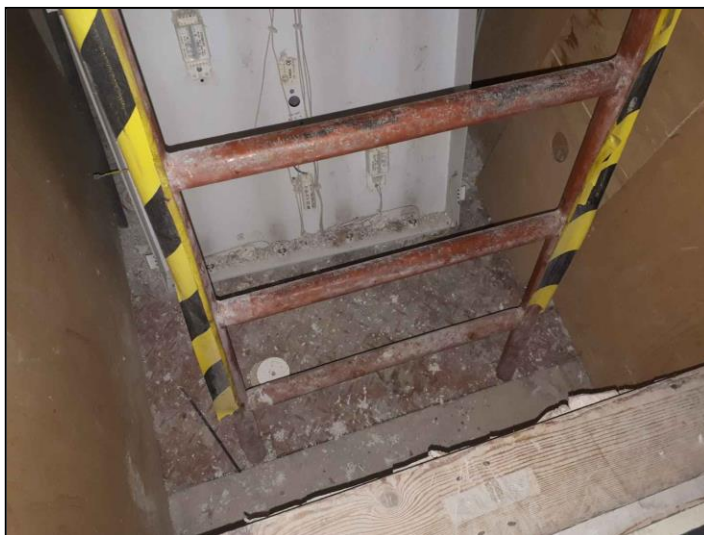
Material Risk: N/A
Asbestos Type: 0 - No asbestos detected

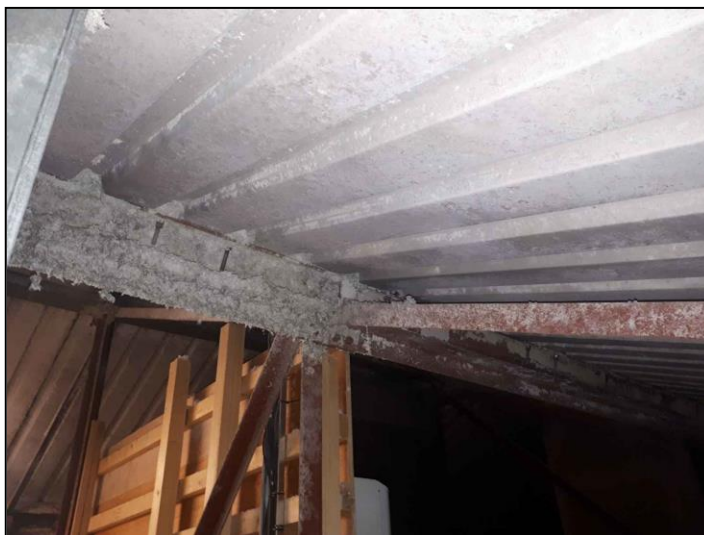
Material Risk: N/A
Asbestos Type: 0 - No asbestos detected
