## ASBESTOS SURVEY REPORT MANAGEMENT SURVEY

**SURVEY REPORT NO: NCC/MA/FI/00251**

Site Address:  
Central Library and Contact Centre 3  
Angel Row  
Nottingham  
Nottinghamshire  
NG1 6HP

<b>CLIENT:</b> Nottingham City Council	<b>DATE OF SURVEY:</b> 16/01/2015
<b>SURVEYED BY: A. Bennett</b>	<b>Signed: .....</b>
<b>AUTHORISED BY: R. Hubbard</b>	<b>Signed: .....</b>

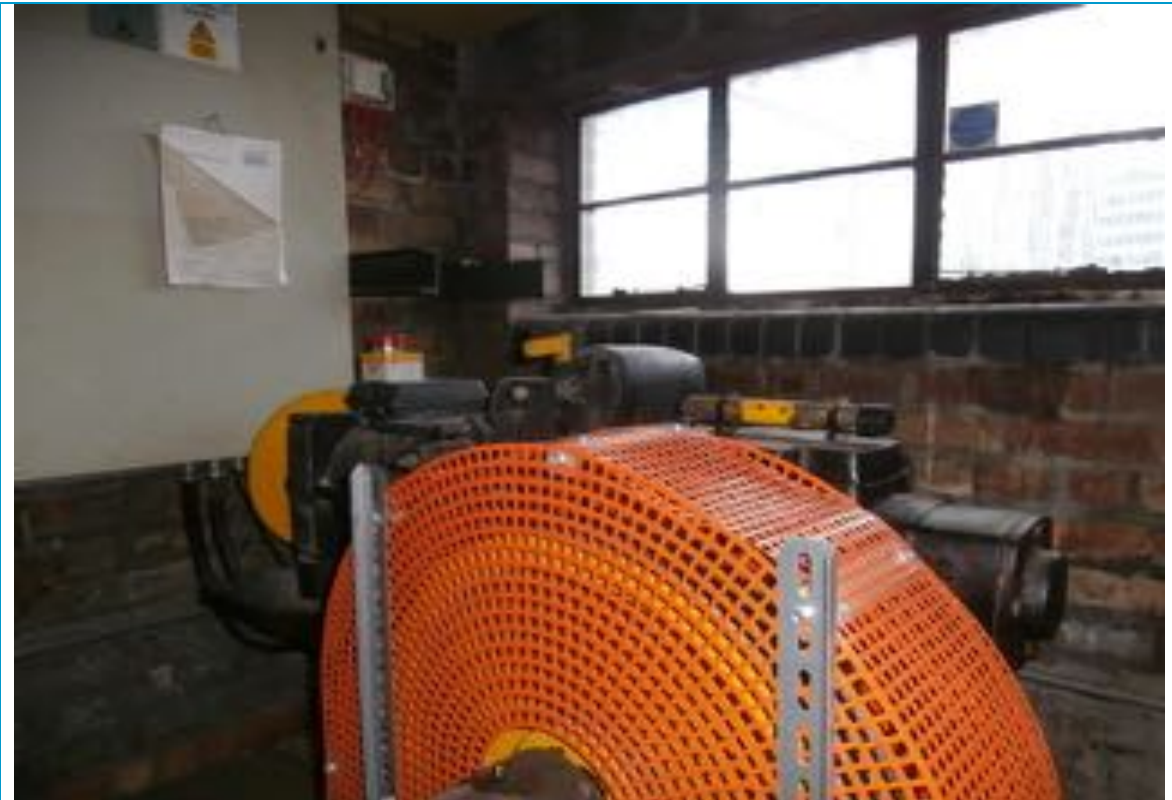
### Photo Ref: 001

<b>Site</b>	Central Library and Contact Centre 3, Angel Row, Nottingham, NG1 6HP		
Location	Roof Space/Lift Machine Room		
Component	Lift motor – may contain concealed asbestos rope & gasket		
BDA Reference	01/5		
Sample No.	N/A	Analysis	Presumed Chrysotile

Amount	Product Type	Damage	Surface Treatment	Asbestos Type	Score	Access	Total	Action Priority	Action Required
x1	2	0	1	1	4	1	4	Low	Manage

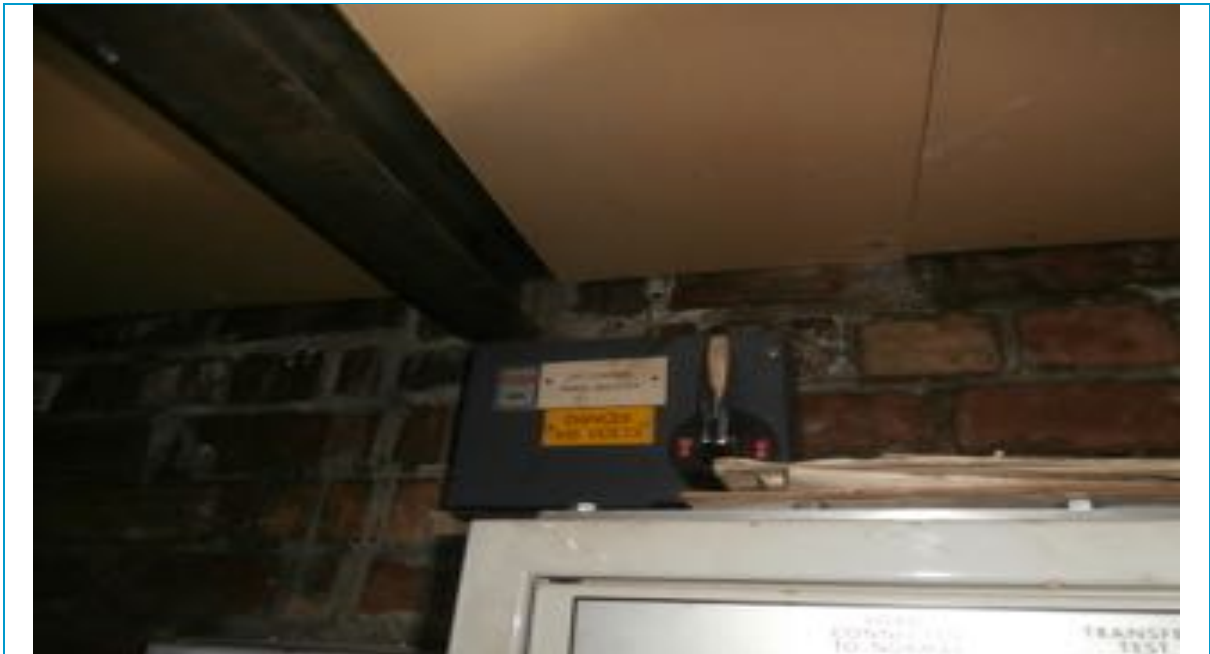
### Photo Ref: 002

<b>Site</b>	Central Library and Contact Centre 3, Angel Row, Nottingham, NG1 6HP		
Location	Roof Space/Lift Machine Room, Electric Cupboard, Lift Motor Rooms, Electrics Room, Stores, Communications Room, Copier Room & Cupboard, Electrical Cupboards, Post Room, Loading Bay, Boiler Room & Lobby, Small Boiler Room, Plant Room & Main Basement		
Component	Electrical switchgear – may contain concealed asbestos flashguards		
BDA Reference	01/6, 11/5, 22/7, 42/5, 54/5, 66/5, 80/5, 92/5, 103/6, 104/5, 109/9, 127/5, 129/5, 130/9, 131/8, 134/12, 142/15, 146/6, 152/5, 154/10, 156/9, 160/6, 161/5, 166/7 & 168/8		
Sample No.	N/A	Analysis	Presumed Crocidolite

Amount	Product Type	Damage	Surface Treatment	Asbestos Type	Score	Access	Total	Action Priority	Action Required
All	2	0	1	3	6	1	6	Low	Manage

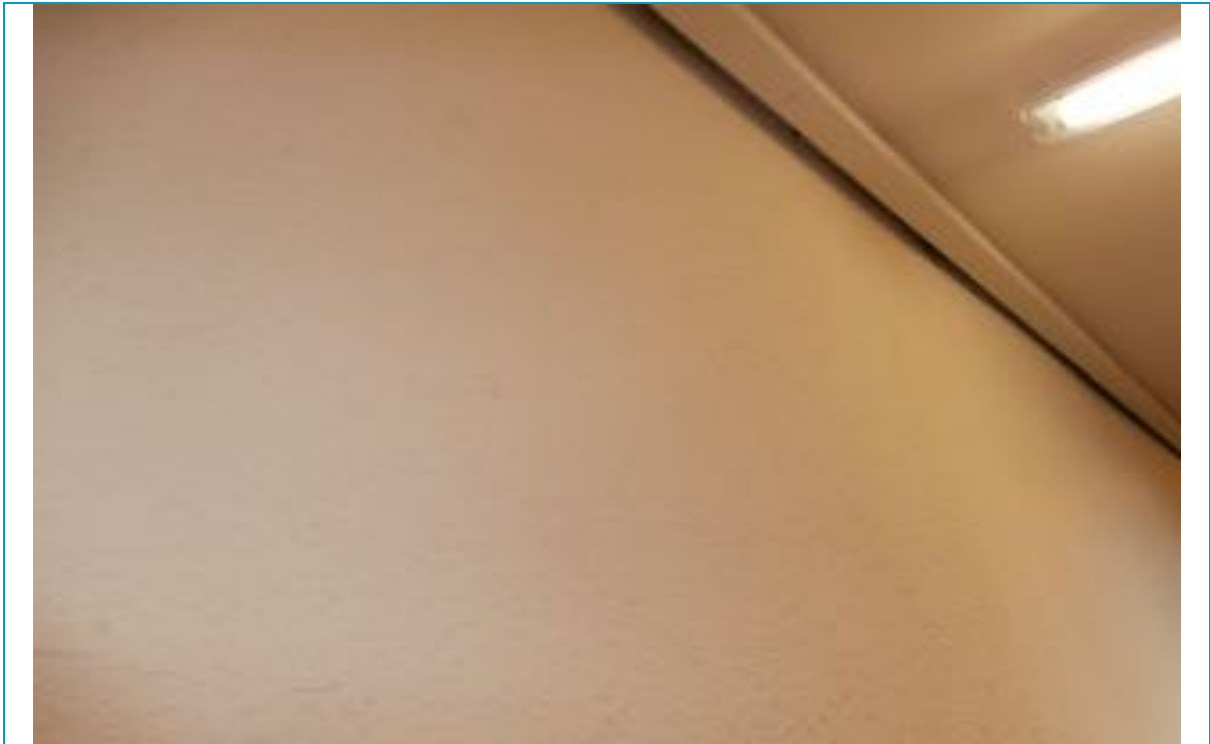
### Photo Ref: 003

<b>Site</b>	Central Library and Contact Centre 3, Angel Row, Nottingham, NG1 6HP		
Location	Stairwells & Store		
Component	Textured coating		
BDA Reference	02/2, 02/10, 35/2, 35/8, 62/2, 85/2, 86/2 & 106/2		
Sample No.	SP/16621	Analysis	Chrysotile

Amount	Product Type	Damage	Surface Treatment	Asbestos Type	Score	Access	Total	Action Priority	Action Required
260 m <sup>2</sup>	1	0	0	1	2	3	6	Low	Manage

The coating is unlikely to give rise to significant airborne fibre release as the asbestos content is low and the fibres are bound into a hard matrix that has been painted. However subjecting the coating to mechanical damage i.e. drilling or sanding may give rise to airborne fibre release and should be avoided.

If future repair/refurbishment works will lead to the disturbance of the textured coating the Control of Asbestos Regs 2012 do not require the use of a licensed asbestos removal contractor for the removal of asbestos coatings of this type, however it should be removed under controlled conditions and disposed of as asbestos waste. A suitable written method of work should be employed by those undertaking the removal works.

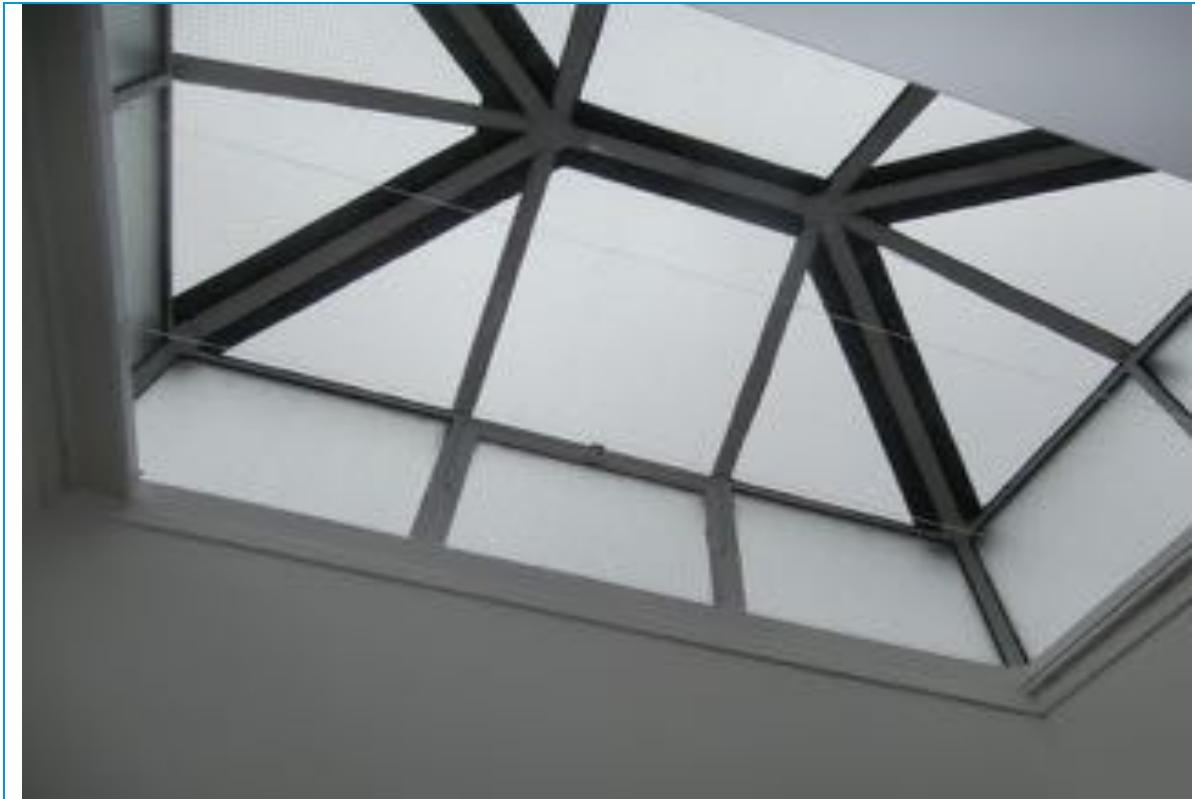
### Photo Ref: 004

<b>Site</b>	Central Library and Contact Centre 3, Angel Row, Nottingham, NG1 6HP		
Location	Call Centre		
Component	Skylights – may contain concealed asbestos rope seals		
BDA Reference	10/8		
Sample No.	N/A	Analysis	Presumed Chrysotile

Amount	Product Type	Damage	Surface Treatment	Asbestos Type	Score	Access	Total	Action Priority	Action Required
All	2	0	1	1	4	1	4	Low	Manage

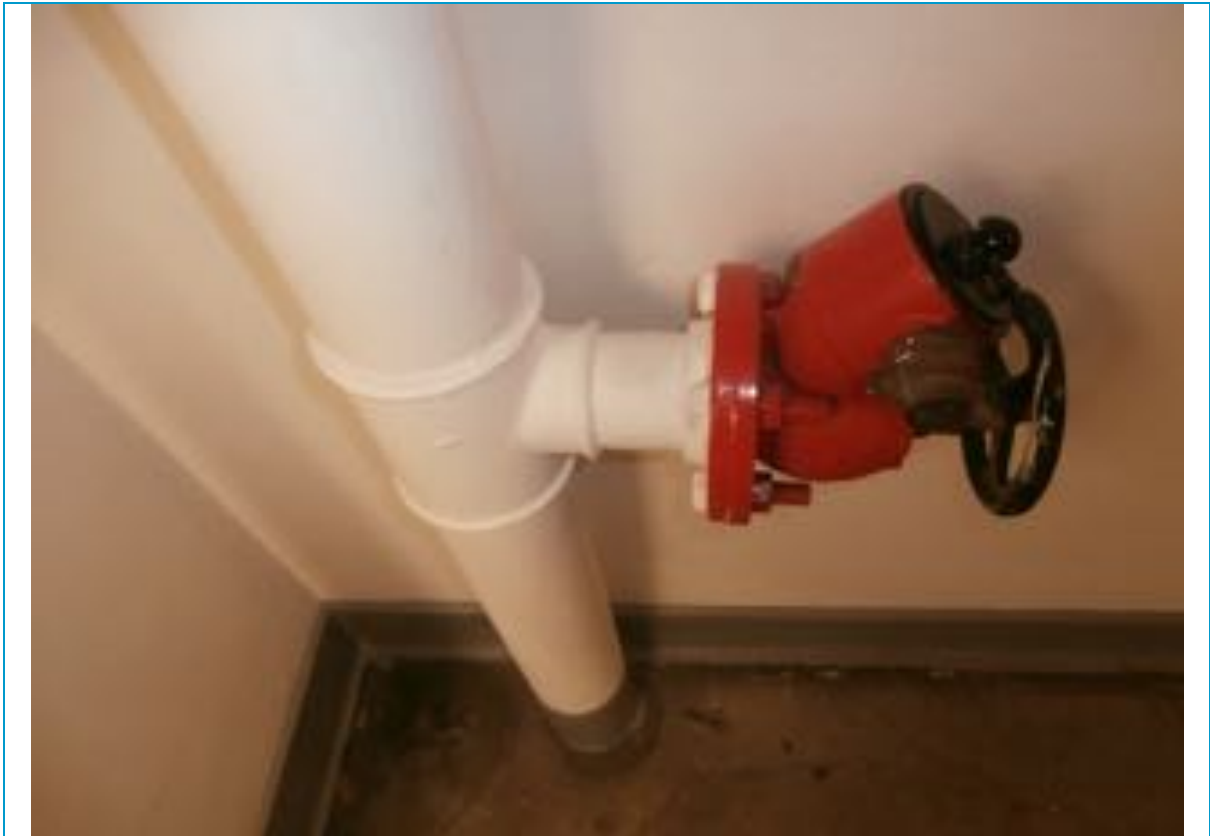
### Photo Ref: 005

<b>Site</b>	Central Library and Contact Centre 3, Angel Row, Nottingham, NG1 6HP		
Location	Stairwells		
Component	Gasket		
BDA Reference	17/9, 46/5, 69/5, 98/5, 111/5 & 159/5		
Sample No.	SP/16632	Analysis	Chrysotile

Amount	Product Type	Damage	Surface Treatment	Asbestos Type	Score	Access	Total	Action Priority	Action Required
All	1	0	0	1	2	3	6	Low	Manage

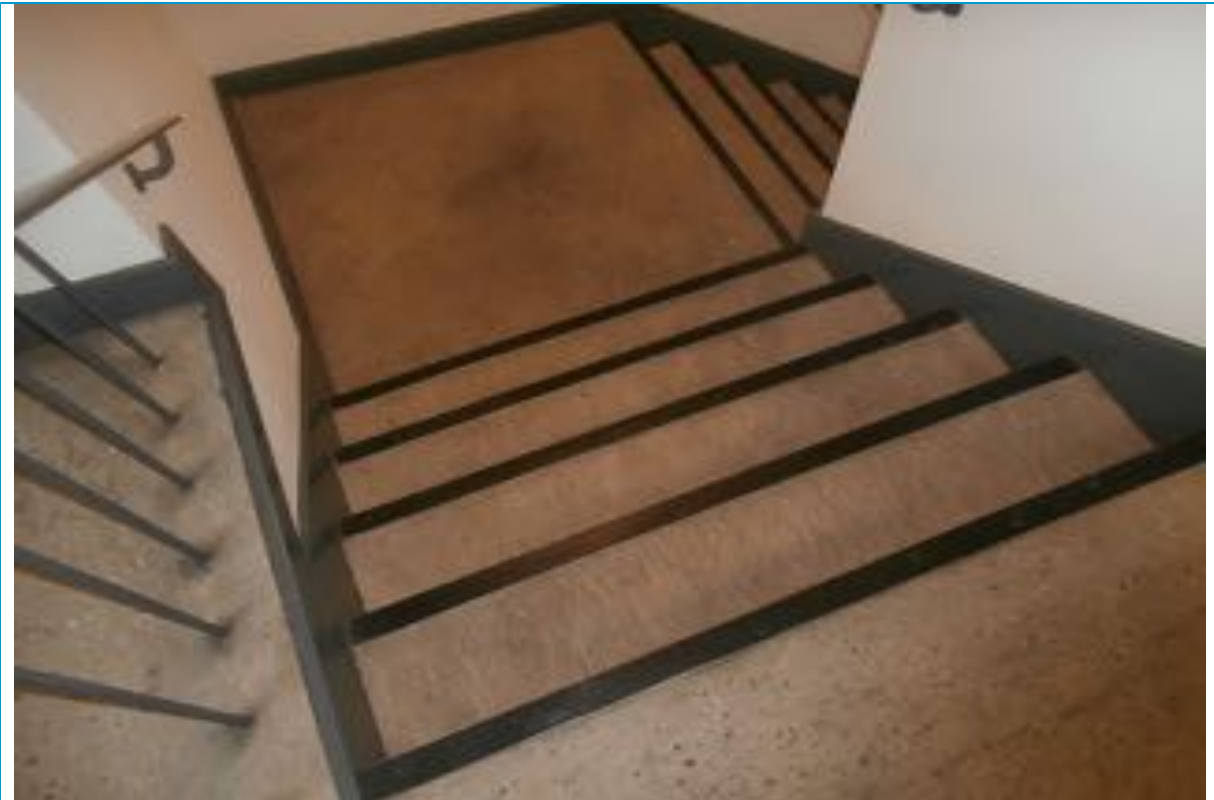
### Photo Ref: 006

<b>Site</b>	Central Library and Contact Centre 3, Angel Row, Nottingham, NG1 6HP		
Location	Stairwell/Lift Lobbys, Stairwells & Stairwell (to Basement)		
Component	Stair nosing		
BDA Reference	25/6, 59/6, 82/5, 101/5, 136/5 & 140/5		
Sample No.	SP/16624	Analysis	Chrysotile

Amount	Product Type	Damage	Surface Treatment	Asbestos Type	Score	Access	Total	Action Priority	Action Required
100 m	1	0	0	1	2	3	6	Low	Manage

If future repair/refurbishment works will lead to the disturbance/removal of the stair nosing the Control of Asbestos Regs 2012 do not require the use of a licensed asbestos removal contractor for the removal of asbestos products of this type, but the works should be carried out in a controlled manner and any tiles removed should be disposed of as asbestos waste.

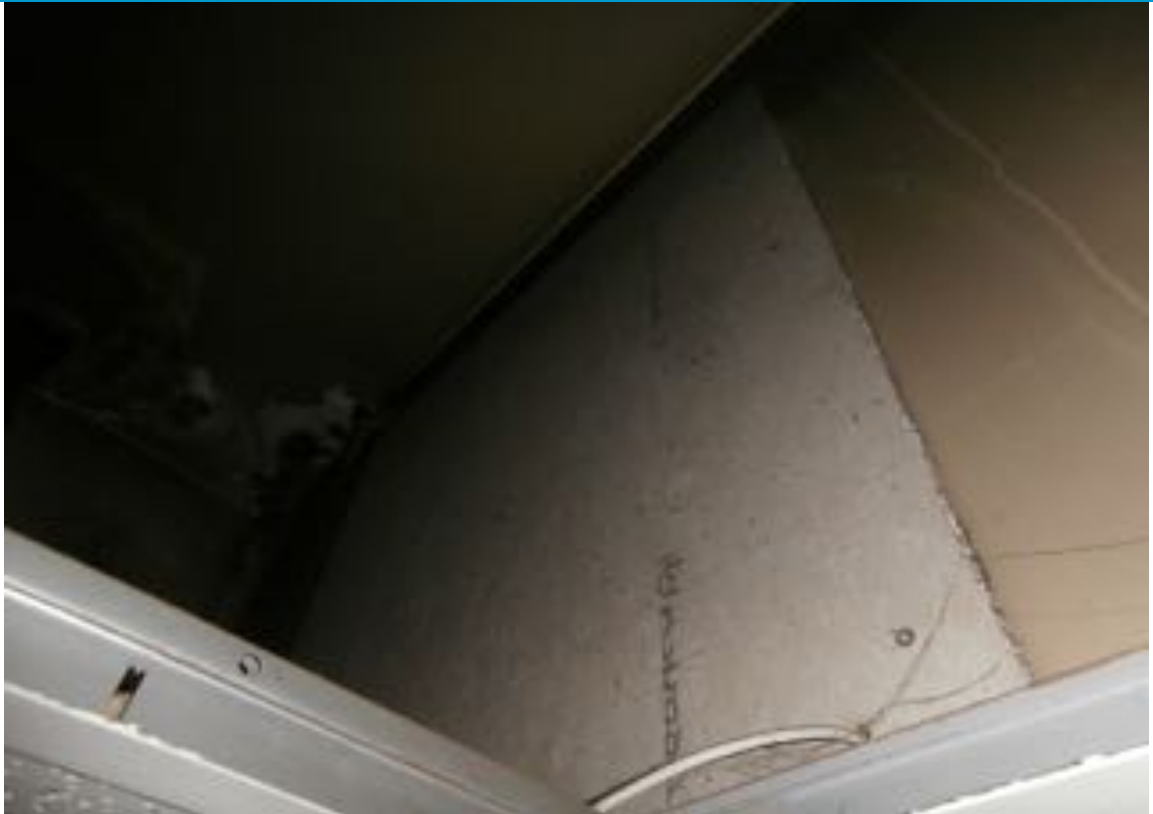
### Photo Ref: 007

<b>Site</b>	Central Library and Contact Centre 3, Angel Row, Nottingham, NG1 6HP		
Location	Female WC		
Component	Upstand to suspended ceiling		
BDA Reference	133/13		
Sample No.	SP/16625	Analysis	Amosite & Chrysotile

Amount	Product Type	Damage	Surface Treatment	Asbestos Type	Score	Access	Total	Action Priority	Action Required
1 m <sup>2</sup>	2	0	2	2	6	3	18	Medium	Encapsulate or overboard

The board is unpainted and liable to give rise to significant airborne fibre release. The board should be encapsulated with a Class '0' fire retardant sealant or overboarded. The encapsulation works should be carried out under controlled conditions by a licensed asbestos removal contractor at the earliest opportunity.

If the board is to be removed the removal works should be carried out by a licensed asbestos removal contractor under fully controlled asbestos removal conditions in accordance with the Control of Asbestos Regs 2012.

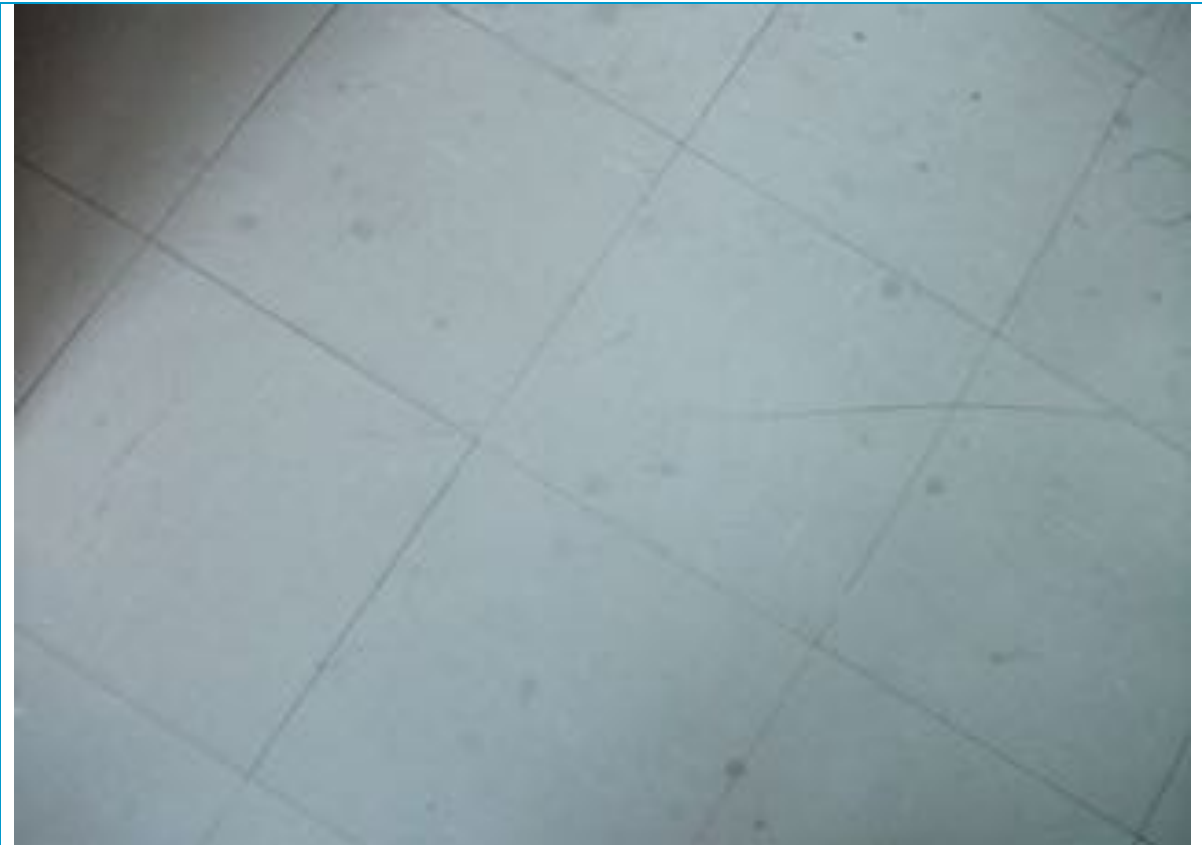
### Photo Ref: 008

<b>Site</b>	Central Library and Contact Centre 3, Angel Row, Nottingham, NG1 6HP		
Location	Lobby & WC		
Component	Light grey floor tile		
BDA Reference	36/3 & 37/3		
Sample No.	SP/16626	Analysis	Chrysotile

Amount	Product Type	Damage	Surface Treatment	Asbestos Type	Score	Access	Total	Action Priority	Action Required
7 m <sup>2</sup>	1	0	0	1	2	3	6	Low	Manage

If future repair/refurbishment works will lead to the disturbance/removal of the floor tiles the Control of Asbestos Regs 2012 do not require the use of a licensed asbestos removal contractor for the removal of asbestos products of this type, but the works should be carried out in a controlled manner and any tiles removed should be disposed of as asbestos waste.

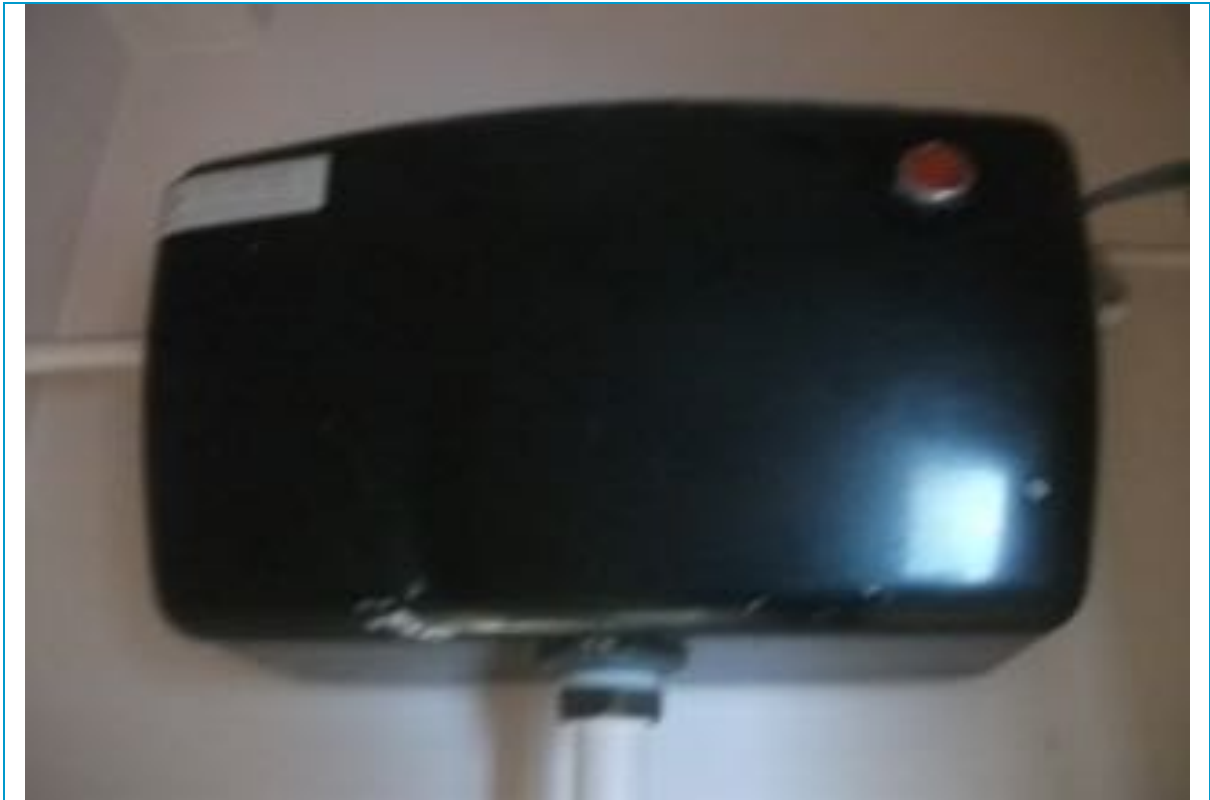
### Photo Ref: 009

<b>Site</b>	Central Library and Contact Centre 3, Angel Row, Nottingham, NG1 6HP		
Location	WC & Female WC		
Component	Cistern		
BDA Reference	37/6 & 133/6		
Sample No.	SP/16628	Analysis	Crocidolite & Amosite

Amount	Product Type	Damage	Surface Treatment	Asbestos Type	Score	Access	Total	Action Priority	Action Required
x2	1	0	0	3	4	3	12	Low	Manage

Due to the hard nature of the reinforced resin matrix the Crocidolite and Amosite fibres are bound into, airborne fibre release is unlikely so they may be left in situ. However subjecting the cistern to mechanical damage i.e. drilling, sanding or breaking may give rise to airborne fibre release and should be avoided.

If future repair/refurbishment works will lead to the disturbance of the cistern the Control of Asbestos Regs 2012 do not require the use of a licensed asbestos removal contractor for the removal of materials of this type, however it should be removed under controlled conditions and disposed of as asbestos waste.

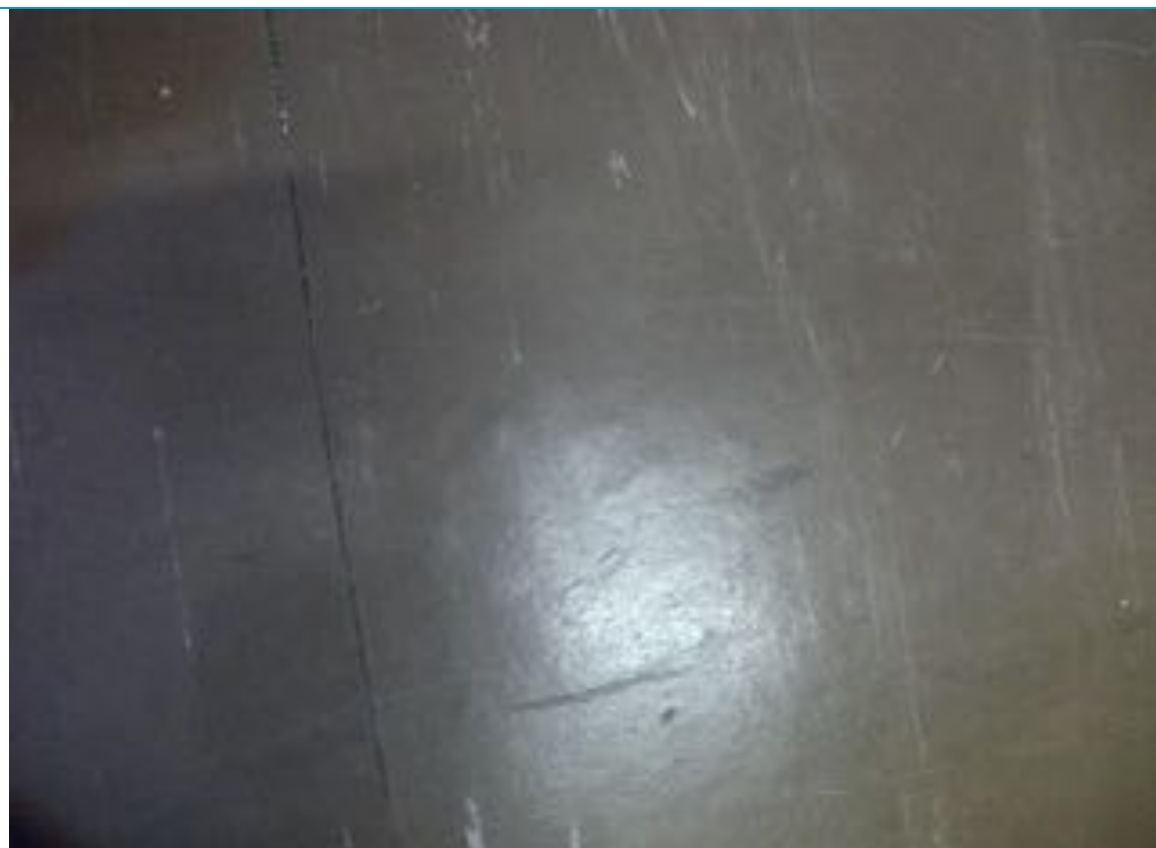
### Photo Ref: 010

<b>Site</b>	Central Library and Contact Centre 3, Angel Row, Nottingham, NG1 6HP		
Location	Stores, Electrics Room, Parent and Baby Room		
Component	Vinyl floor		
BDA Reference	39/3, 42/3, 43/3, 48/3, 63/3, 66/3, 70/3 & 92/3		
Sample No.	SP/16629	Analysis	Chrysotile

Amount	Product Type	Damage	Surface Treatment	Asbestos Type	Score	Access	Total	Action Priority	Action Required
25 m <sup>2</sup>	1	0	0	1	2	3	6	Low	Manage

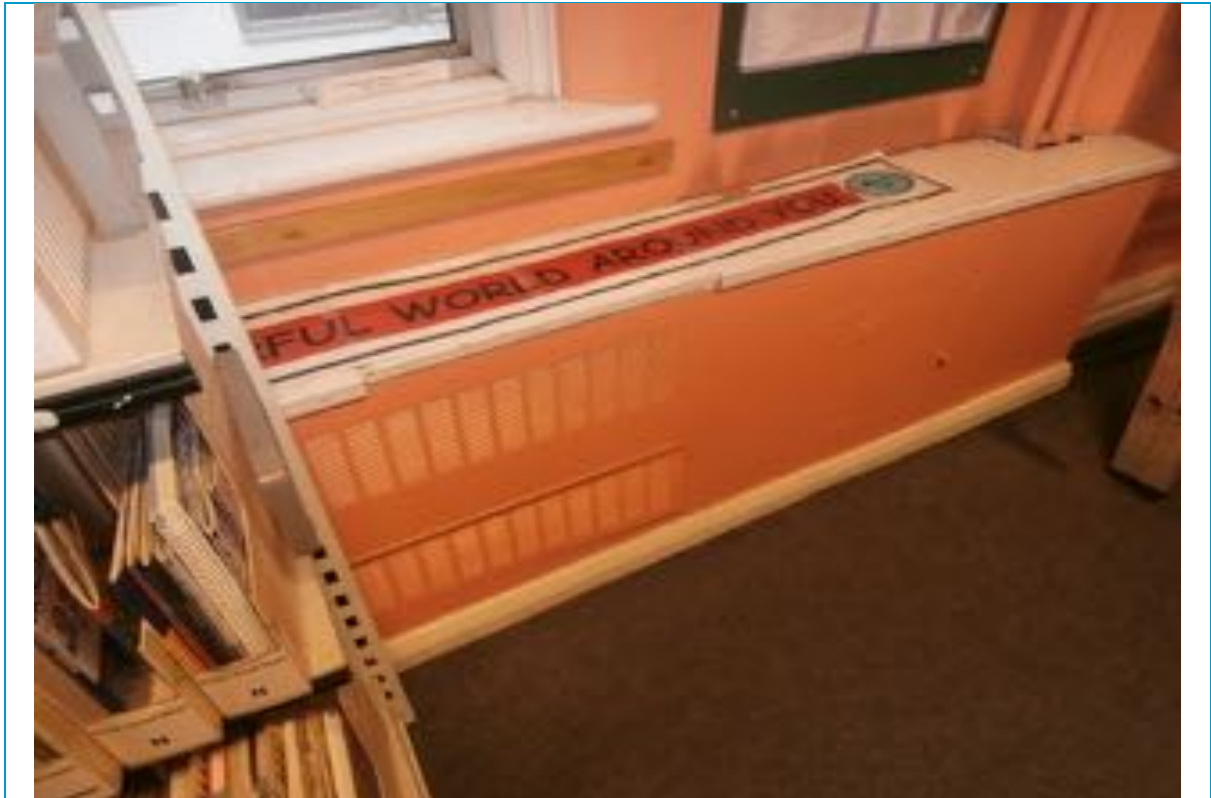
### **Photo Ref: 011**

<b>Site</b>	Central Library and Contact Centre 3, Angel Row, Nottingham, NG1 6HP		
Location	Library's, Archives, Study Area, Office, Stores & Main Basement		
Component	Heaters – may contain concealed asbestos rope & gaskets		
BDA Reference	41/6, 47/5, 49/8, 67/8, 71/5, 72/8, 146/5, 161/6 & 166/6		
Sample No.	N/A	Analysis	Presumed Chrysotile

Amount	Product Type	Damage	Surface Treatment	Asbestos Type	Score	Access	Total	Action Priority	Action Required
All	2	0	1	1	4	1	4	Low	Manage

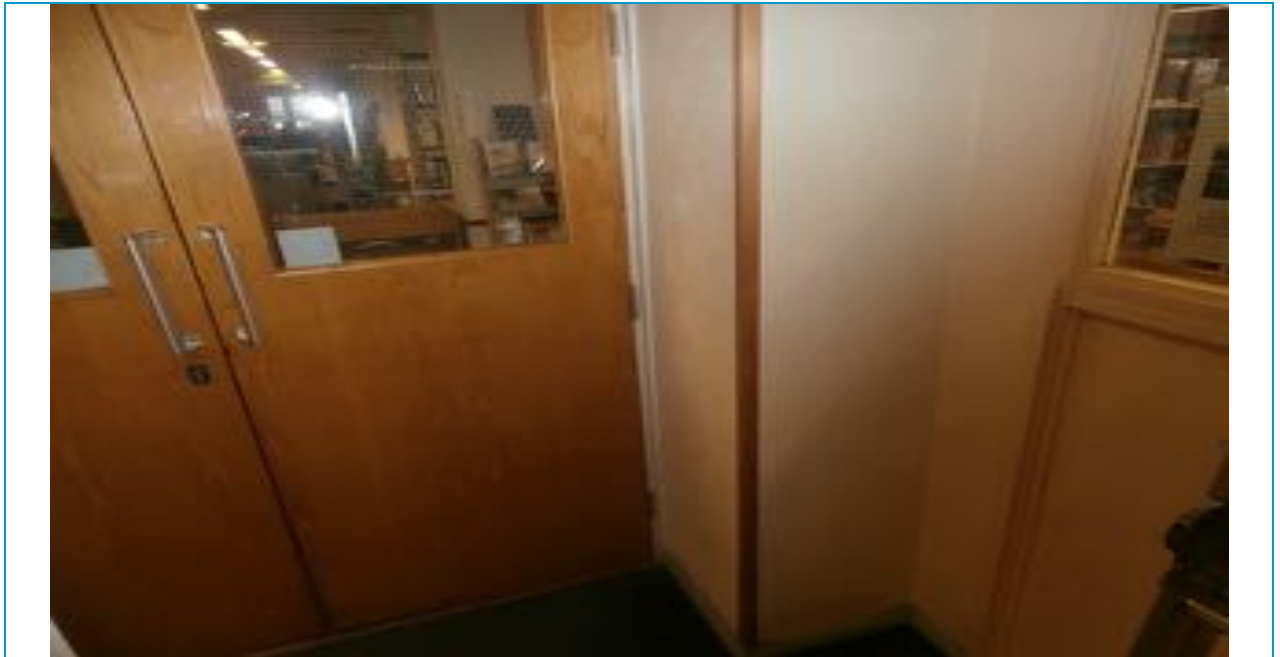
### Photo Ref: 012

<b>Site</b>	Central Library and Contact Centre 3, Angel Row, Nottingham, NG1 6HP		
Location	Library's, Study Area, Lift Lobby & Stairwells		
Component	Risers & Columns		
BDA Reference	35/7, 41/10, 49/5, 62/6, 67/9, 68/5 & 72/6		
Sample No.	SP/16625	Analysis	Amosite & Chrysotile

Amount	Product Type	Damage	Surface Treatment	Asbestos Type	Score	Access	Total	Action Priority	Action Required
5 m <sup>2</sup>	2	0	2	2	6	3	18	Medium	Encapsulate or overboard

The boards are unpainted above the suspended ceilings and liable to give rise to significant airborne fibre release. The boards should be encapsulated with a Class '0' fire retardant sealant or overboarded. The encapsulation works should be carried out under controlled conditions by a licensed asbestos removal contractor at the earliest opportunity.

If the boards are to be removed the removal works should be carried out by a licensed asbestos removal contractor under fully controlled asbestos removal conditions in accordance with the Control of Asbestos Regs 2012.

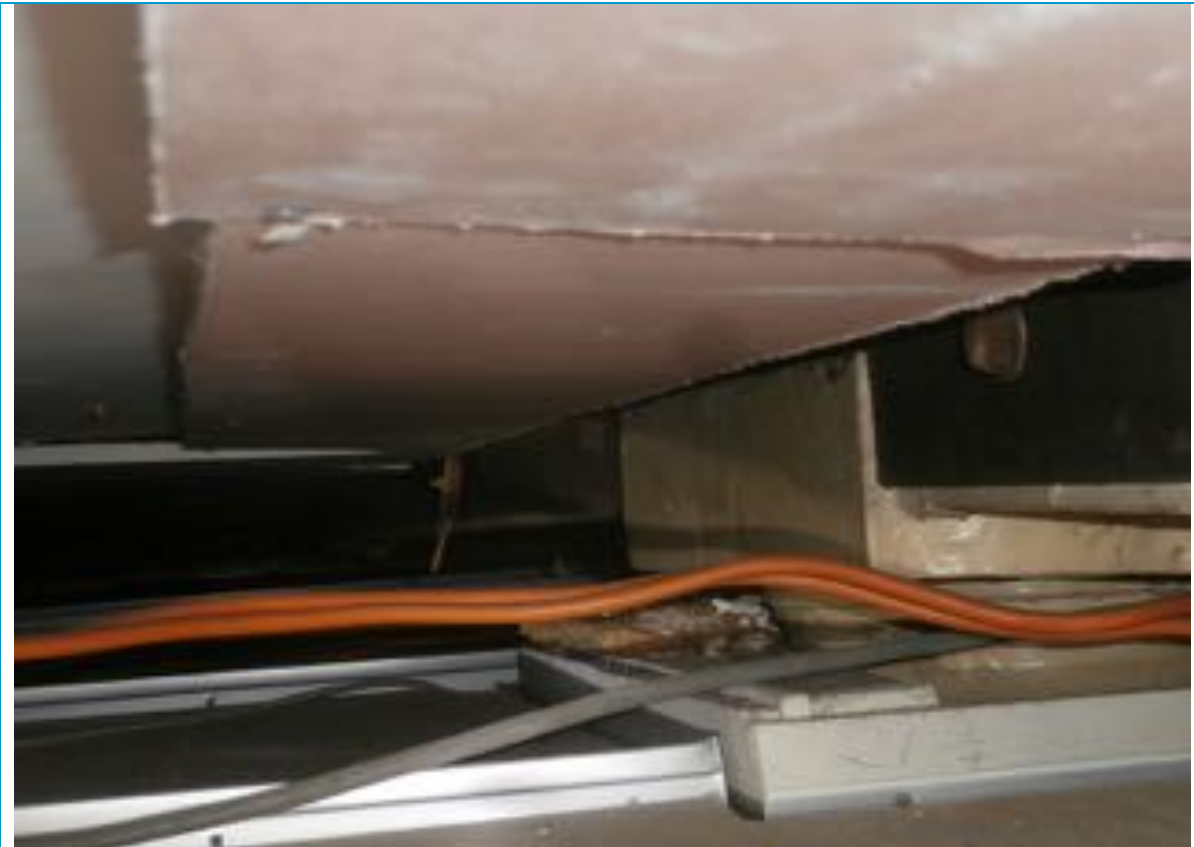
### Photo Ref: 013

<b>Site</b>	Central Library and Contact Centre 3, Angel Row, Nottingham, NG1 6HP		
Location	Library, Study Area, Parent & Baby Room		
Component	Debris above suspended ceiling		
BDA Reference	41/18, 49/10 & 63/11		
Sample No.	SP/16625	Analysis	Amosite & Chrysotile

Amount	Product Type	Damage	Surface Treatment	Asbestos Type	Score	Access	Total	Action Priority	Action Required
All	2	3	2	2	9	1	9	Low	Remove

The removal works should be carried out by a licensed asbestos removal contractor under fully controlled asbestos removal conditions in accordance with the Control of Asbestos Regs 2012.

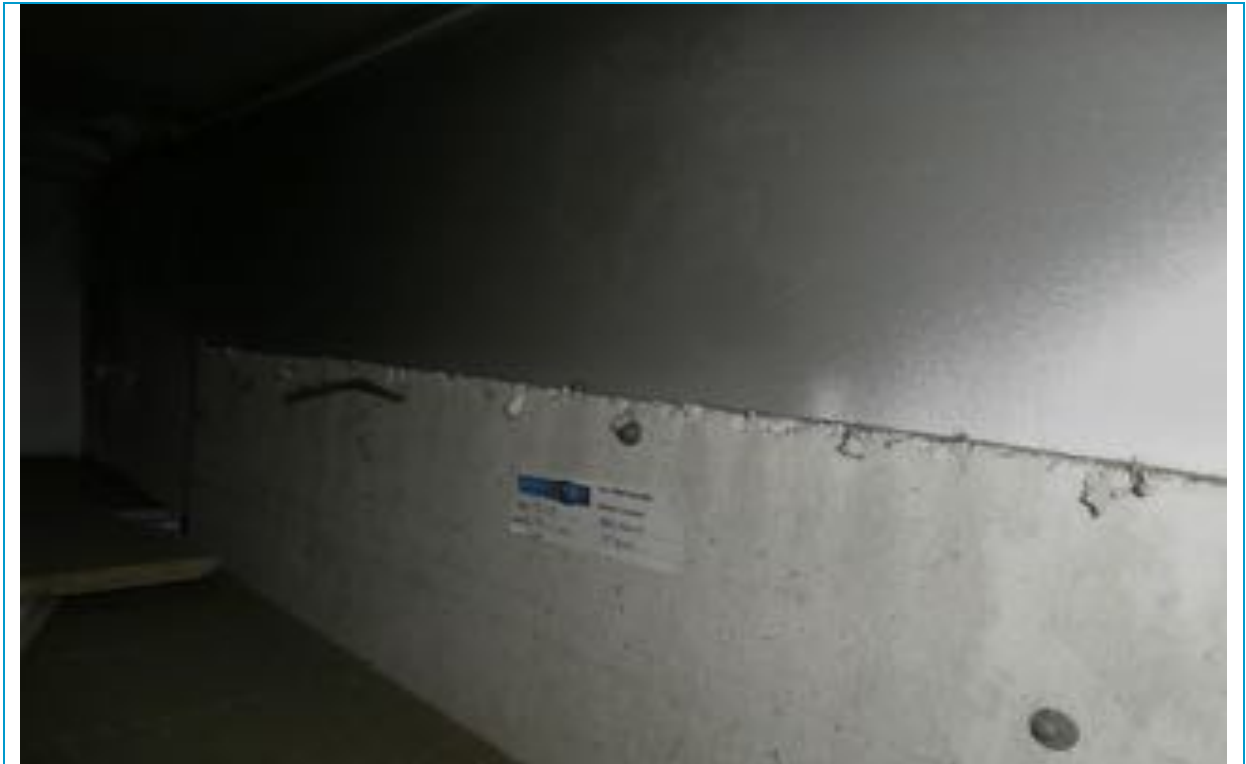
### Photo Ref: 014

<b>Site</b>	Central Library and Contact Centre 3, Angel Row, Nottingham, NG1 6HP		
Location	Parent & Baby Room and Store		
Component	Upstand to suspended ceiling		
BDA Reference	63/10 & 70/7		
Sample No.	SP/16625	Analysis	Amosite & Chrysotile

Amount	Product Type	Damage	Surface Treatment	Asbestos Type	Score	Access	Total	Action Priority	Action Required
2 m <sup>2</sup>	2	3	2	2	9	1	9	Low	Encapsulate or overboard

The boards are unpainted and liable to give rise to significant airborne fibre release. The boards should be encapsulated with a Class '0' fire retardant sealant or overboarded. The encapsulation works should be carried out under controlled conditions by a licensed asbestos removal contractor at the earliest opportunity. Access to the areas listed above should be prohibited until the areas have been decontaminated.

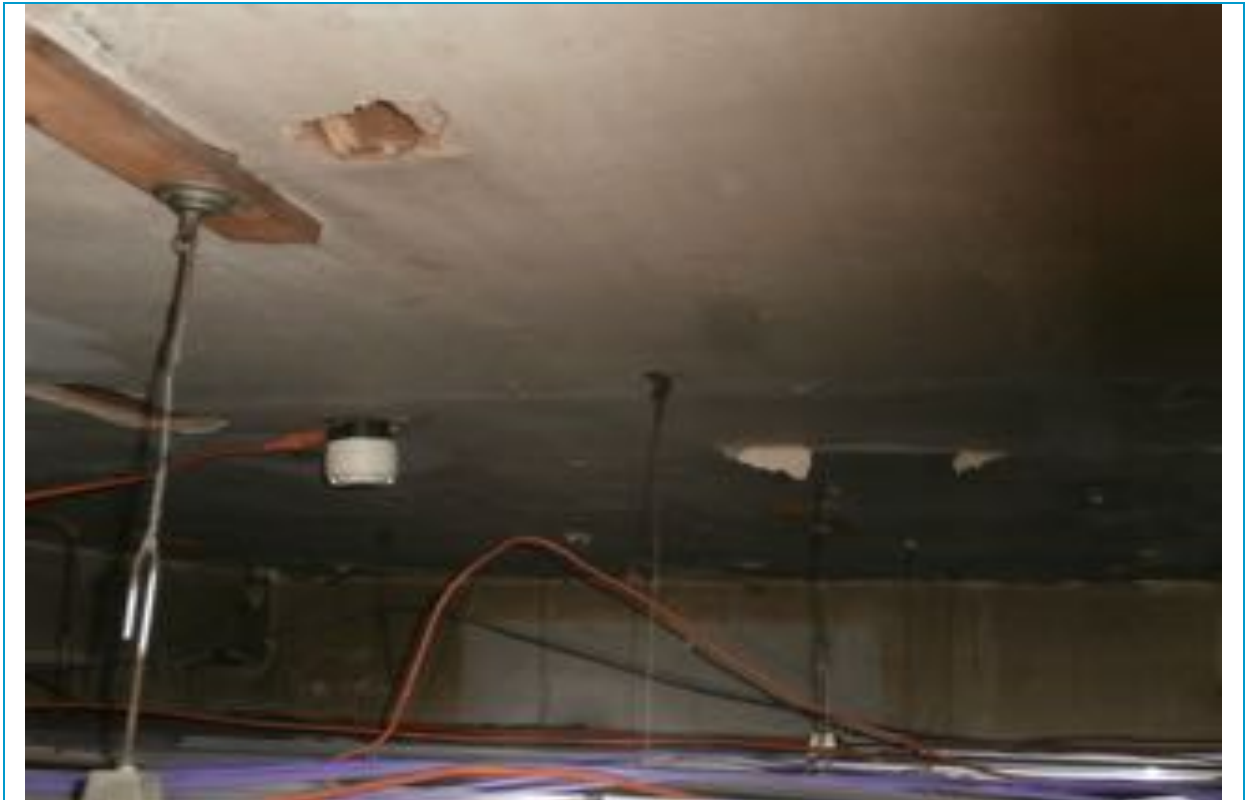
### Photo Ref: 015

Amount	Product Type	Damage	Surface Treatment	Asbestos Type	Score	Access	Total	Action Priority	Action Required
18 m <sup>2</sup>	2	0	2	2	6	2	12	Low	Encapsulate or overboard

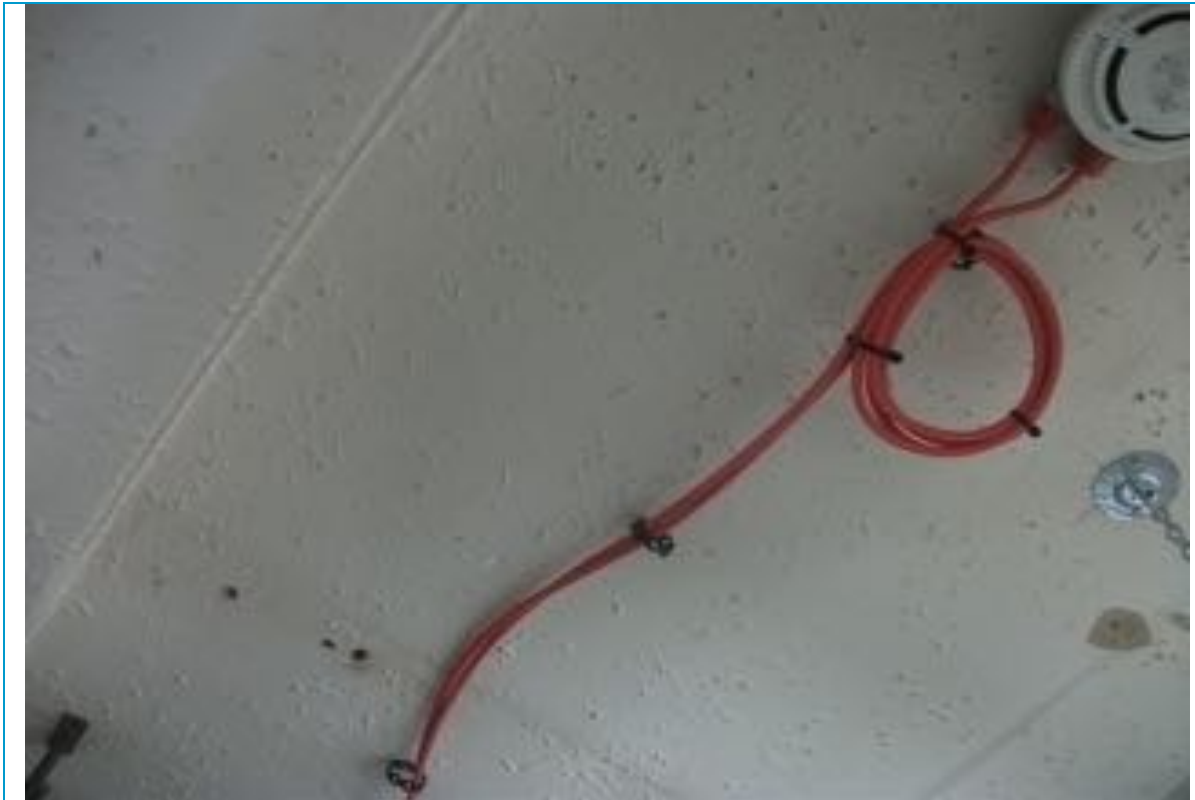
### Photo Ref: 016

Amount	Product Type	Damage	Surface Treatment	Asbestos Type	Score	Access	Total	Action Priority	Action Required
31 m <sup>2</sup>	1	0	0	1	2	3	6	Low	Manage

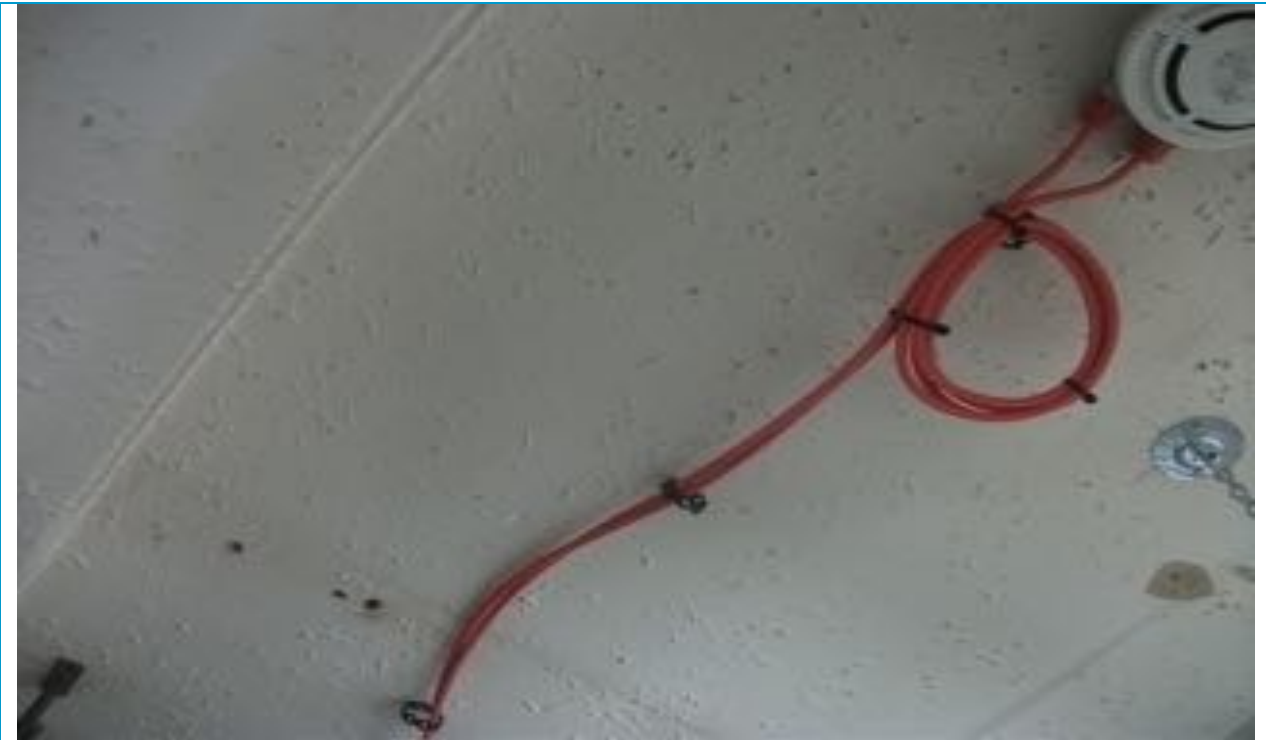
### **Photo Ref: 017**

Amount	Product Type	Damage	Surface Treatment	Asbestos Type	Score	Access	Total	Action Priority	Action Required
16 m <sup>2</sup>	1	2	0	1	4	3	12	Low	Encapsulate or overboard

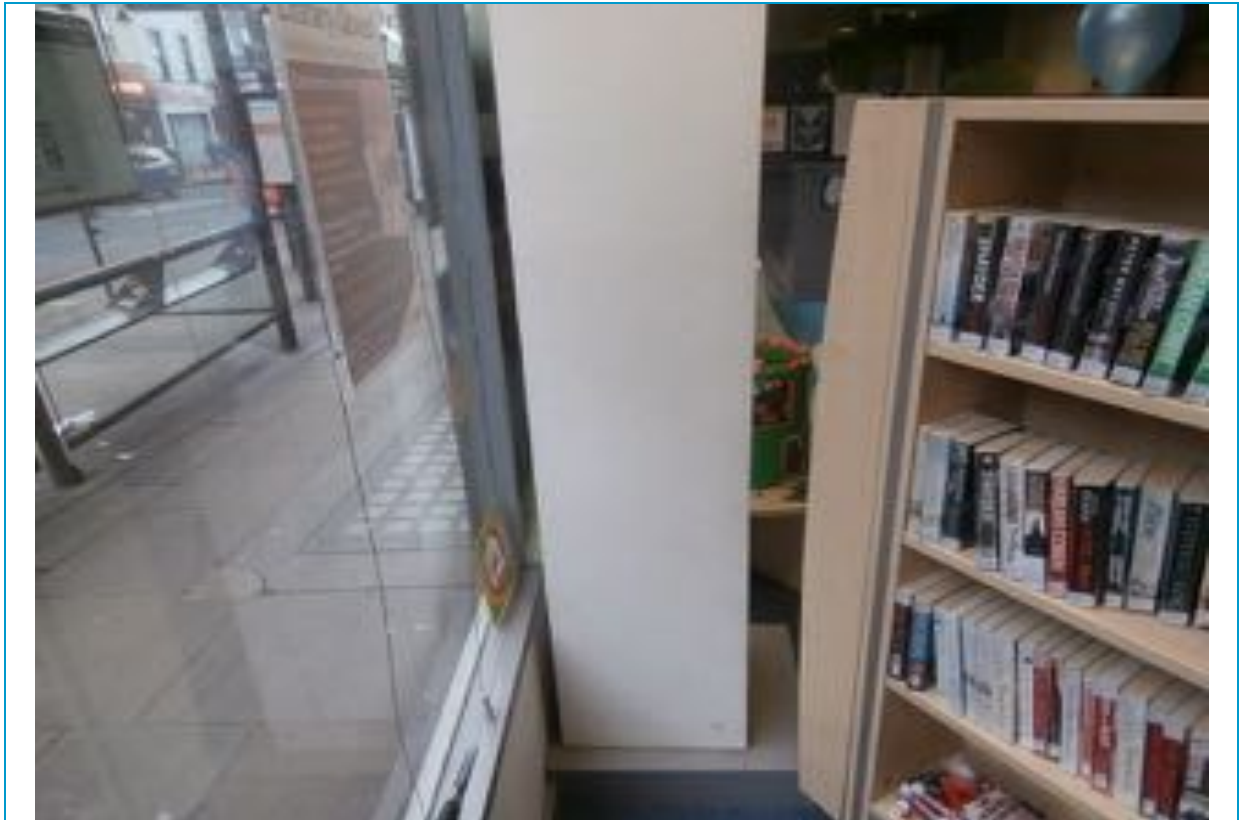
### Photo Ref: 018

Amount	Product Type	Damage	Surface Treatment	Asbestos Type	Score	Access	Total	Action Priority	Action Required
4 m <sup>2</sup>	2	0	1	2	5	3	15	Medium	Manage

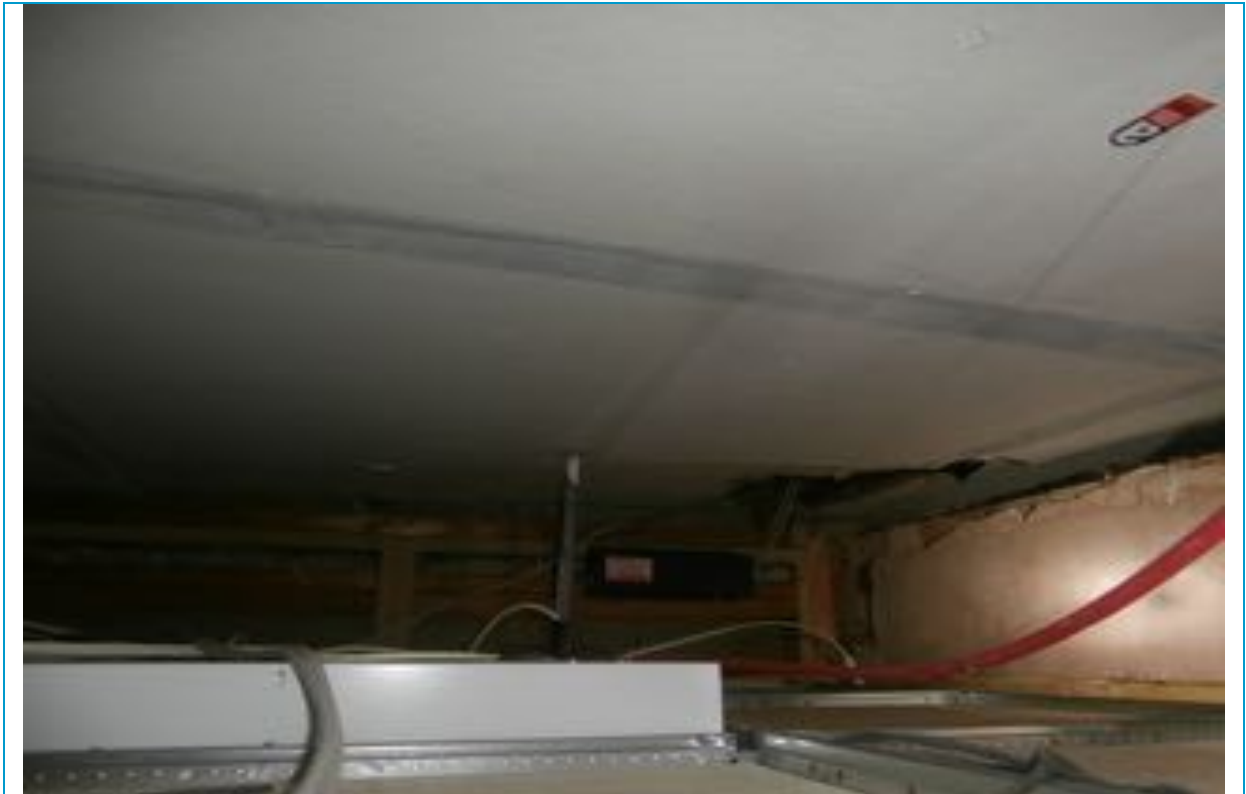
### Photo Ref: 019

Amount	Product Type	Damage	Surface Treatment	Asbestos Type	Score	Access	Total	Action Priority	Action Required
20 m <sup>2</sup>	2	3	2	2	9	1	9	Low	Encapsulate or overboard

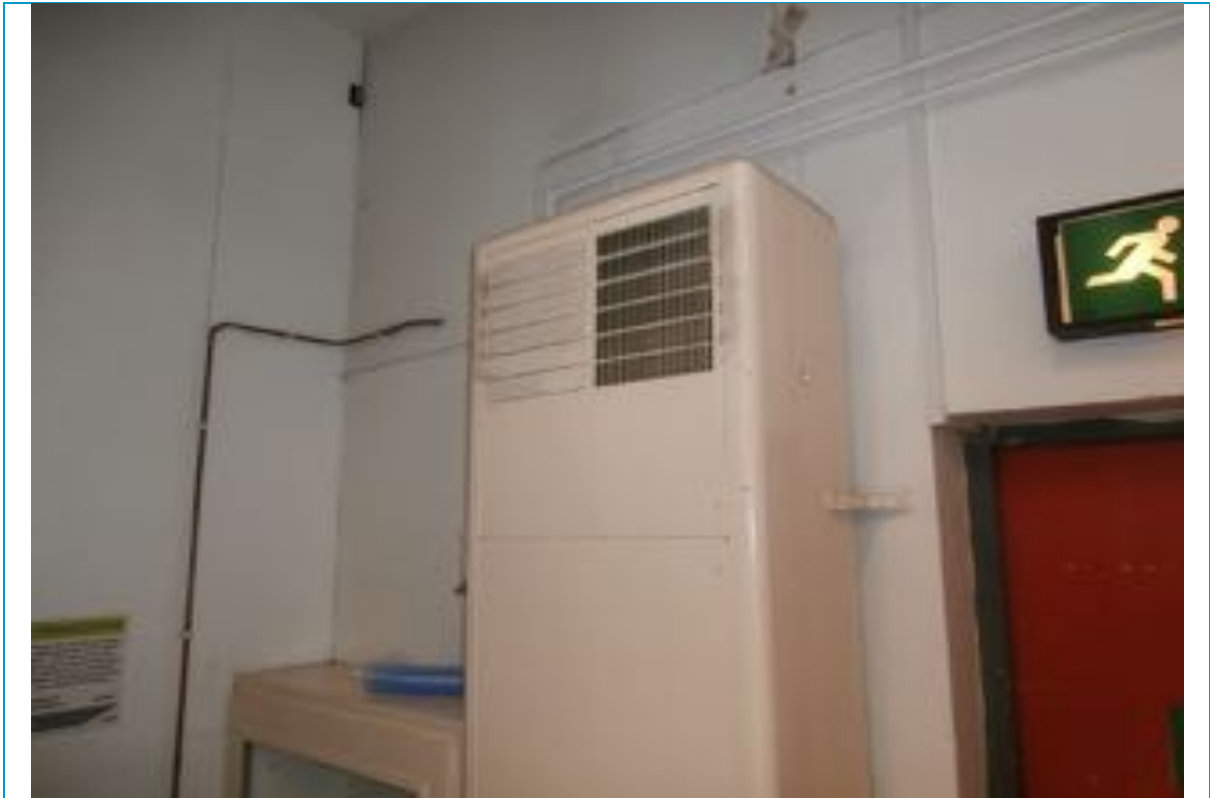
### **Photo Ref: 020**

Amount	Product Type	Damage	Surface Treatment	Asbestos Type	Score	Access	Total	Action Priority	Action Required
x1	2	0	1	1	4	1	4	Low	Manage
