## ASBESTOS SURVEY REPORT MANAGEMENT SURVEY

**SURVEY REPORT NO: NCC/MA/FI/00251**

Site Address:  
Central Library and Contact Centre 3  
Angel Row  
Nottingham  
Nottinghamshire  
NG1 6HP

<b>CLIENT:</b> Nottingham City Council	<b>DATE OF SURVEY:</b> 16/01/2015
<b>SURVEYED BY: A. Bennett</b>	<b>Signed: .....</b>
<b>AUTHORISED BY: R. Hubbard</b>	<b>Signed: .....</b>

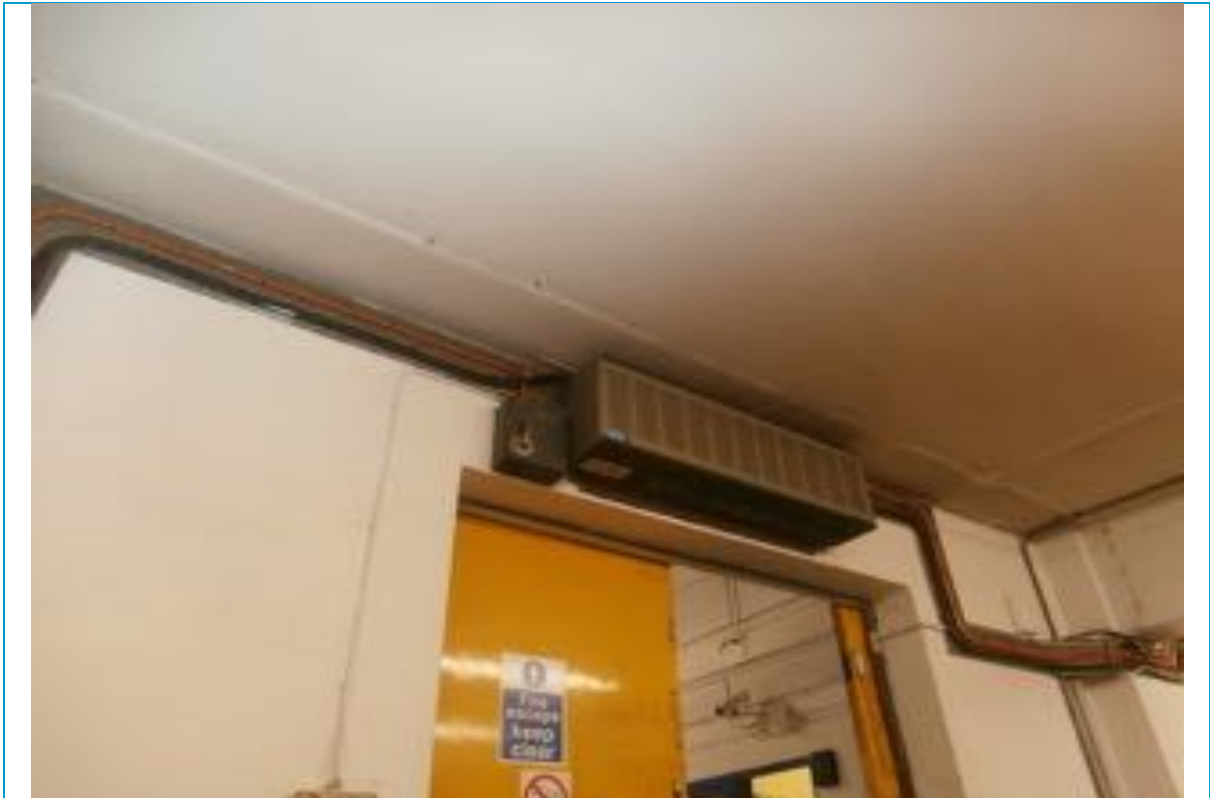
### **Photo Ref: 021**

Amount	Product Type	Damage	Surface Treatment	Asbestos Type	Score	Access	Total	Action Priority	Action Required
x4	2	0	1	1	4	1	4	Low	Manage

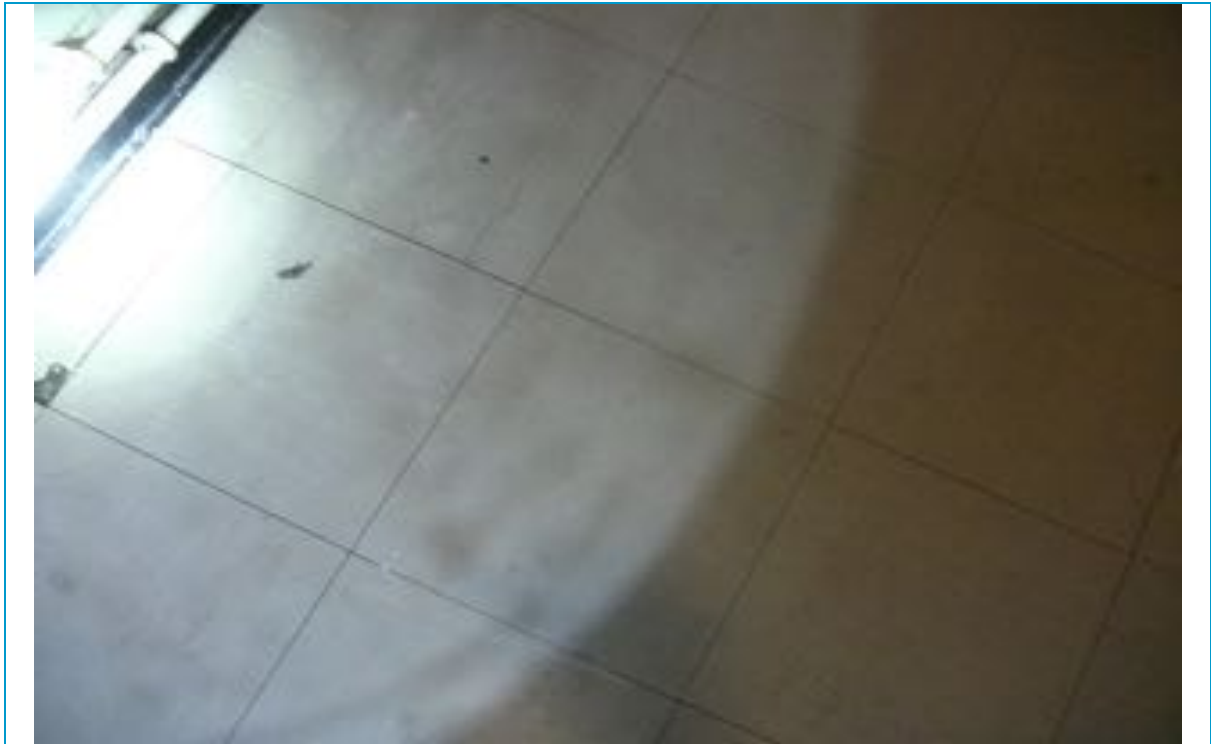
### **Photo Ref: 022**

Amount	Product Type	Damage	Surface Treatment	Asbestos Type	Score	Access	Total	Action Priority	Action Required
6 m2	1	0	0	1	2	3	6	Low	Manage

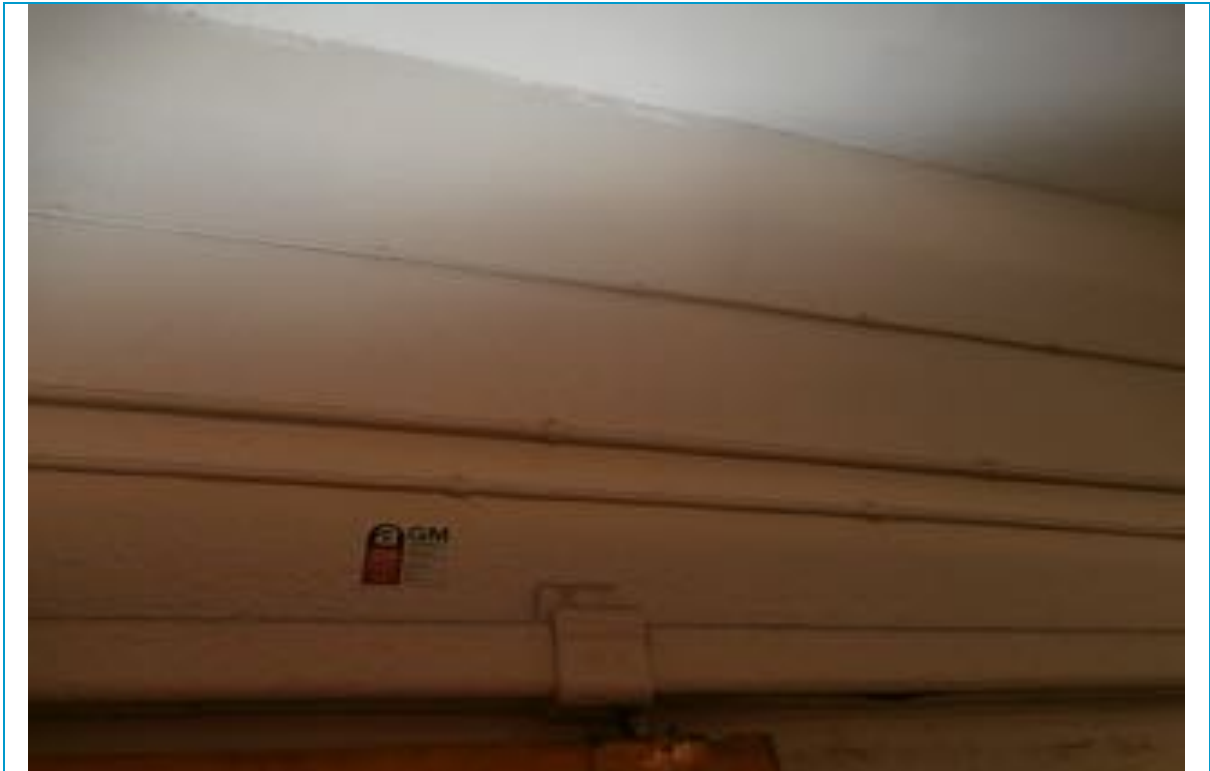
### Photo Ref: 023

Amount	Product Type	Damage	Surface Treatment	Asbestos Type	Score	Access	Total	Action Priority	Action Required
132 m <sup>2</sup>	1	0	0	1	2	3	6	Low	Manage

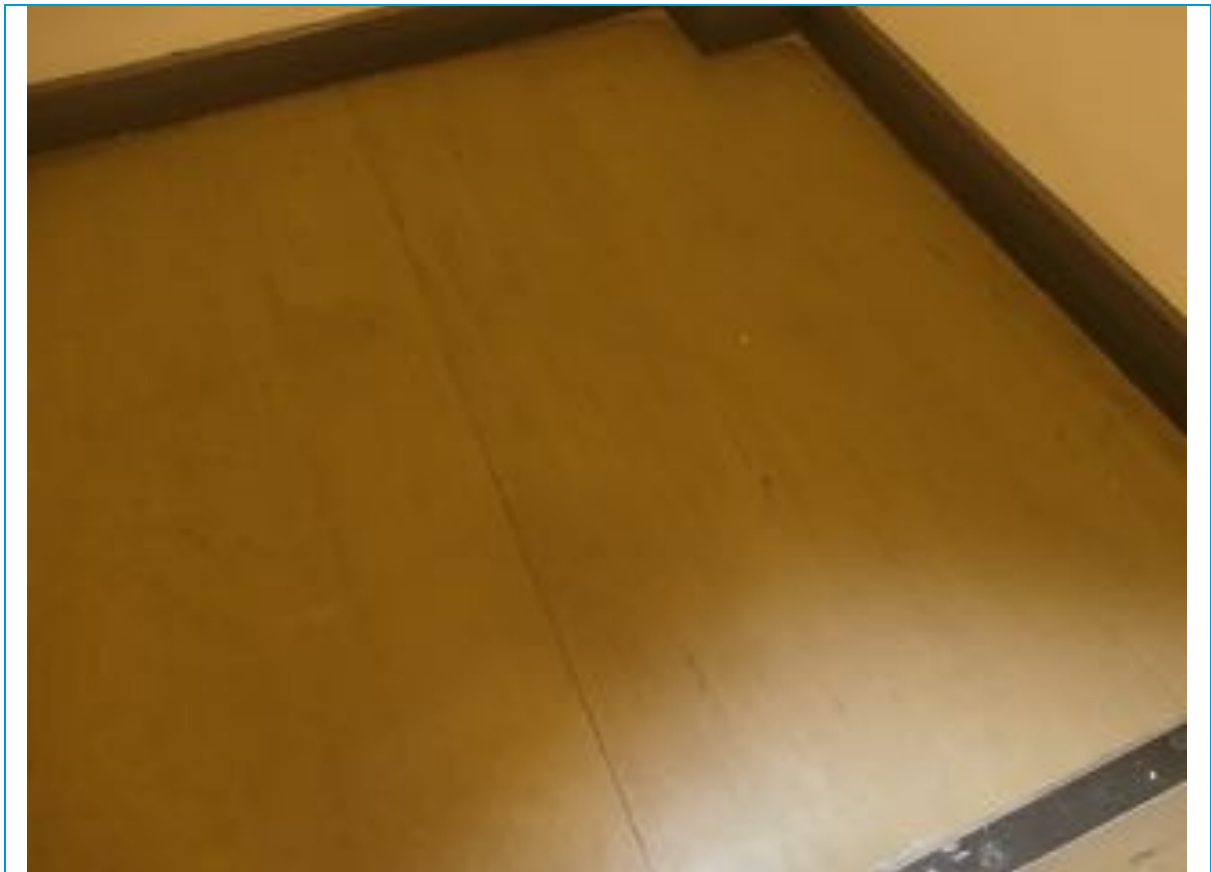
### **Photo Ref: 024**

<b>Site</b>	Central Library and Contact Centre 3, Angel Row, Nottingham, NG1 6HP		
Location	Stairwell		
Component	Green vinyl		
BDA Reference	136/3		
Sample No.	SP/16646	Analysis	Chrysotile

Amount	Product Type	Damage	Surface Treatment	Asbestos Type	Score	Access	Total	Action Priority	Action Required
10 m <sup>2</sup>	1	0	0	1	2	3	6	Low	Manage

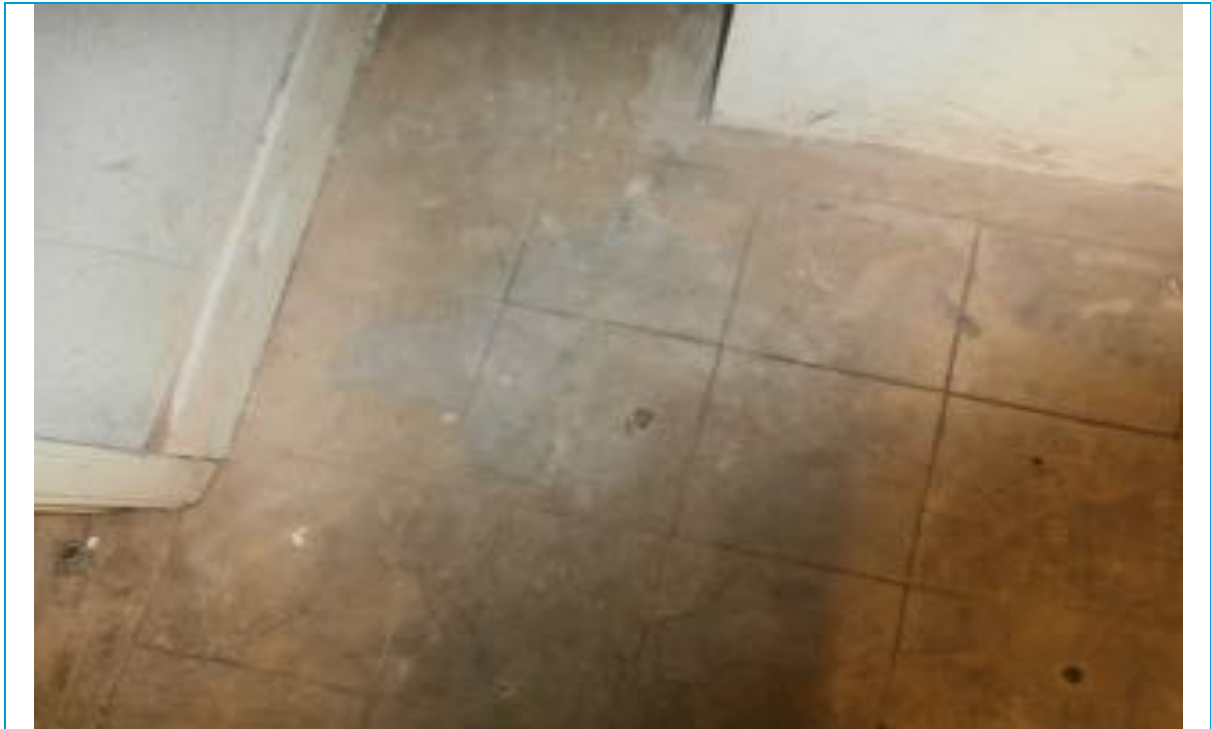
### Photo Ref: 025

Amount	Product Type	Damage	Surface Treatment	Asbestos Type	Score	Access	Total	Action Priority	Action Required
16 m <sup>2</sup>	1	0	0	1	2	3	6	Low	Manage

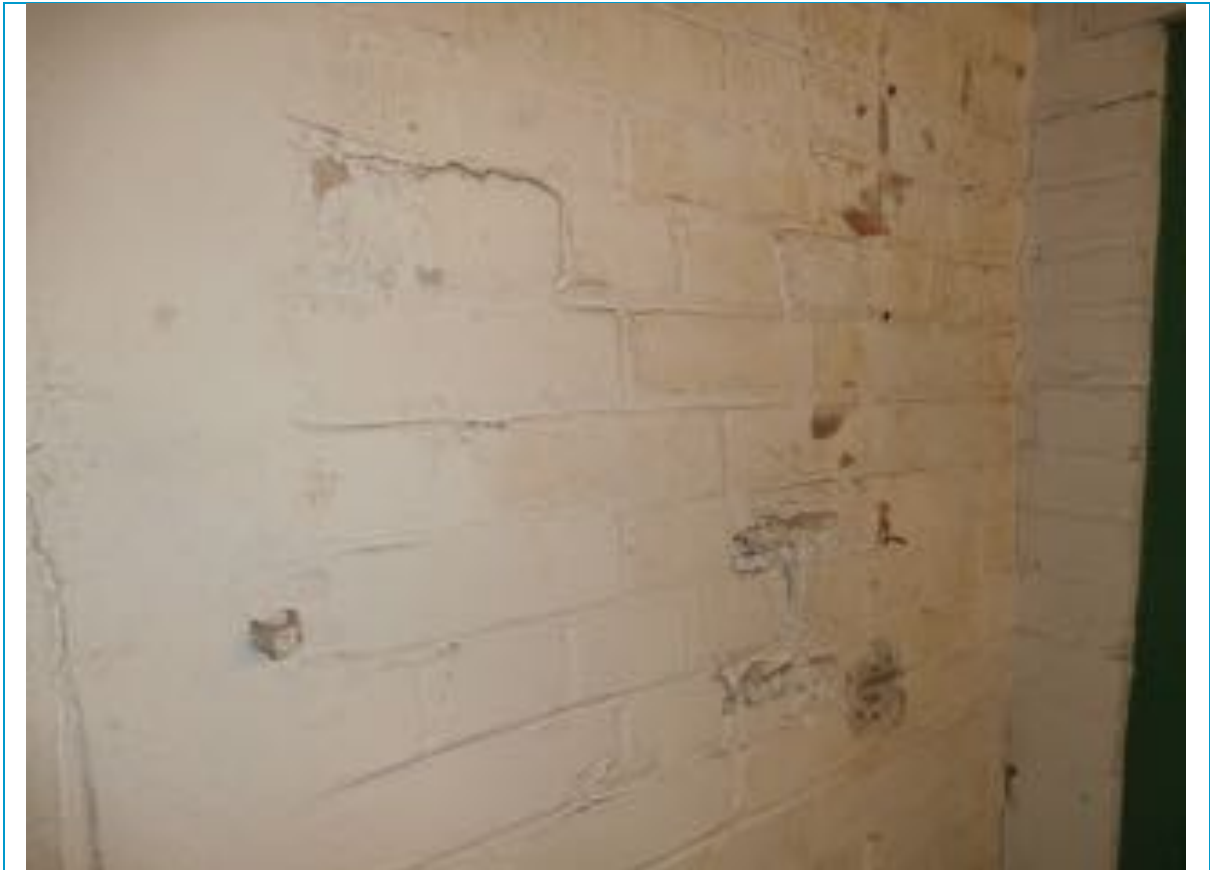
### **Photo Ref: 026**

Amount	Product Type	Damage	Surface Treatment	Asbestos Type	Score	Access	Total	Action Priority	Action Required
All	3	3	3	3	12	3	36	High	Remove

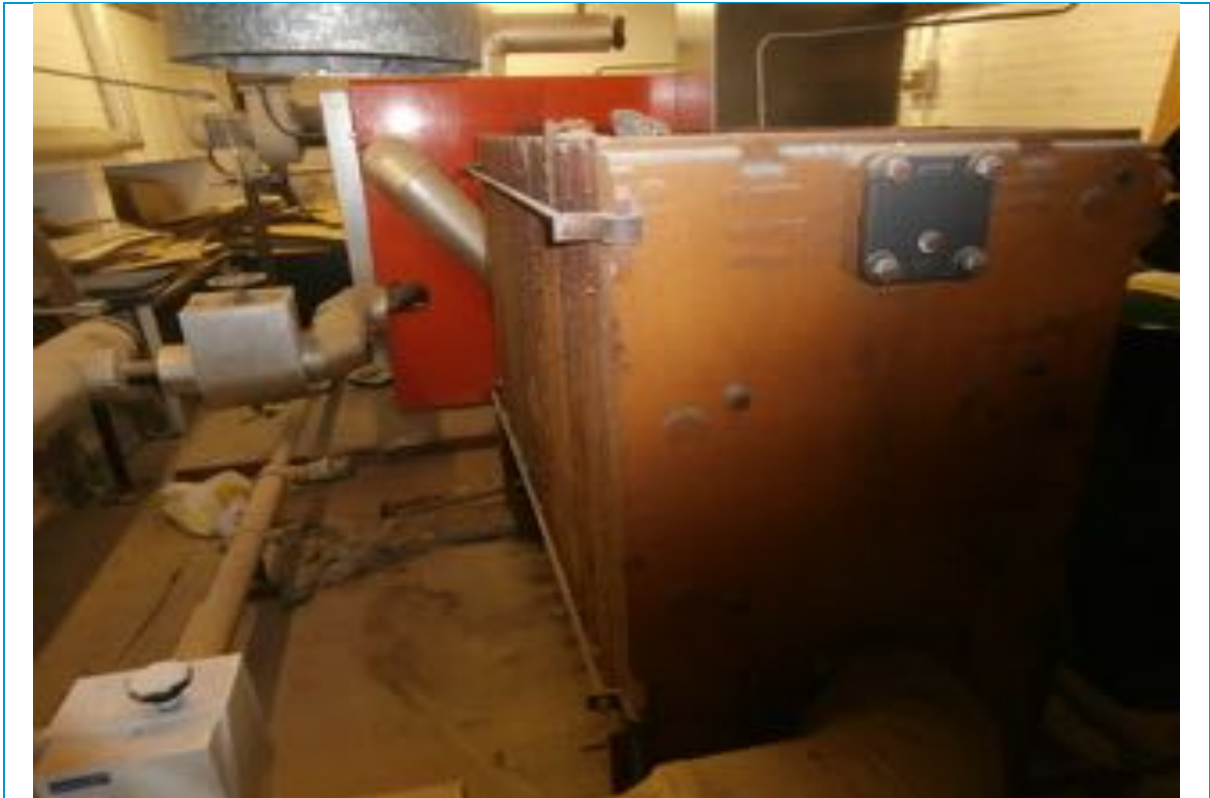
### Photo Ref: 027

Amount	Product Type	Damage	Surface Treatment	Asbestos Type	Score	Access	Total	Action Priority	Action Required
x1	2	0	1	1	4	1	4	Low	Manage

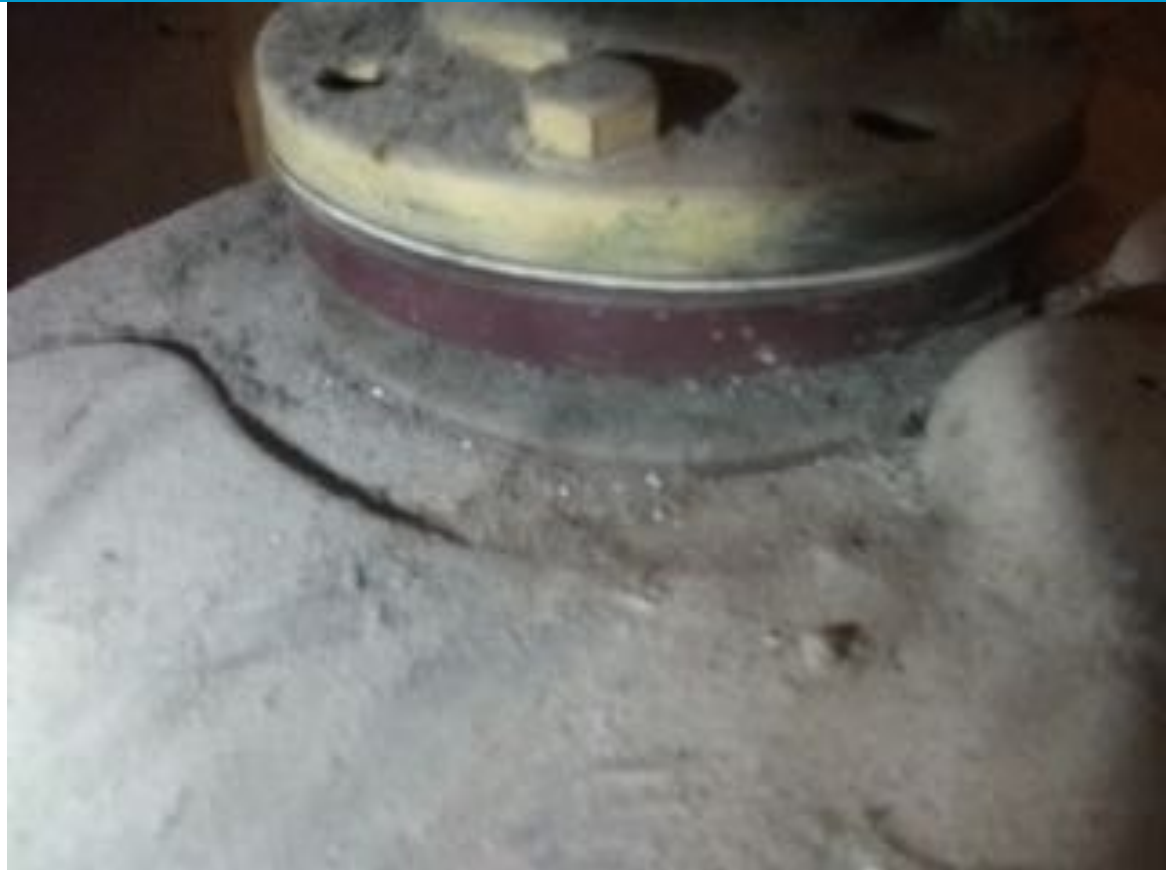
### Photo Ref: 028

Amount	Product Type	Damage	Surface Treatment	Asbestos Type	Score	Access	Total	Action Priority	Action Required
All	1	0	0	1	2	3	6	Low	Manage

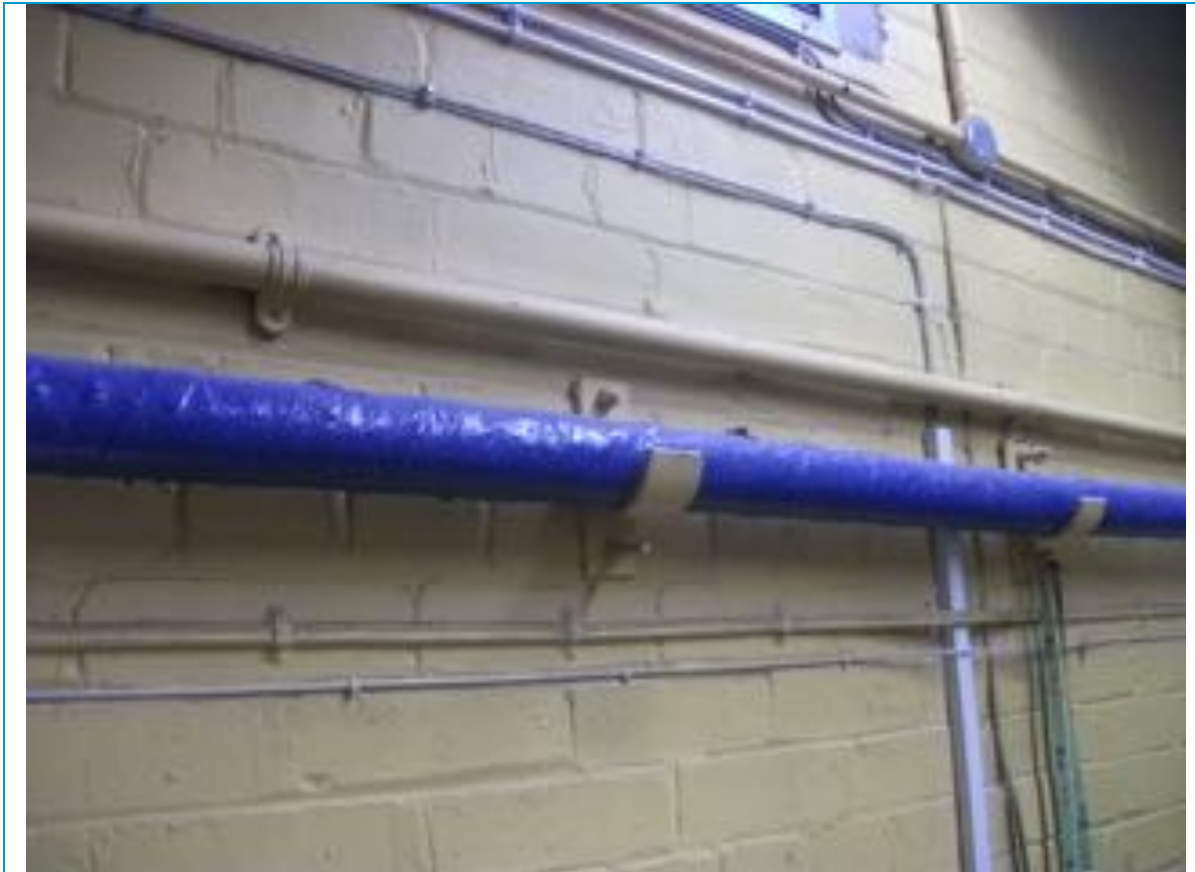
### Photo Ref: 029

Amount	Product Type	Damage	Surface Treatment	Asbestos Type	Score	Access	Total	Action Priority	Action Required
11 m	1	0	0	1	2	1	2	Low	Manage

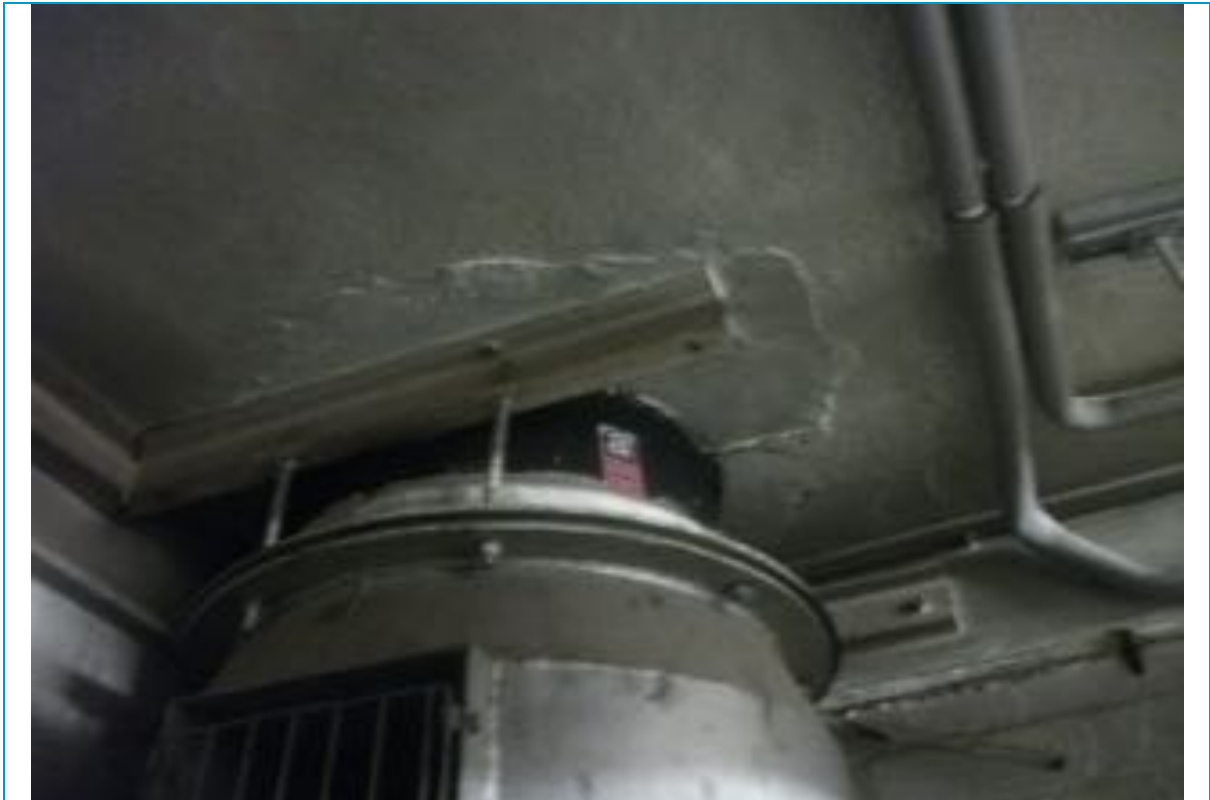
### **Photo Ref: 030**

Amount	Product Type	Damage	Surface Treatment	Asbestos Type	Score	Access	Total	Action Priority	Action Required
1 off	1	0	0	1	2	3	6	Low	Manage

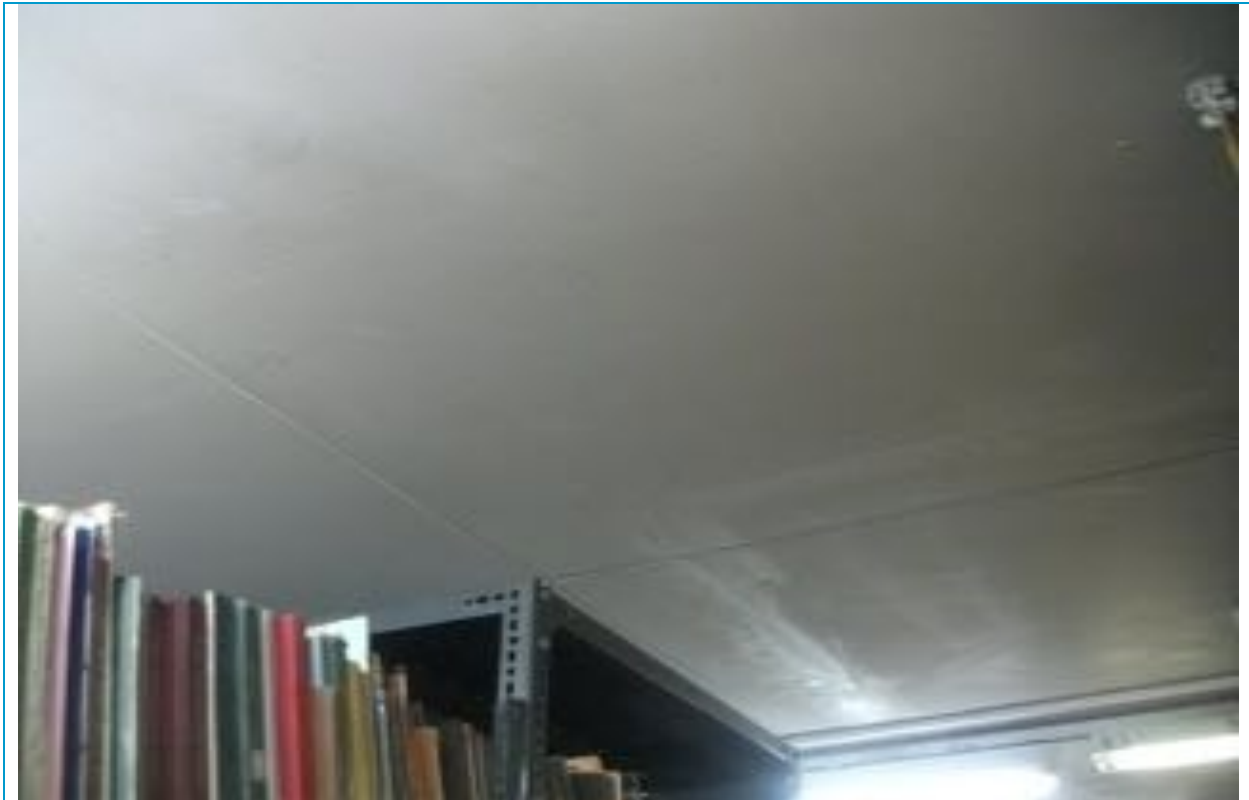
### **Photo Ref: 031**

Amount	Product Type	Damage	Surface Treatment	Asbestos Type	Score	Access	Total	Action Priority	Action Required
500 m <sup>2</sup>	2	0	1	2	5	3	15	Medium	Manage

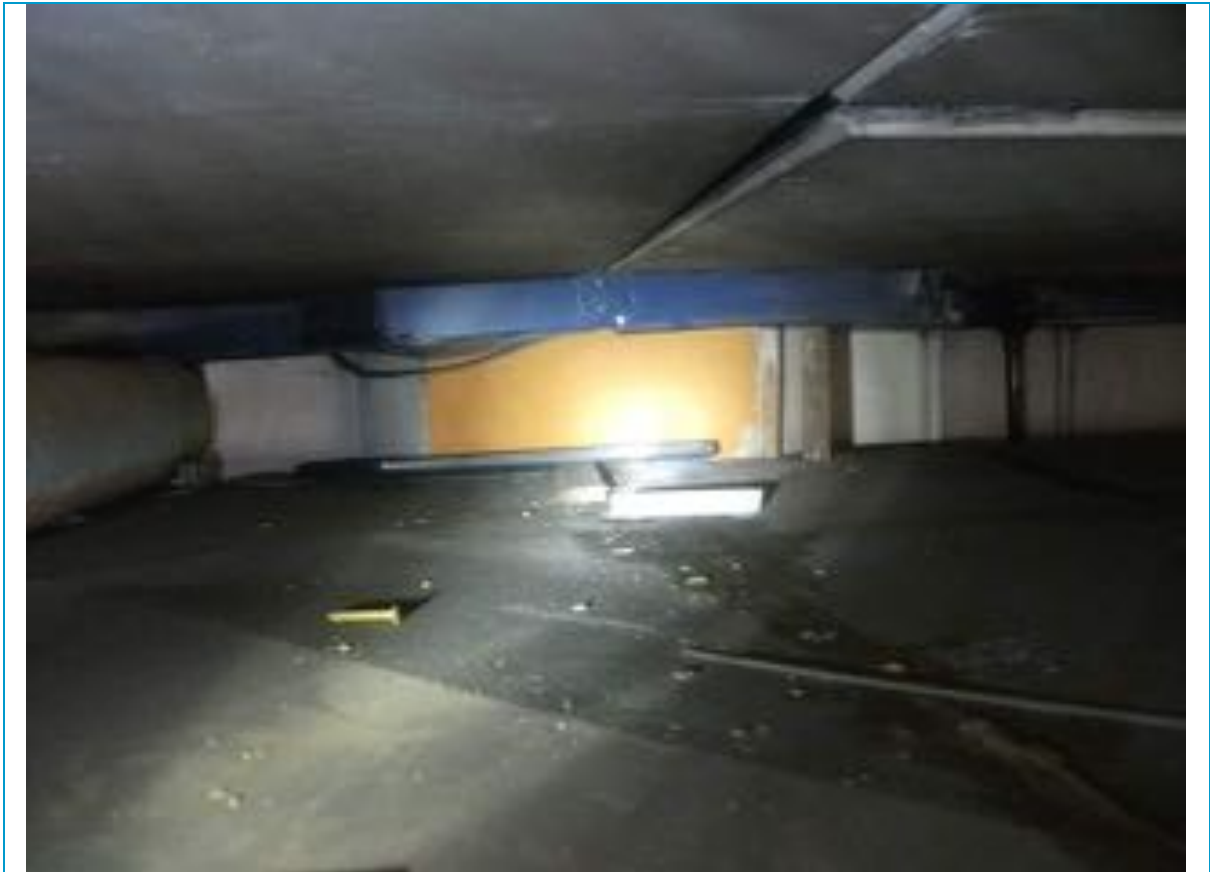
### **Photo Ref: 032**

Amount	Product Type	Damage	Surface Treatment	Asbestos Type	Score	Access	Total	Action Priority	Action Required
All	2	3	2	2	9	3	27	High	Remove

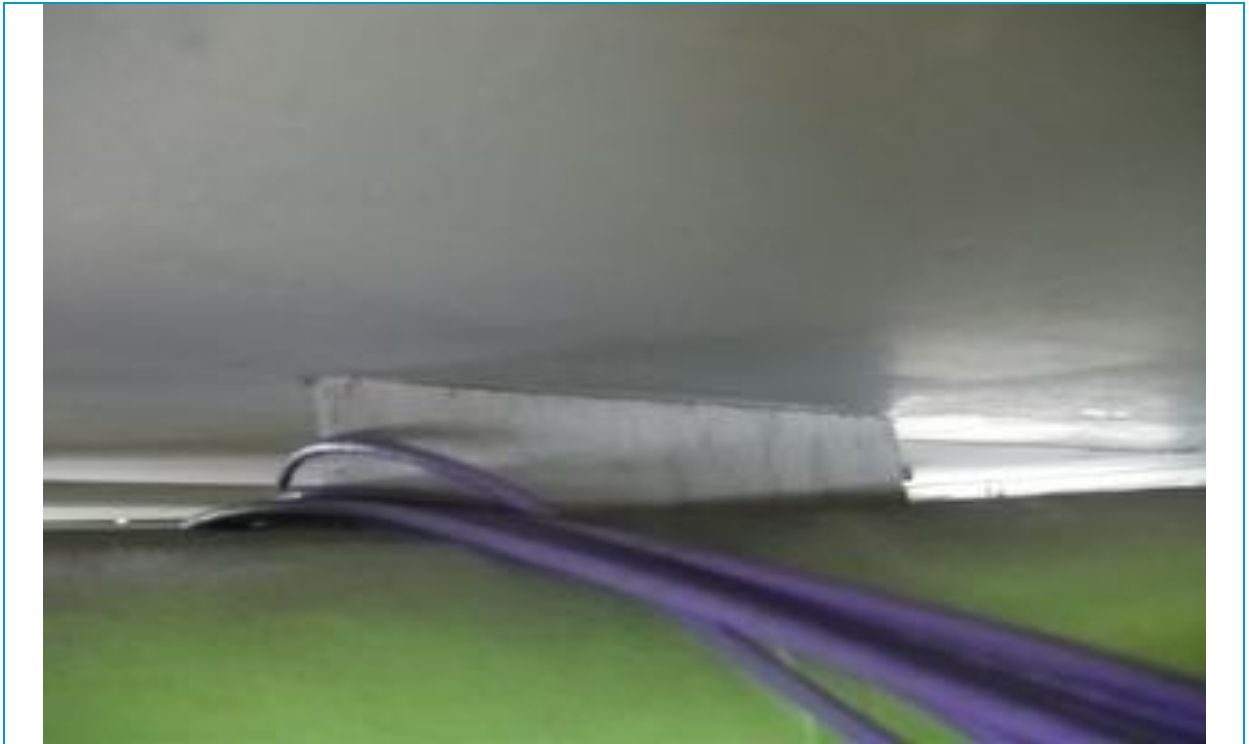
### Photo Ref: 033

Amount	Product Type	Damage	Surface Treatment	Asbestos Type	Score	Access	Total	Action Priority	Action Required
All	2	1	2	2	7	3	21	High	Encapsulate or overboard

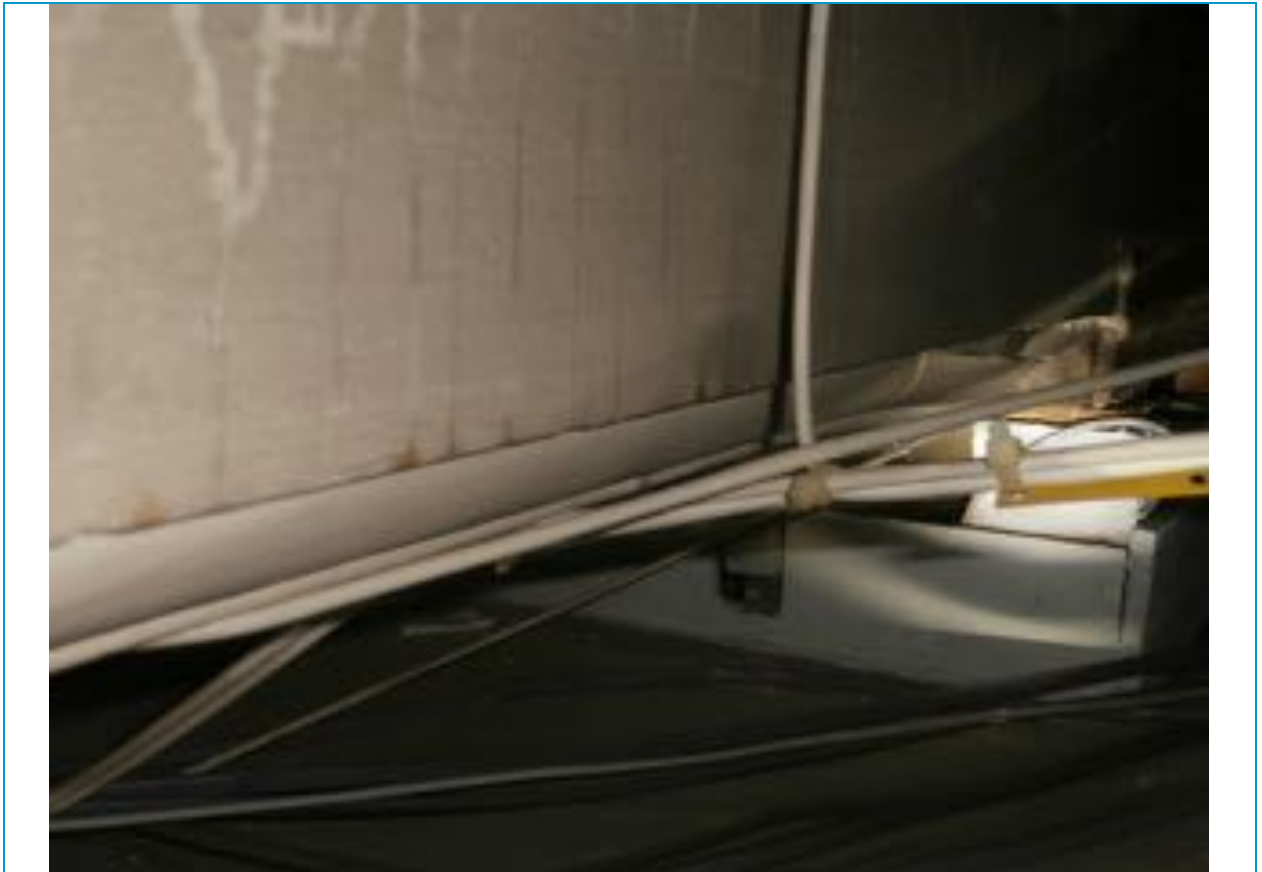
### **Photo Ref: 034**

Amount	Product Type	Damage	Surface Treatment	Asbestos Type	Score	Access	Total	Action Priority	Action Required
All	2	3	2	2	9	1	9	Low	Remove

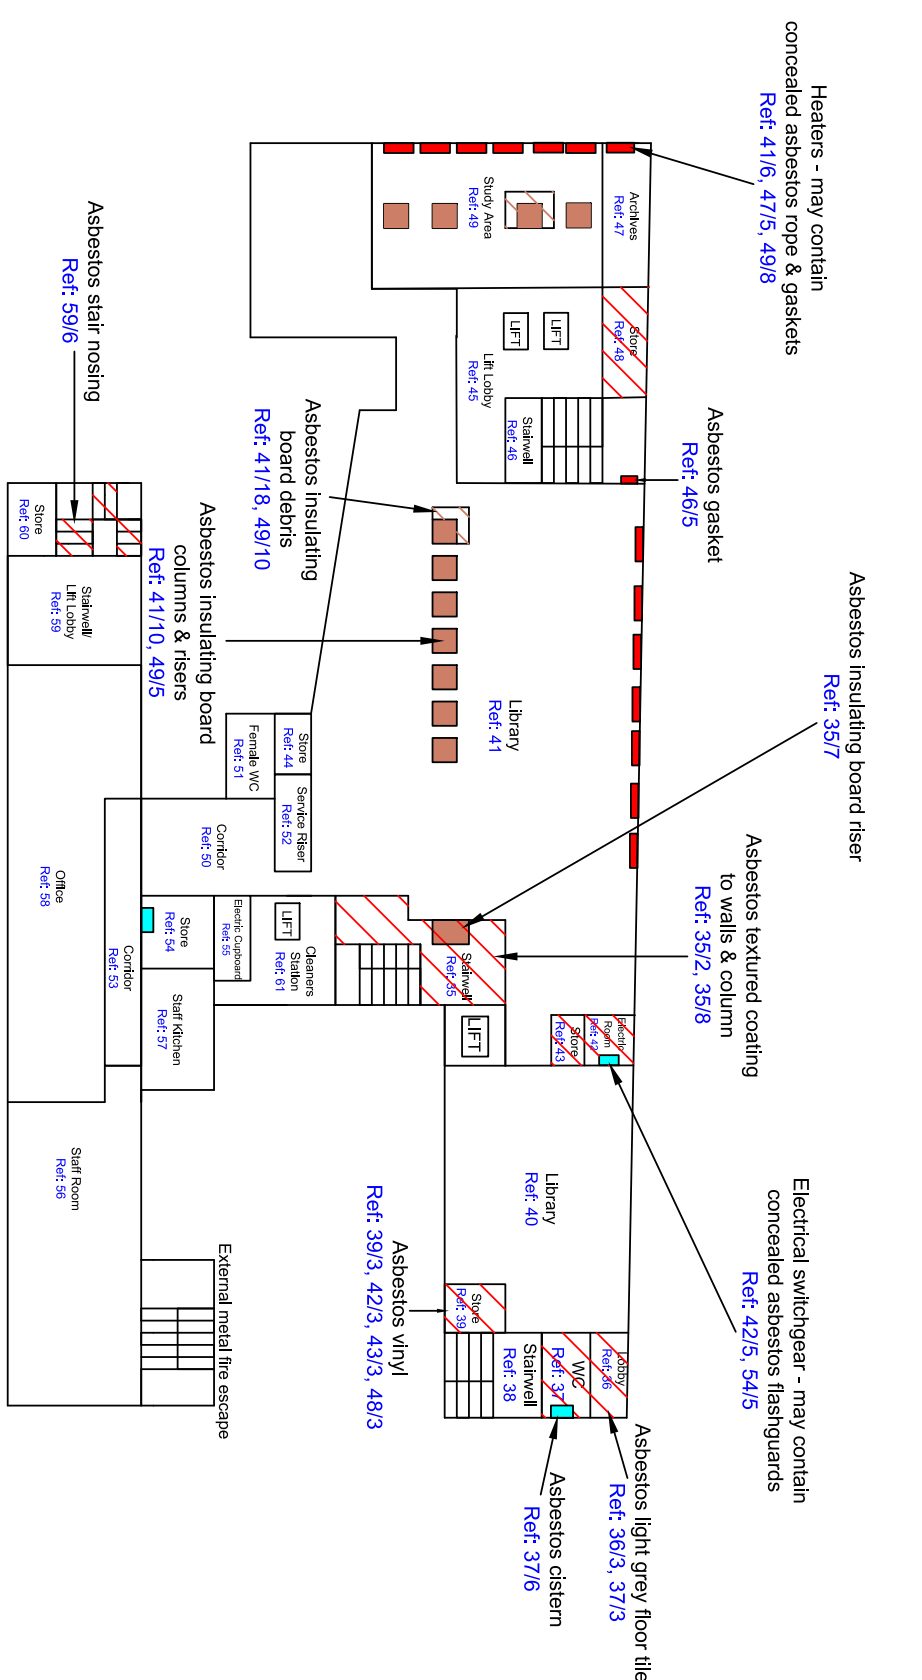
**THIRD FLOOR**

Heaters - may contain  
concealed asbestos rope & gaskets  
Ref: 416, 47/5, 49/8

Asbestos gasket  
Ref: 46/5

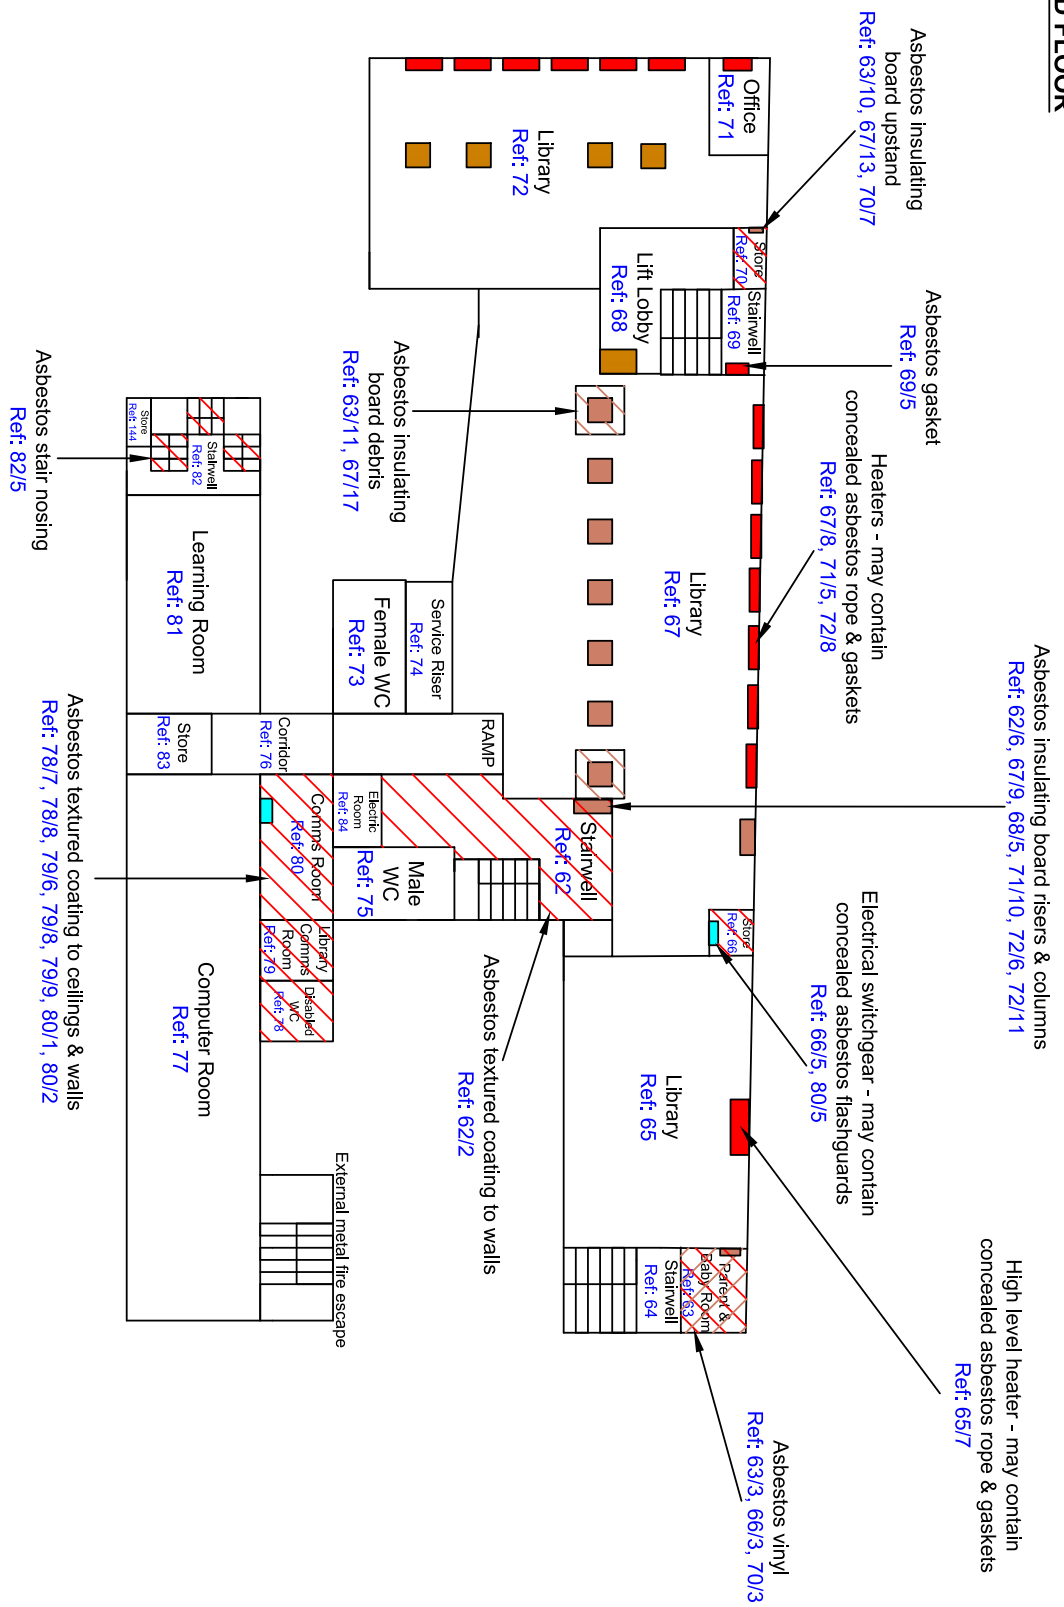
**SECOND FLOOR**

Asbestos insulating board risers & columns  
Ref: 62/6, 67/9, 68/5, 71/10, 72/6, 72/11

High level heater - may contain  
concealed asbestos rope & gaskets  
Ref: 65/7
