# Your survey report

172 Burton Road, Lincoln, LN1 3LT

02-09-2025

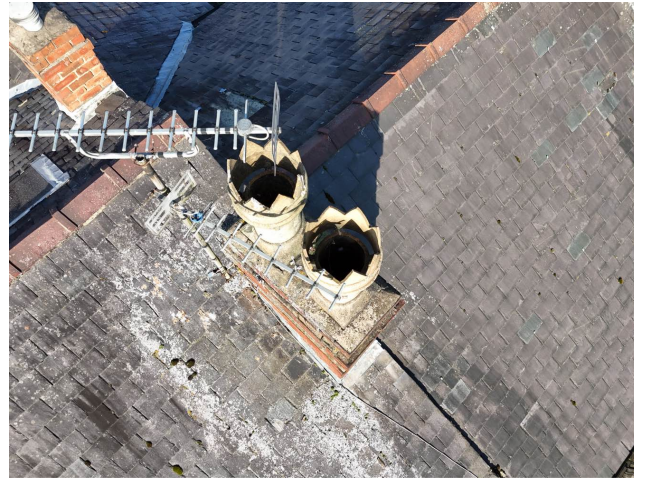
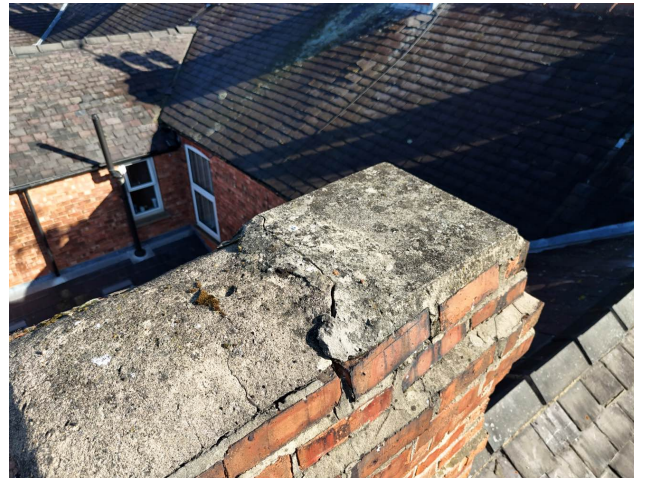
The chimney stacks were seen to be in overall serviceable condition, requiring some general repair and maintenance works not considered unusual for their age and type. For example, lack of covers/cowls, cracked flaunching, perished brickwork and weathered pointing. The flues could not be verified or inspected and further upgrading and improvement in this regard, therefore, cannot be ruled out.

The mortar base (flaunching) to the chimney pots is very exposed and subject to driving rain and frost. It should be kept in good condition at all times.

Any repairs or maintenance should be done using materials sympathetic to the age and construction of the property i.e. like for like bricks and lime based mortar.

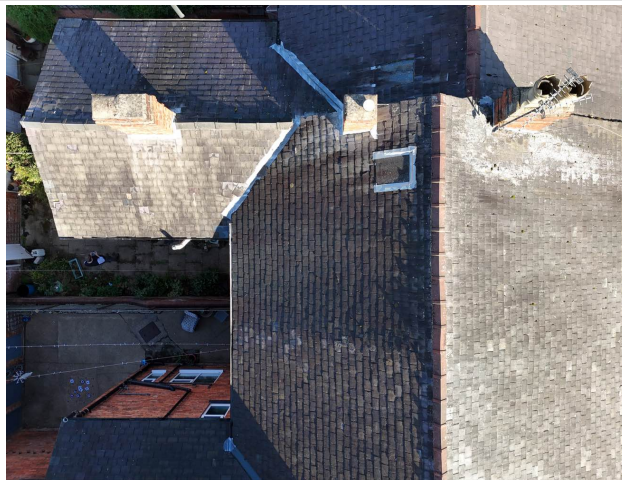
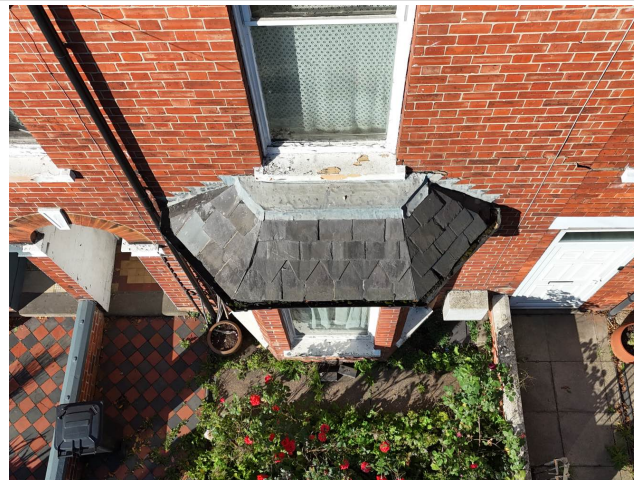
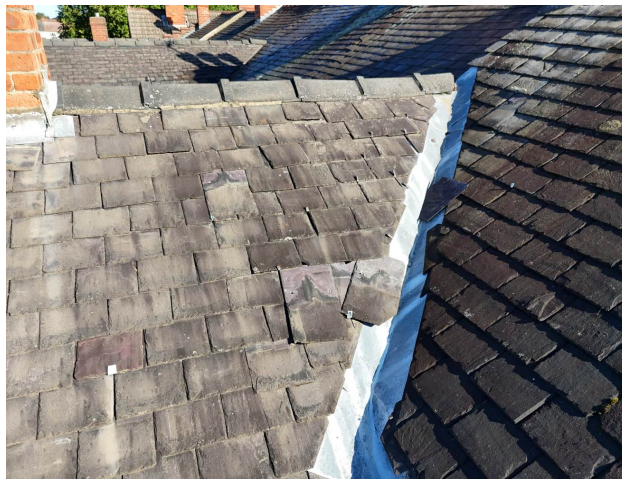
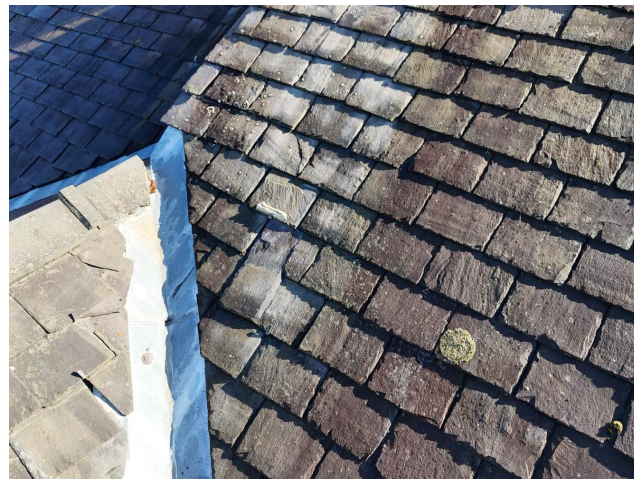
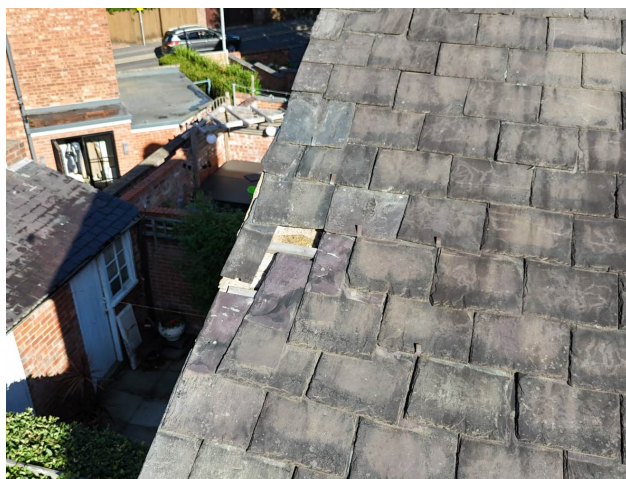
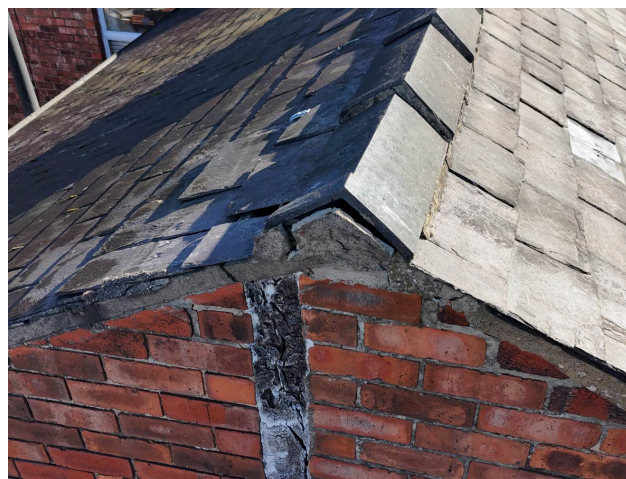
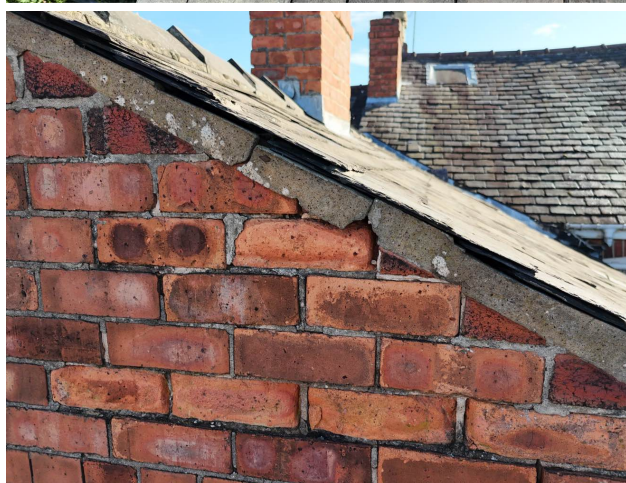
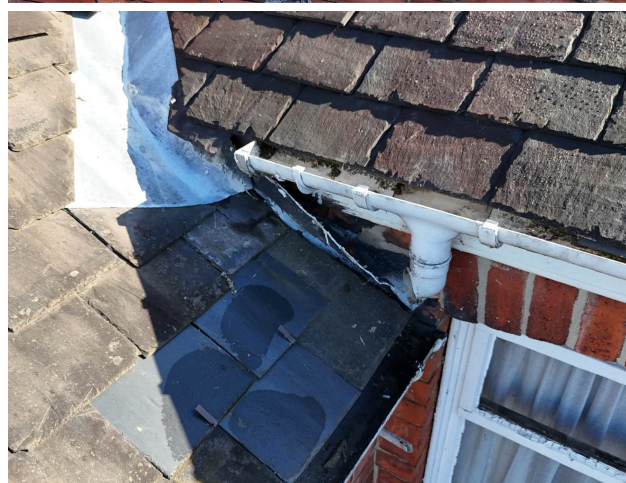
## D2 Roof coverings

We noted holes in the roof and evidence of a leak internally due to slipped, defective and missing slates. We also noted deteriorating verge and ridge bedding mortar, and a loose lead upstand to the rear. Some slates are now held in place with metal strips (often referred to as tingles). This is an indication that slates have slipped in the past and have been replaced on an individual basis. The nails securing the original coverings will be more susceptible to failure and further slippage will be likely. A roof covering of this type and age is likely to require ongoing maintenance to ensure that it remains weathertight. Some repairs may be difficult due to the possible fragile nature of the original material. Renewal is likely to be a more economic option and you should therefore budget accordingly. It would be prudent to consult a competent roofer prior to exchange of contracts.

There is a general unevenness to the roof surfaces which is probably due to the displacement of roof timbers over a number of years. This is not an unusual defect in a roof of this age and it is unlikely to progress significantly.

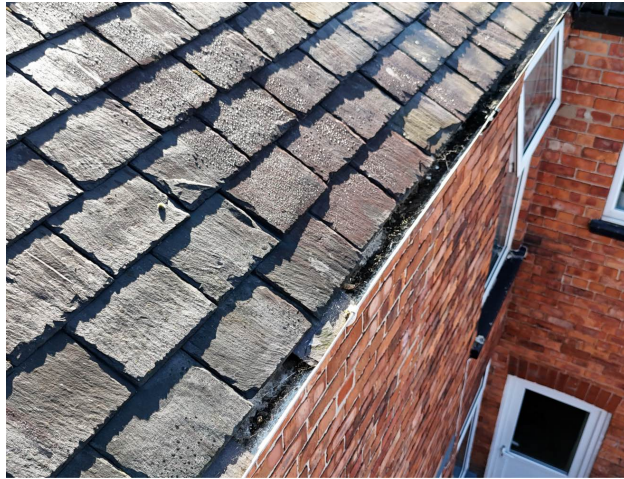
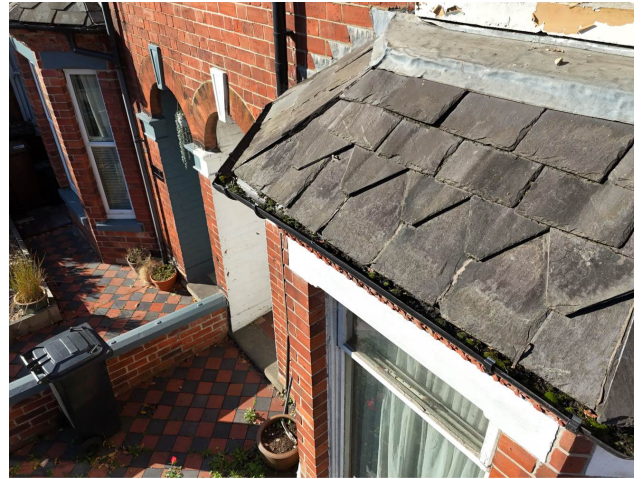
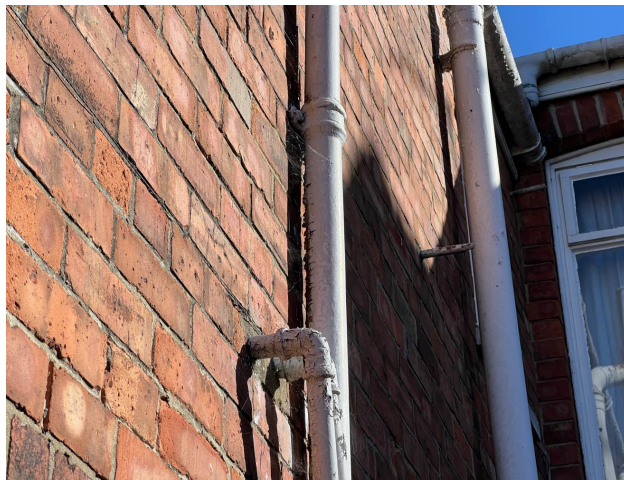
### D3 Rainwater pipes and gutters

The rainwater goods were found to be generally functional but we noted some defects such as debris in gutters and corrosion to metal sections. Repair, maintenance and improvement works are now required.

As stated above, partial corrosion was evident to the cast-iron sections. Repairs can be carried out to prolong the units but deterioration is likely to be ongoing. If they are to be retained, frequent maintenance should be expected with increased costs. You may wish to consider renewal with modern sections.

To replace the corroded sections of rainwater goods. This should be done in the short term. To clear the debris from the gutters. This should be done in the short term and continuously as part of cyclical maintenance.

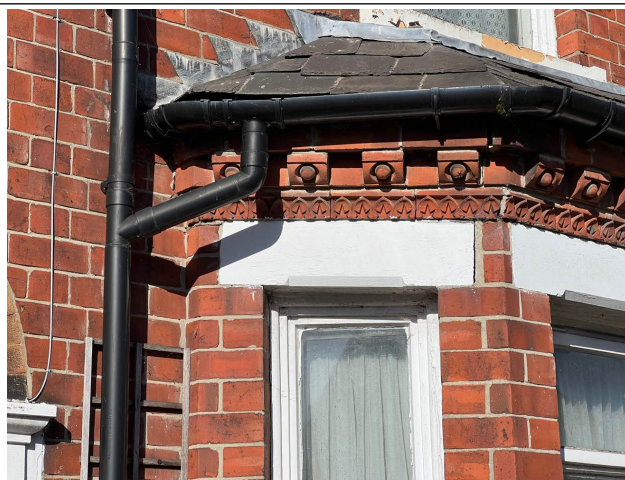
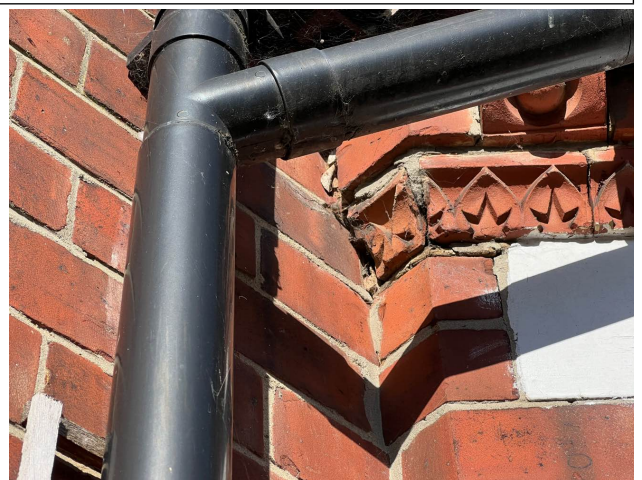
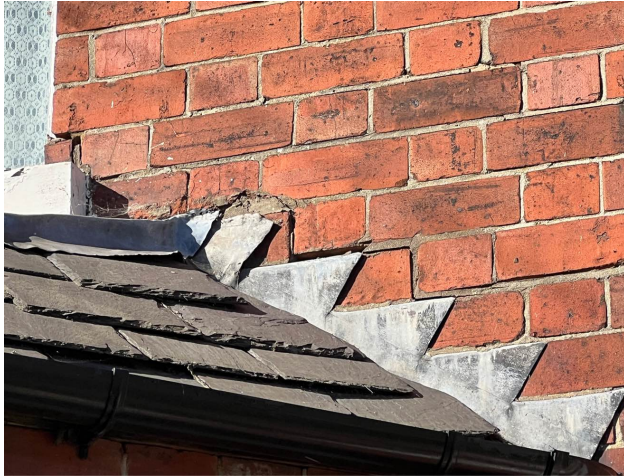
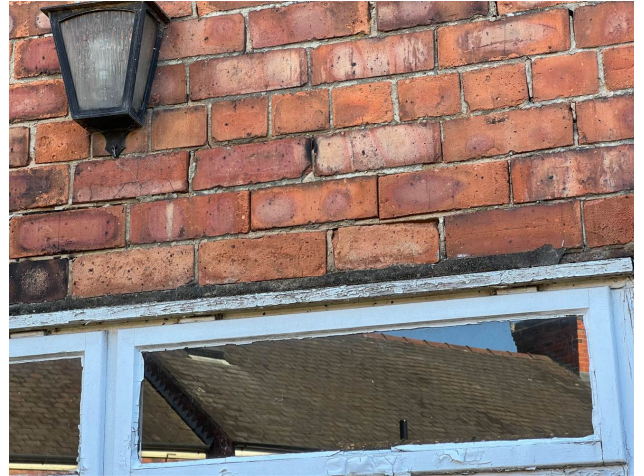
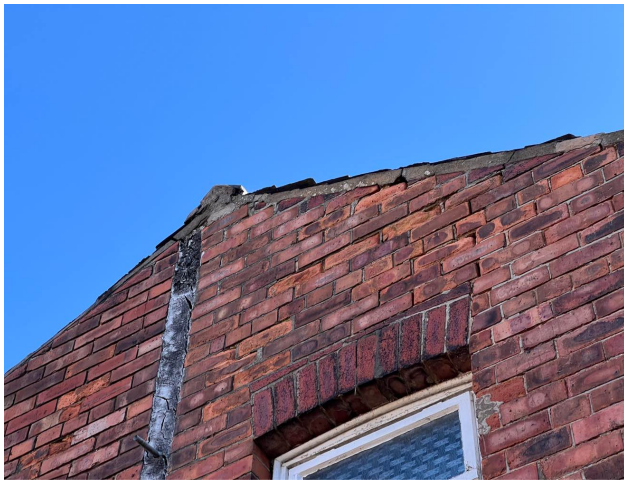
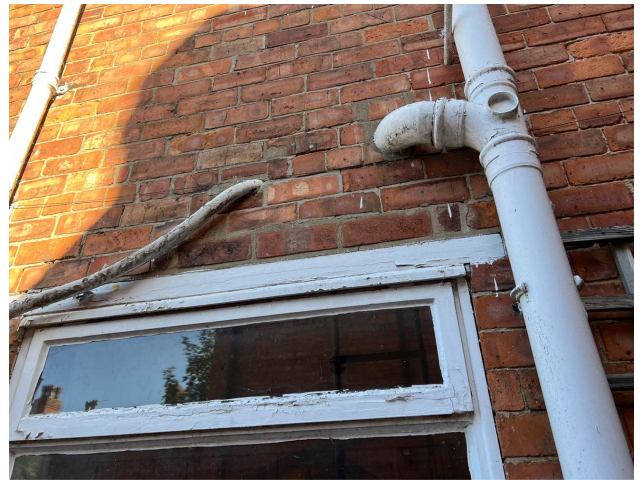
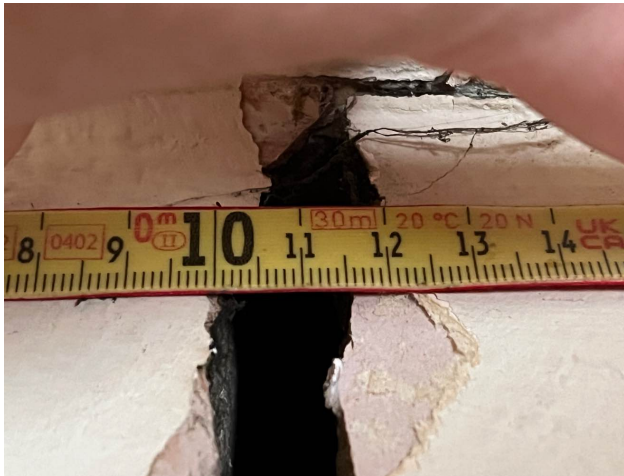
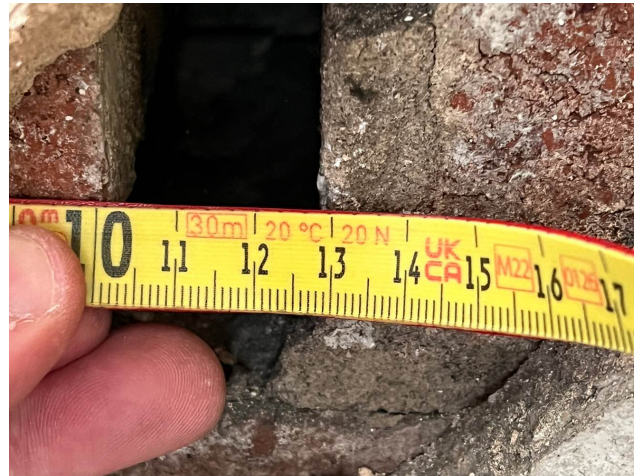
#### D4 Main walls

There are signs that the property is affected by serious structural movement as evidenced by distortion and cracking internally around the bay windows structure. The possibility of further movement occurring cannot be discounted. You must obtain a report from a Structural Engineer which should include a detailed analysis of the cause of the defect and the works that are required to remedy the problem, and associated costs. Structural repairs in the way of strapping and, as per the BRE 251 Digest, bracing out and partial rebuilding works are likely to be required.

Some of the openings are supported by timber lintels, which tend to suffer from decay, particularly at the ends where they are supported by the masonry. We noted areas of distorted masonry around these timber lintels and repairs/improvements are required.

Some of the masonry to the arch over the front door is cracking and has displaced. Remedial works and possibly partial rebuilding of the affected opening will be necessary.

DPCs should ideally be 150mm above external ground level. It was noted that ground levels around the property are too high in some areas. This can lead to a bridging of the DPC, causing dampness to occur in the interior of the building, together with potentially associated defects noted above. Whilst this does not appear to be contributing to any significant damp related issues internally at present, external ground levels should be reduced as a precautionary measure against unwanted damp problems. Where this is not feasible, you could consider installing perimeter drainage such as ACO drains or French drains.

Significant structural movement was noted around the bay window structure, more so internally. We believe this to be due to the shallow foundations of the bay window sinking and pulling away from the main structure. As the brickwork appears to be toothed in, it is pulling the surrounding masonry away with it. Structural strapping and potential rebuilding works are likely to be required and you should consult a Structural Engineer regarding the specification and design of this. This should be done prior to exchange of contracts and works should be carried out as soon as possible.

Some spalling and weathered pointing were noted to the walls. Some localised repointing and brickwork replacement will be required. Where distortion was noted around the kitchen windows, this is due to lack of lintel support and due to the defective timber lintel. You should look to install appropriate lintel support in these areas. Where the masonry has dropped to the brick arch above the main front door, repairs and potential partial rebuilding works will be required. The filling to the gap between the two adjoining properties to the rear off-shot has deteriorated and should be repaired/replaced as necessary. These works should be carried out in the short term.

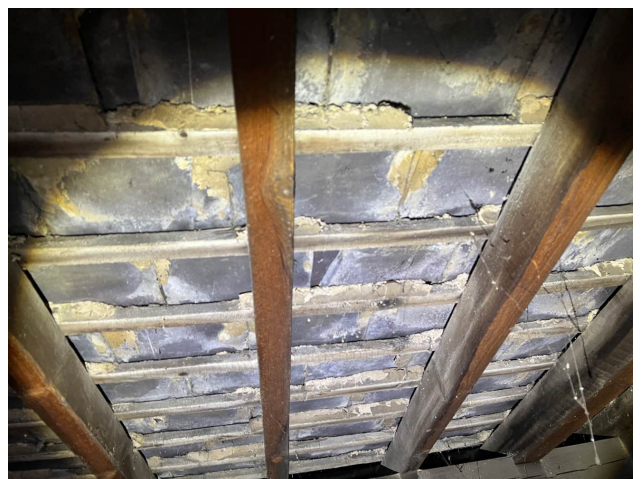
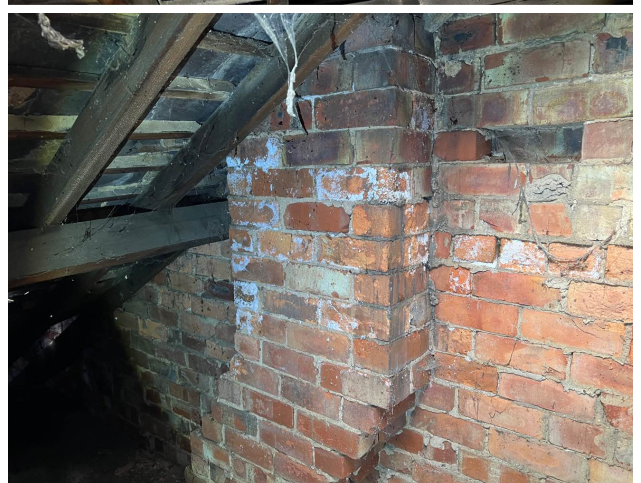
significant issues at present, but as mentioned, the now redundant flues should be ventilated.

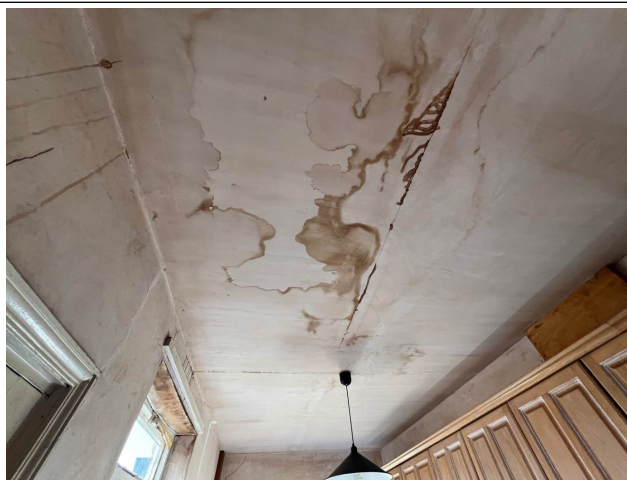
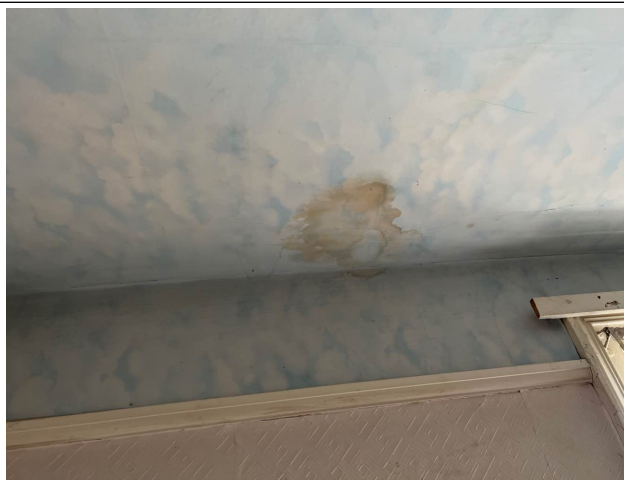
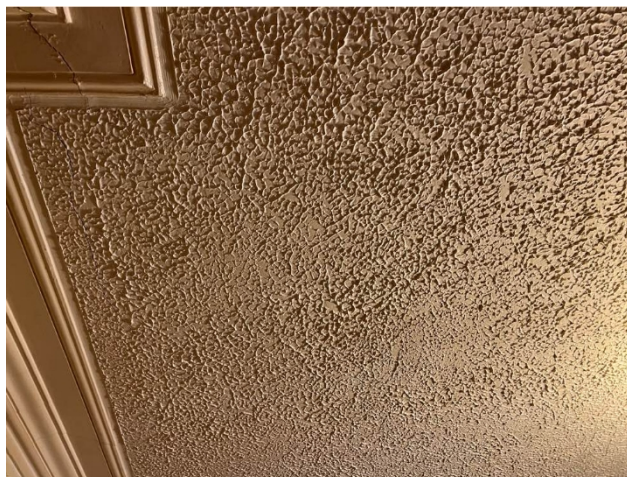
## E2 Ceilings

A textured finish has been applied to some ceilings. It is now known that such finishes may contain low levels of asbestos. As repairs are needed in the lounge which are likely to extend to the ceiling, you should consult an asbestos specialist regarding the testing and subsequent removal, if required. Further advice is available from the Health & Safety Executive - <https://www.gov.uk/search?q=asbestos>.

Lath and plaster ceilings of this age can be prone to sudden, partial or complete failure. Realistically, you should allow for ongoing repair to areas of defective plaster and ultimately, renewal will be required. This can be exacerbated when paper linings are removed during decoration.

Stains were noted to the front right bedroom which are believed to be due to the leaking roof. When the roof is addressed, some repairs to the ceiling may become required. Stains were noted to the recently reskimmed ceiling in the kitchen. This is believed to be due to a leak in the bathroom and/or to the water cylinder in the bathroom. Once the bathroom and hot water system have been replaced, some replastering may become required to the kitchen below. The we works should be carried out as soon as possible.

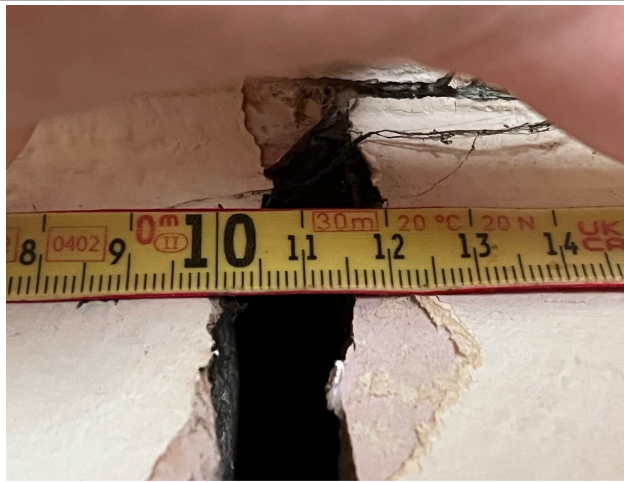
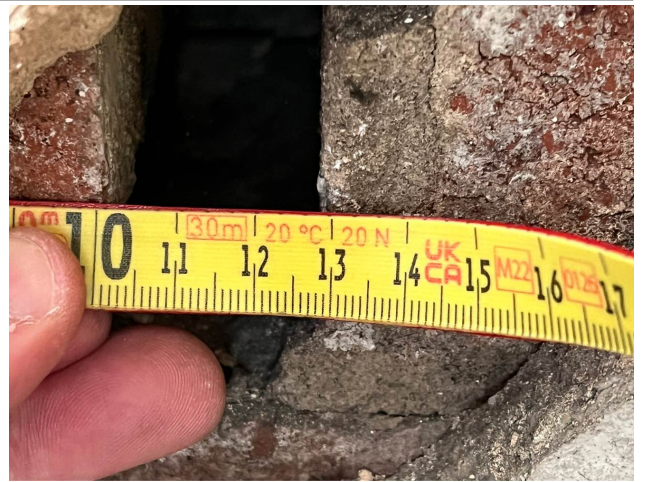
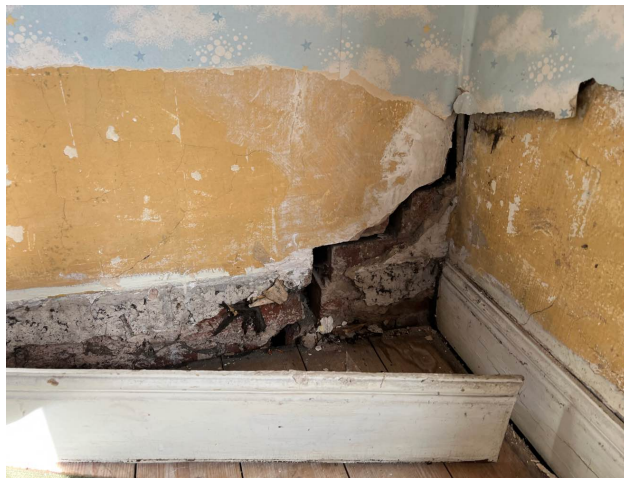
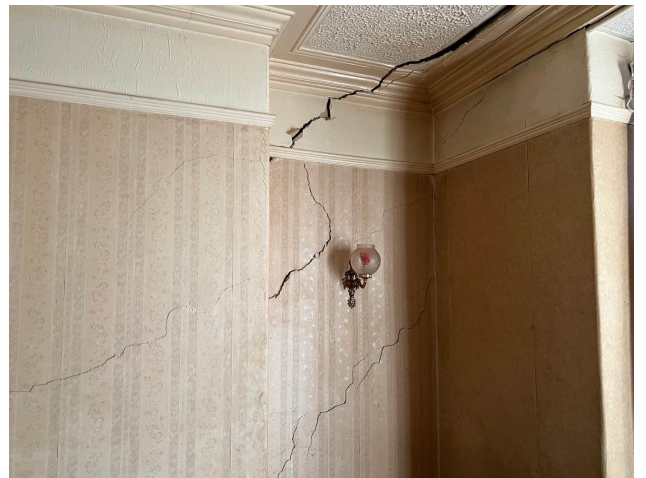
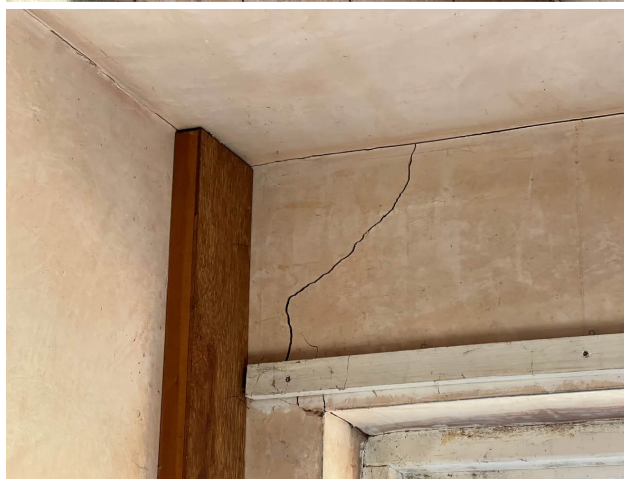
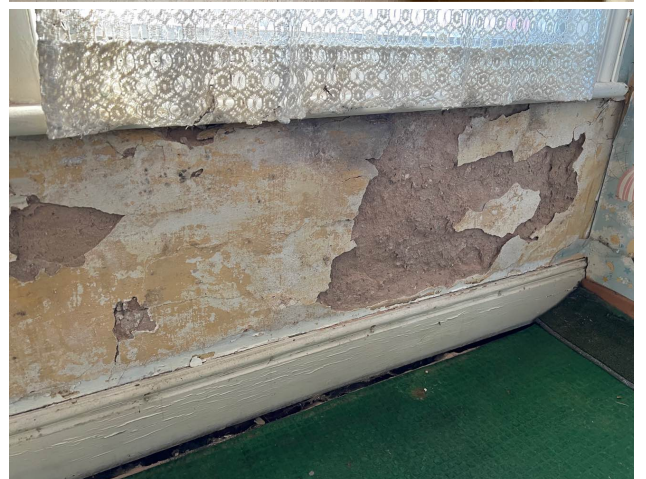
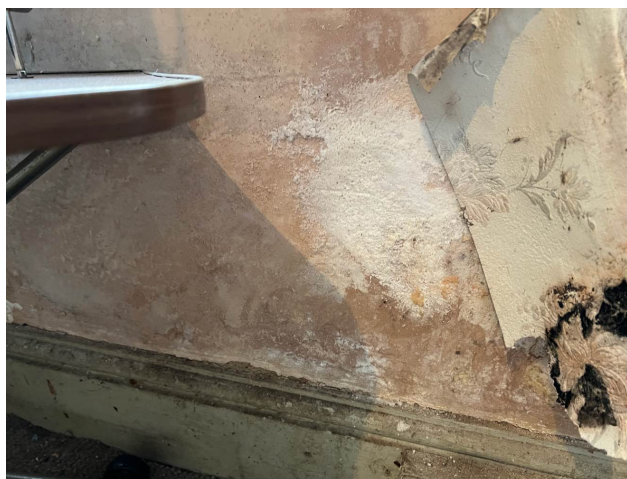
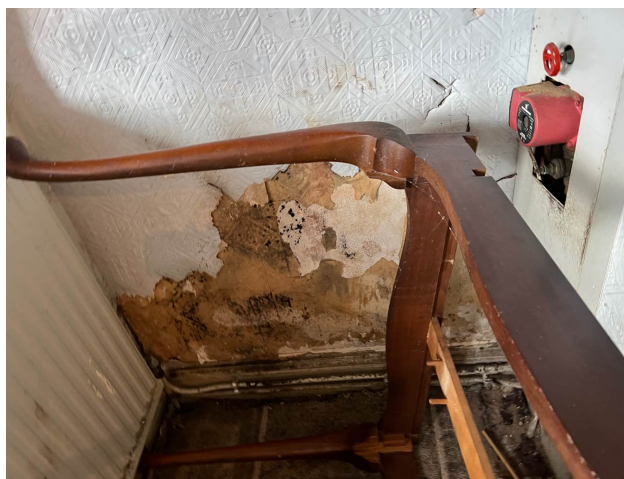
### E3 Walls and partitions

Some further localised cracking was noted to internal walls and when tapping the walls, we noted some areas of hollow plaster, typical of a building of this type and age and you should allow for some re-plastering when internal redecoration or alterations are carried out. The extent of repair or replacement is likely to be variable and you should allow a contingency and budget accordingly.

As mentioned, significant structural movement was noted to the front of the property, noted most prominently in the living room and front right bedroom. Cracks up to 30mm in width were noted where visible and once the structure is stabilised, significant repairs and potentially partial rebuilding works will be required to the affected areas, as per the BRE 251 digest. As mentioned, you should appoint a Structural engineer to design and spec these repairs. This should be done prior to exchange of contracts.

Some sections of plaster have become salt contaminated, likely due to a combination of hygroscopic salts within the modern/inappropriate materials being used and lack of heating/ventilation measures within the property. Replastering will be required, either with a more age-appropriate lime plaster, or by adding a membrane, timber batten and dry lining the walls to conceal any dampness within the outer brick leaf. These repairs should be carried out as part of the overall refurb that is required, so as soon as practicable.

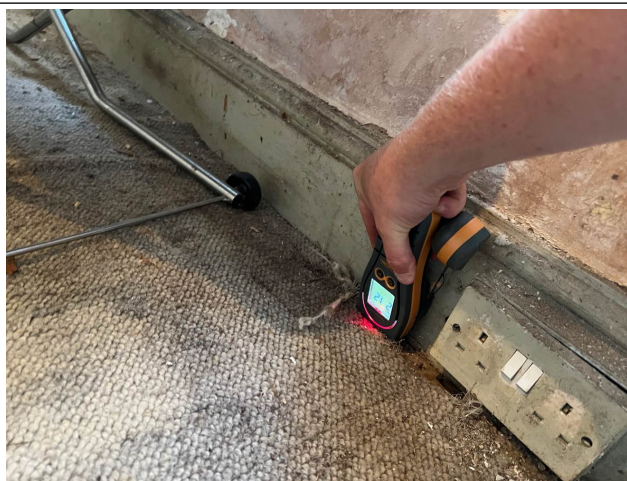
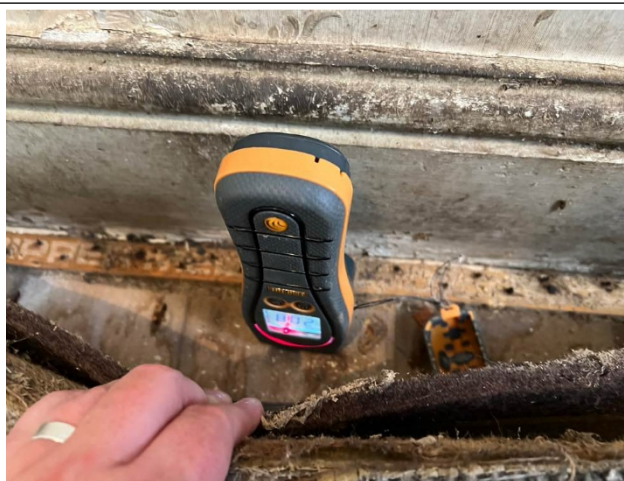
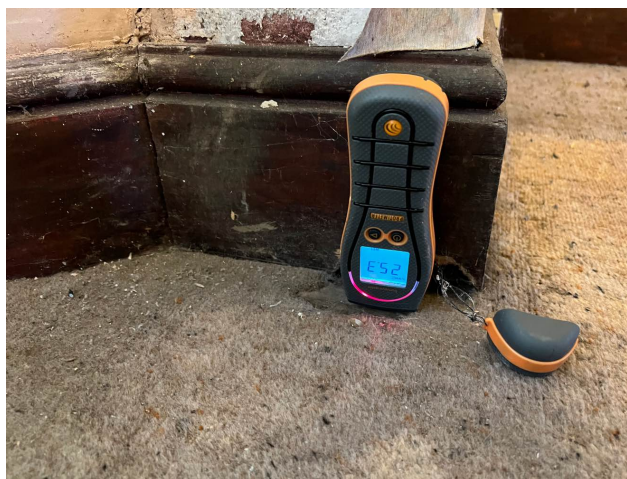
## E4 Floors

High moisture content was found to the suspended timber floor at ground level. Suspended ground floors require ventilation to prevent an accumulation of moisture within the floor voids. This is achieved by vents built into the base of the main walls. There are an inadequate number of vents of sufficient size to provide satisfactory ventilation under the floors and it is probable that further dampness and condensation will develop. You should arrange for competent builders to install additional ventilation. Failure to address may also lead to more severe issues such as woodworm infestation.

You should look to repair the defective sub floor vents and to add additional ventilation where possible, particularly down the side of the property in the side passage. This should be addressed in the short term.

The floor joists in the living room appear to have dropped towards the bay window. Similar to the bay structures, structural repairs/reinforcement is likely to be required and your chosen Structural Engineer should design and spec this. A high level of moisture was noted to the floor boards in the lounge and in the dining room which is likely due to the lack of sub-floor ventilation. Improvements are required as mentioned above.

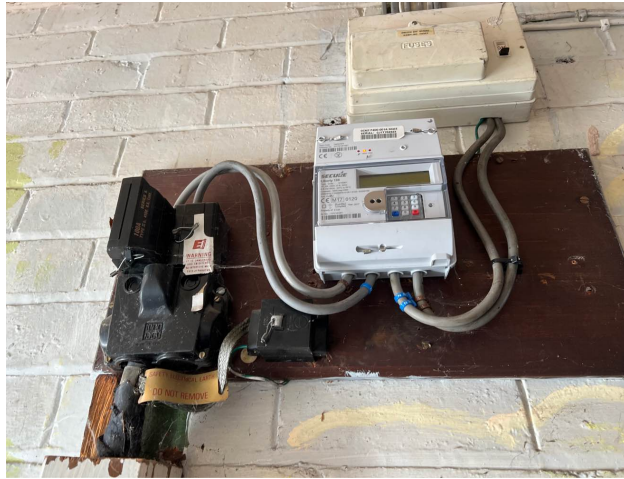
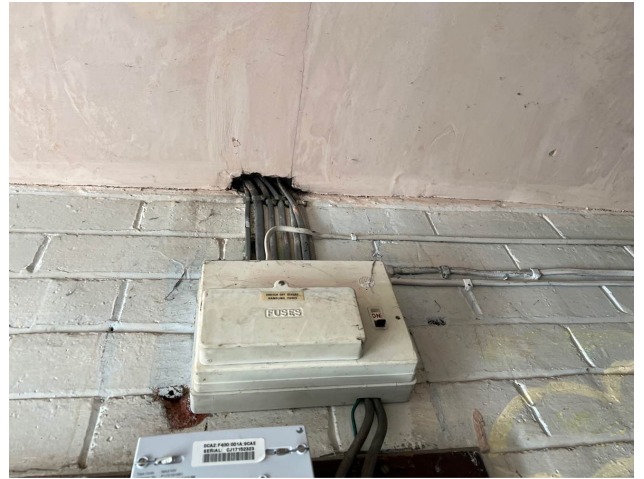
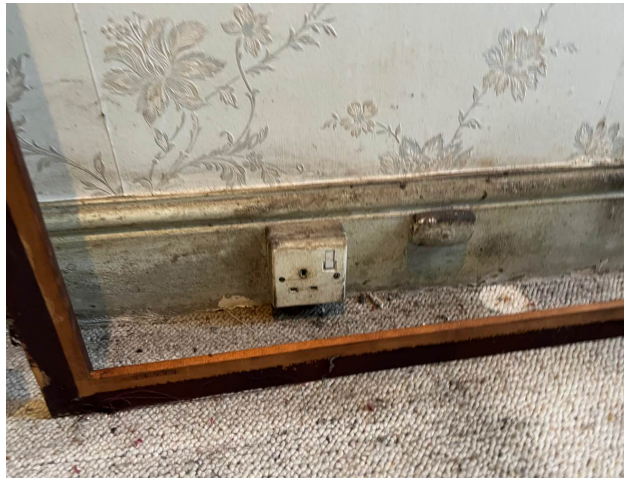
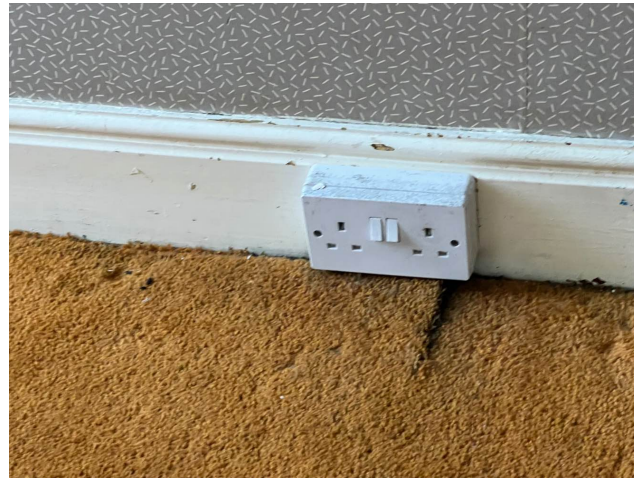
A considerable number of defects and deficiencies were noted to the electrical installation, including dated rewirable fuses and inadequate second fix items. It is likely that significant repairs will be required, if not a complete replacement. You should now arrange for an appropriately qualified specialist contractor, registered with either NICEIC or a similar approved body, to carry out a full investigation of the system prior to the exchange of contracts to establish the full extent of the upgrading or replacement required.

The service installations should be thoroughly checked and tested by appropriate specialist contractors prior to the exchange of contracts. We suspect that full renewal of the electrical, central heating and hot water systems will be recommended due to them being dated and potentially defective.

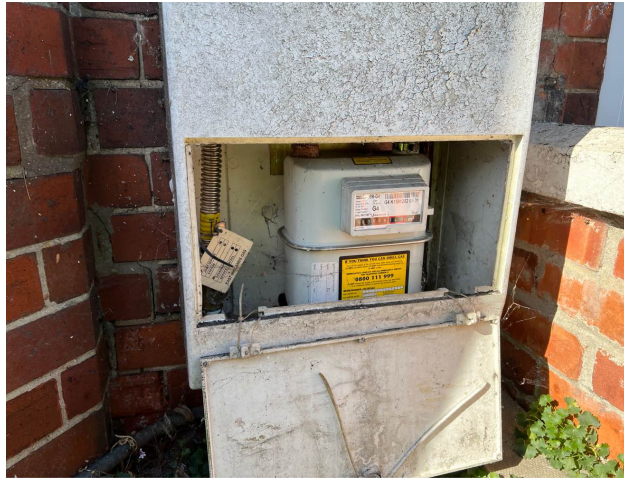
## F2 Gas/oil

The meter housing was found to be defective and should be repaired/replaced as necessary.

In view of the guidance above and as a matter of safety, you should now arrange for the installation and all gas appliances to be inspected and tested by a Gas Safe engineer prior to the exchange of contracts.

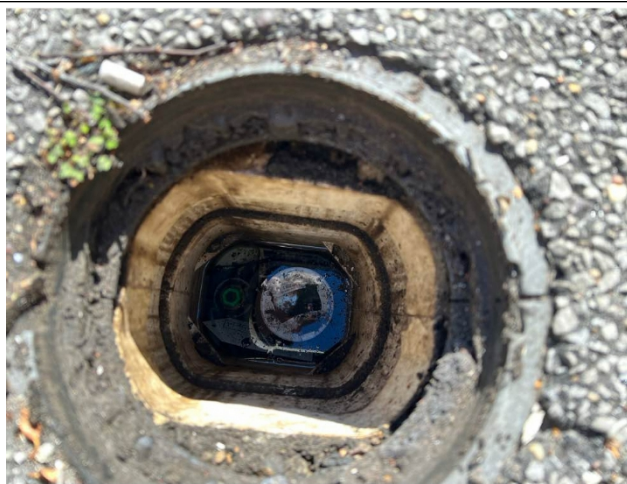
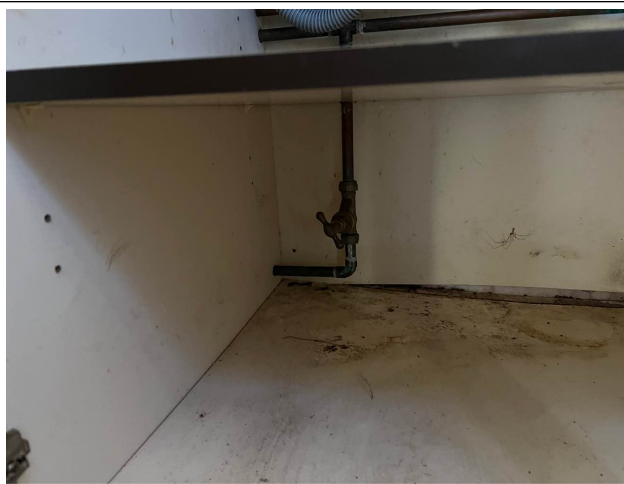
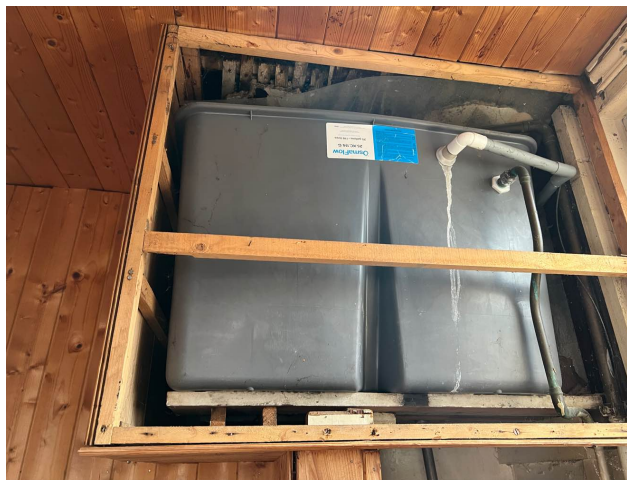
### F3 Water

The plastic tank may be contributing to the leak noted to the ceiling and its repair/replacement may be required. This should be inspected as part of the whole system being checked.

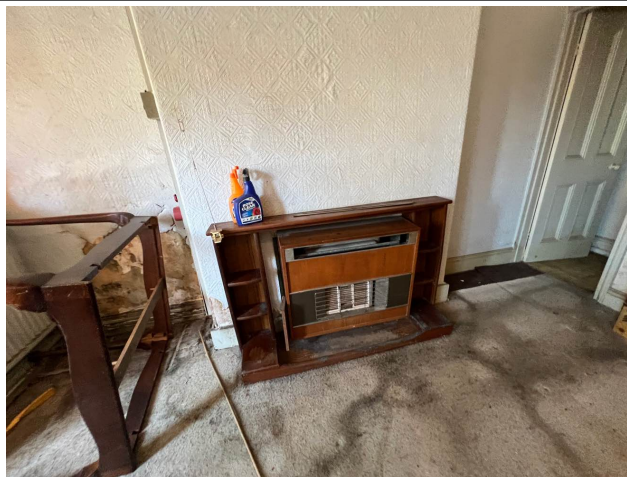
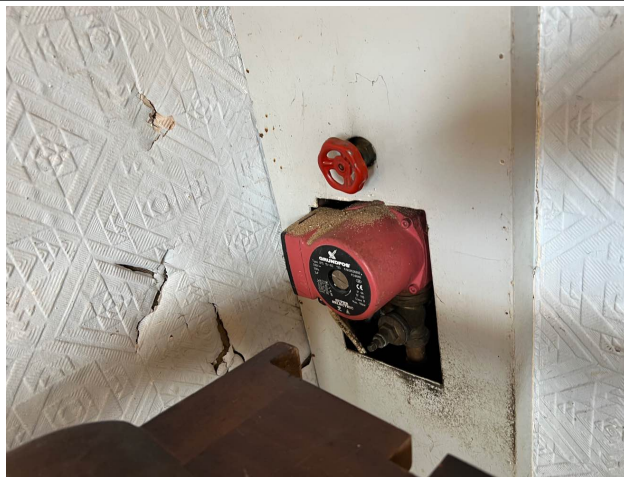
#### F4 Heating

The property has a back-boiler system located behind the gas fire in the dining room. This appears to feed a series of radiators in the various rooms. There are also some supplementary gas fires.

This type of central heating system is deemed dated and most likely towards/having surpassed its useful life. Replacement should be anticipated and we recommend you budget for the renewal of the whole central heating system as part of the recommended scheme of refurbishment. You should arrange for a Gas Safe engineer to check and test the system prior to the exchange of contracts as a matter of safety.

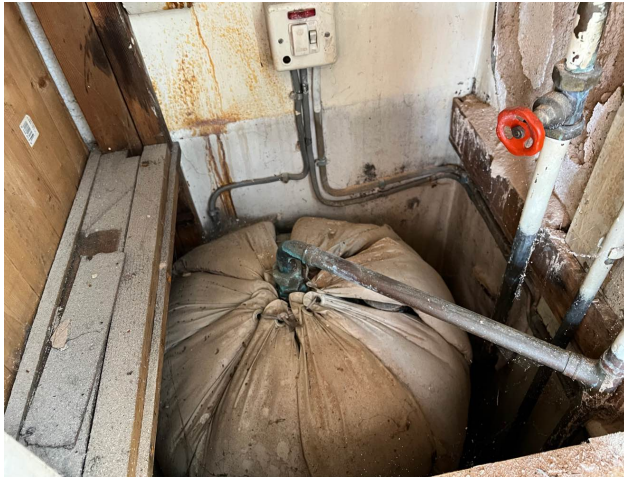
## F5 Water heating

Hot water is created and stored in a cylinder located in the bathroom.

Hot water was not readily available during the survey. This system is considered inadequate by modern standards. You should arrange for a suitably qualified person to check and test this system prior to the exchange of contracts, to confirm the condition. Replacement is likely to be recommended.

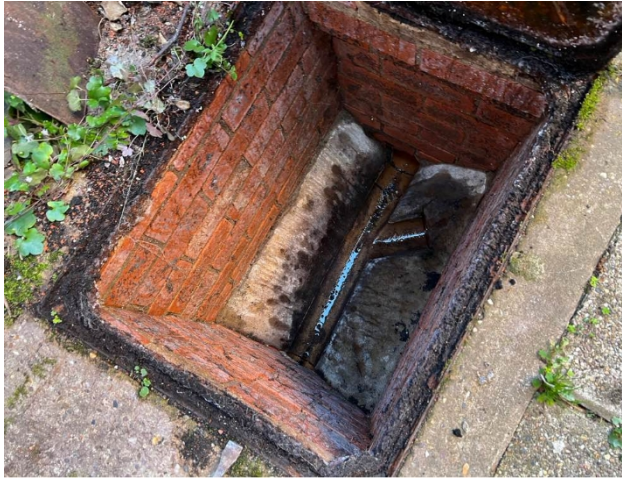
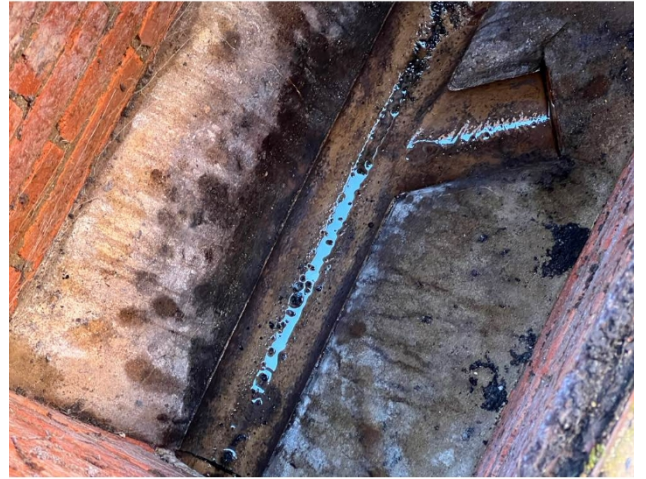
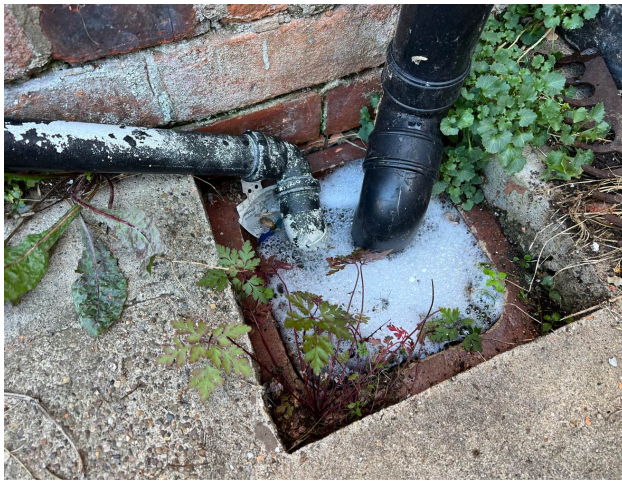
## F6 Drainage

The underground system was accessed via the inspection chamber in the rear garden. Waste water was not flowing freely into the underground drainage system and was found to be backing up to the gulley. A full CCTV survey and test by a drainage specialist, prior to legal commitment to purchase is recommended.

Due to the blockages noted during the survey, a more detailed survey and appraisal of the below-ground drainage system should be commissioned prior to purchase.

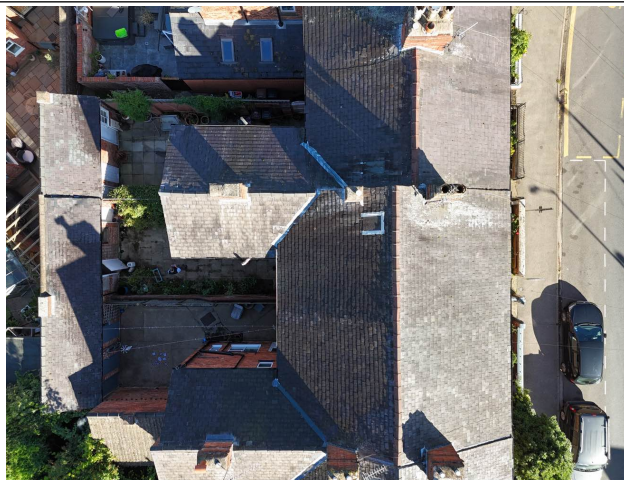
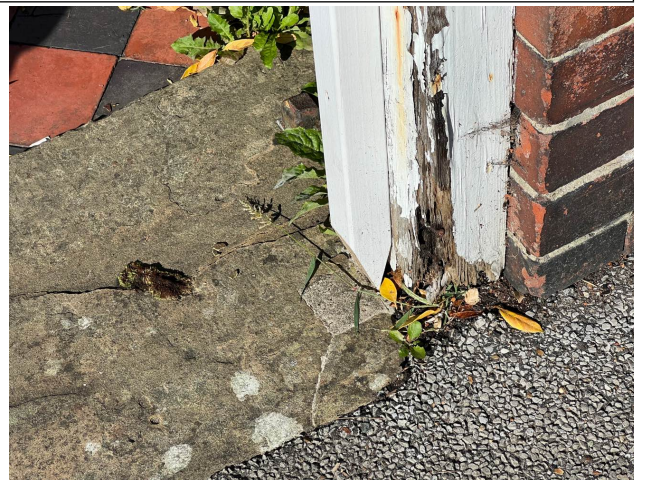
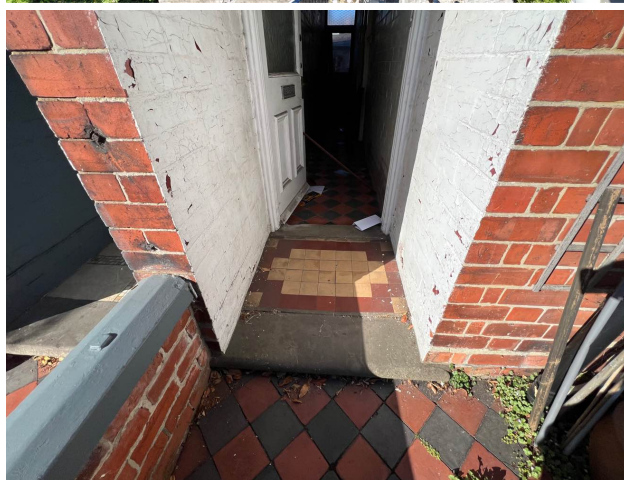
### G3 Other

The external areas appeared generally maintainable but we noted some defects/issues that will require repair or renewal including worn pointing and perished brickwork to the garden walls, rot to the gate/fence post and uneven/damaged paving. Repairs and improvements are required in the medium term in order to prevent issues from arising in the future.

To repair/replace defective quarry tiles, the defective and rotting gate/fencing and to repoint weathered pointing/replace spalled masonry to the brick garden walls. These can be addressed in the medium term due to it not affecting the main dwelling.
