HOME REPORT

170B NORTH HIGH STREET
FISHERROW
MUSSELBURGH
EH21 6AR

Single Survey

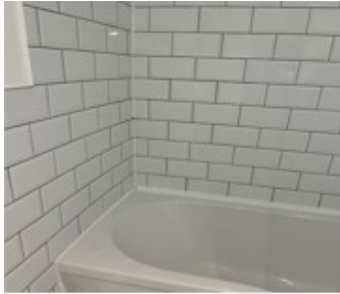
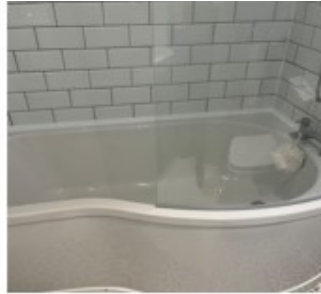
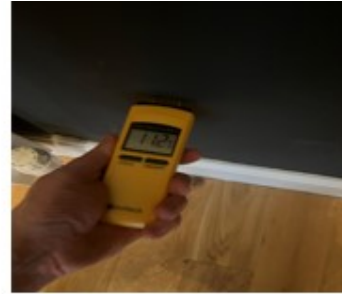
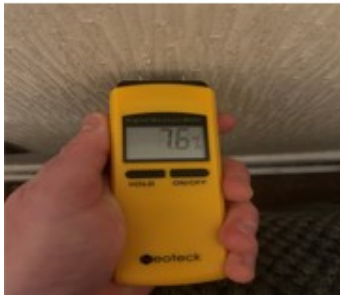
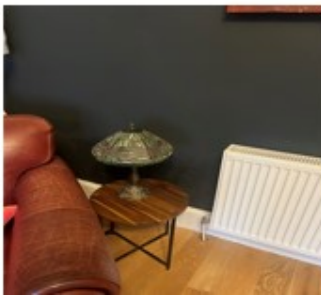
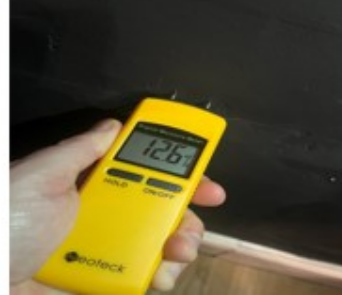
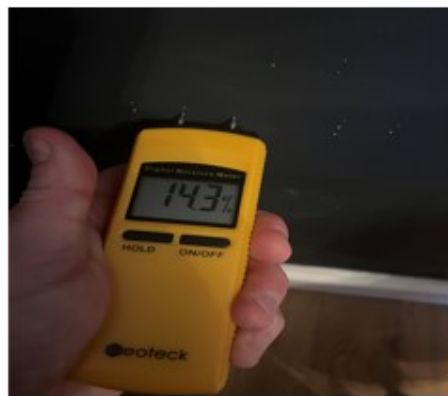
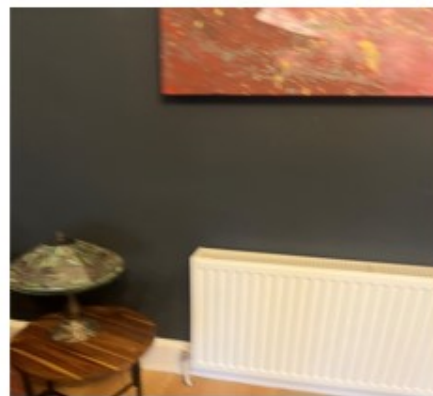
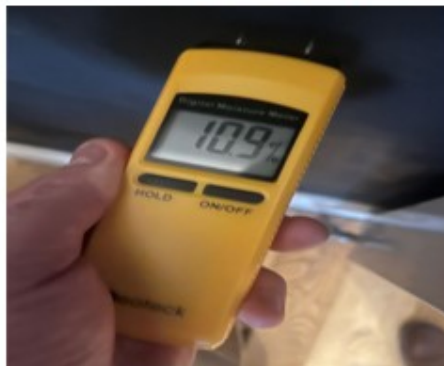
The bath has had an issue with the waste pipe leaking overtime, causing moisture to soak into the floor joists, flooring and solum in under the bath and wall backing onto the Livingroom.

We found that there was no signs that were likely to cause any issues in the future.
