Home Report

15 Monifieth Road
Broughty Ferry Dundee DD5 2RN

Single Survey

Property Address	15 Monifieth Road Dundee DD5 2RN
Customer	Miss Margaret Mackie
Prepared by	Graham + Sibbald Property Consultants Limited
Date of Inspection	11/09/2025

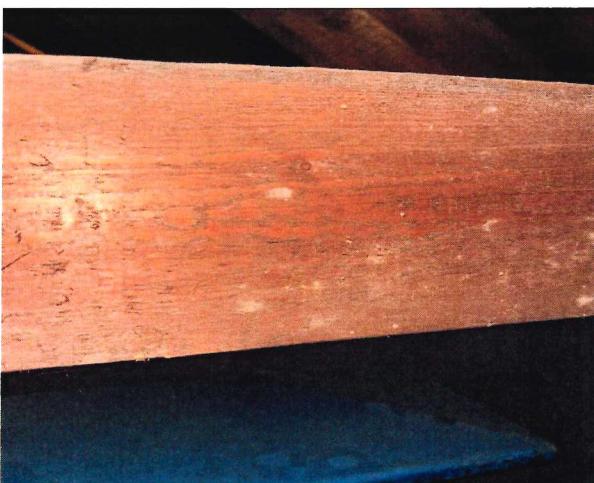
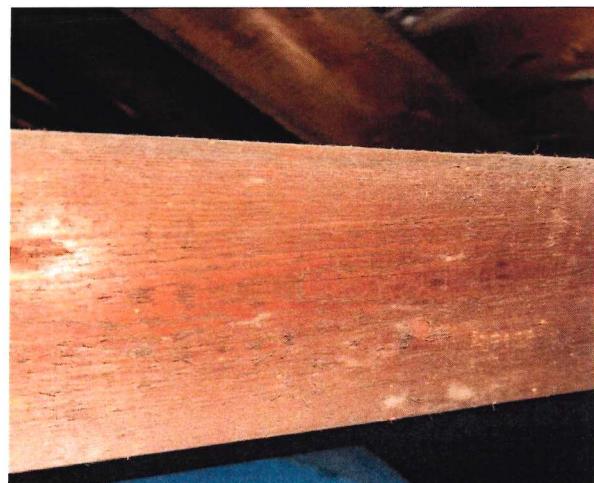
Restricted inspection due to insulation materials and stored articles. Where seen, a slight scattered infestation of Woodworm was evident in roof timbers.

TREATMENT RECOMMENDED: FULL ROOF VOID TREATMENT

Our technicians will carry out the necessary precautions prior to and during treatments i.e., protect all water tanks and electrical junction boxes with polythene. They will also remove all fuses appertaining to wiring within roof void prior to spraying (all as applicable).

Our technicians will lift and store insulation material in roof void and relay same after our treatments.
