Home Report

54 Seymour Street
Dundee DD2 1HA

Single Survey

Property Address	54 Seymour Street Dundee DD2 1HA
Customer	Saifeldin Shehata
Prepared by	Graham + Sibbald Property Consultants Limited
Date of Inspection	29/01/2026

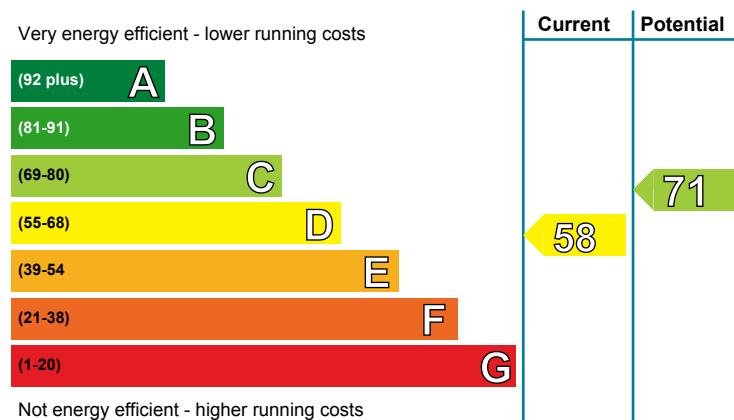
Energy Efficiency Rating

Your current rating is **band D (58)**. The average rating for EPCs in Scotland is **band D (61)**.
