Home Report

Single Survey

Property address	2/2 1232 Argyle Street Glasgow G3 8TJ
Customer	Mr & Mrs McColl
Customer address	2/2 1232 Argyle Street Glasgow G3 8TJ
Prepared by	Shepherd Chartered Surveyors
Date of inspection	24/04/2025

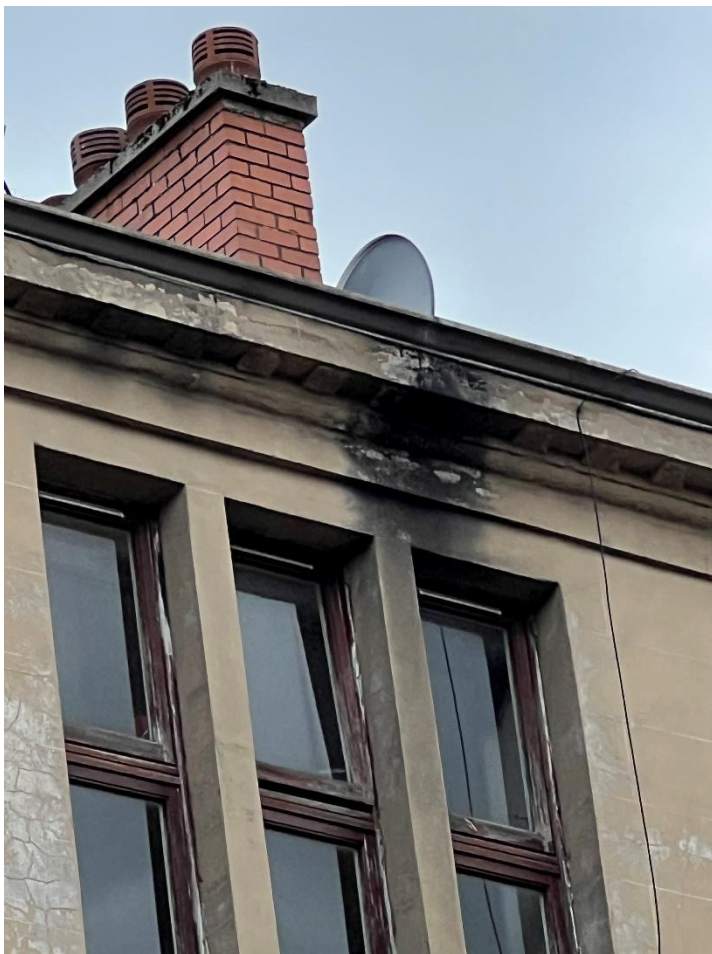
Example of leaking guttering with no undercloak

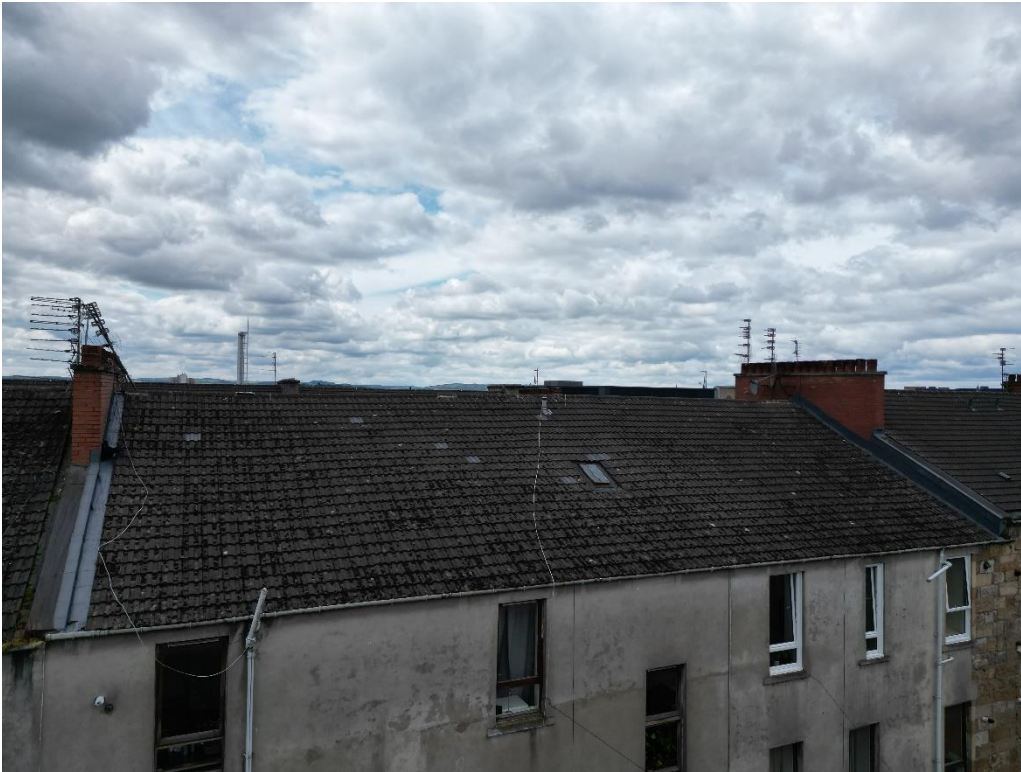
General rear slope view

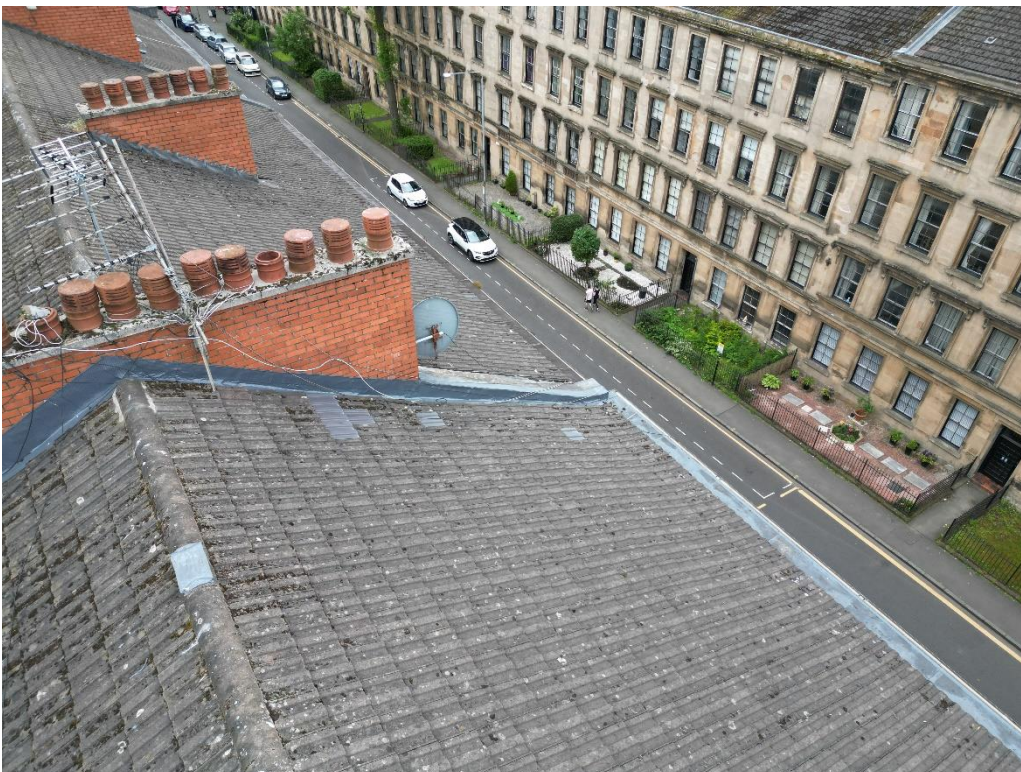
“Painted” skew and wallhead

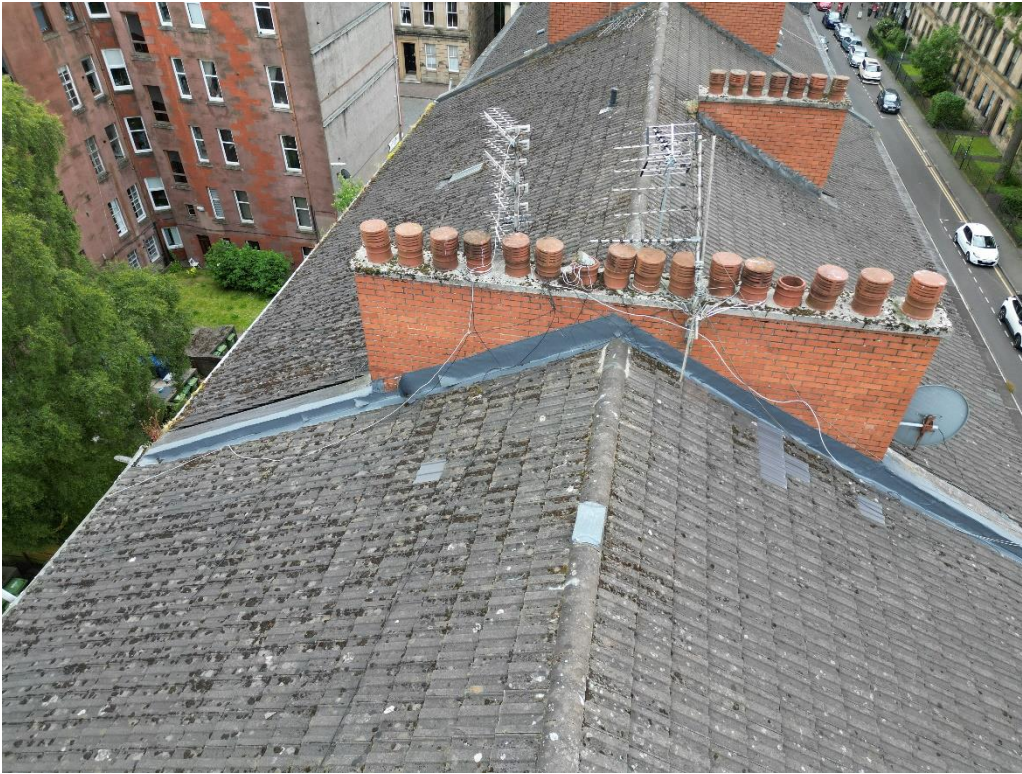
Flaking painterwork from the skew

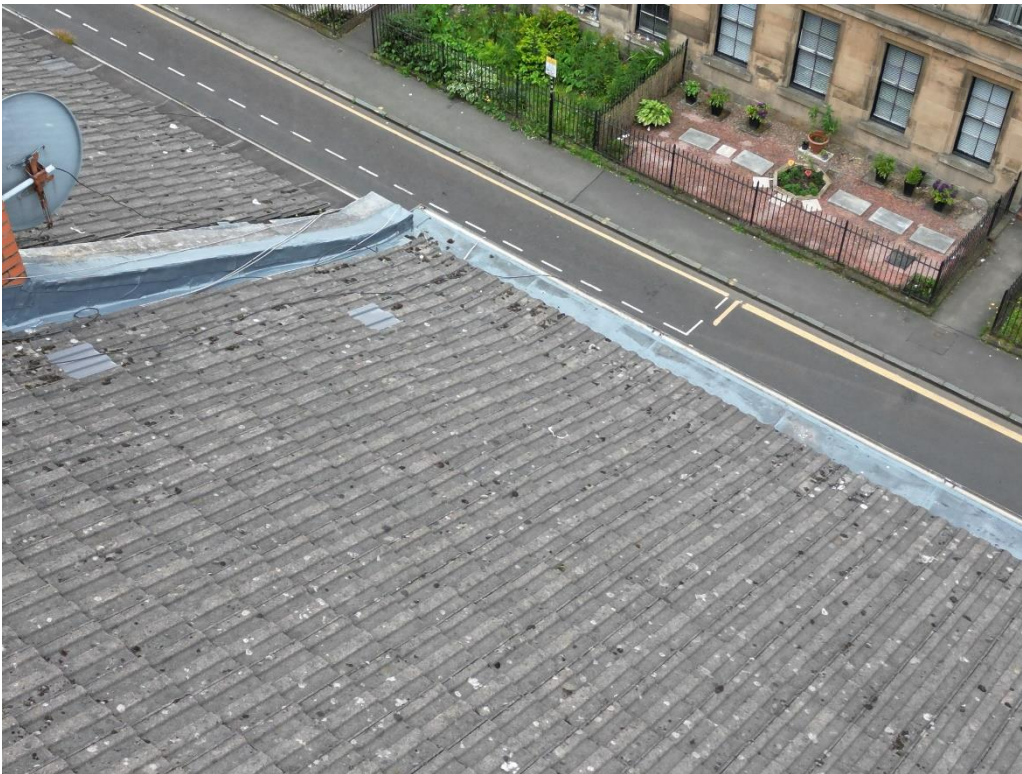
Dilapidated front lead deck

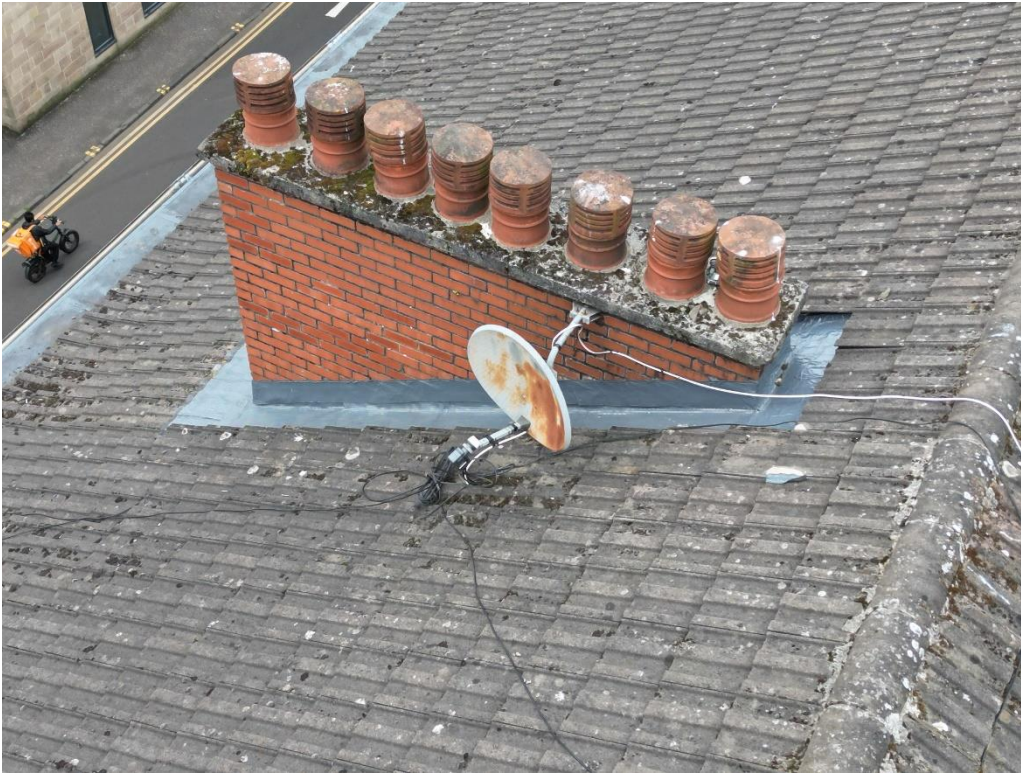
“Painted” chimneyhead flashing

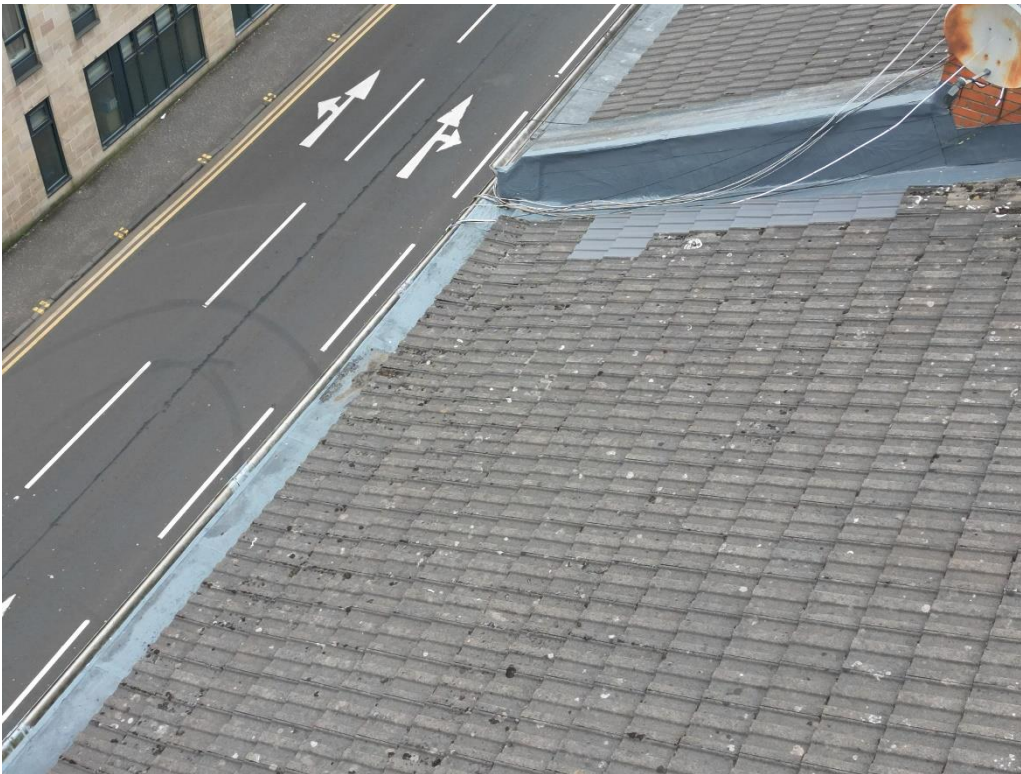
“Painted” parapet gutter deck and skew

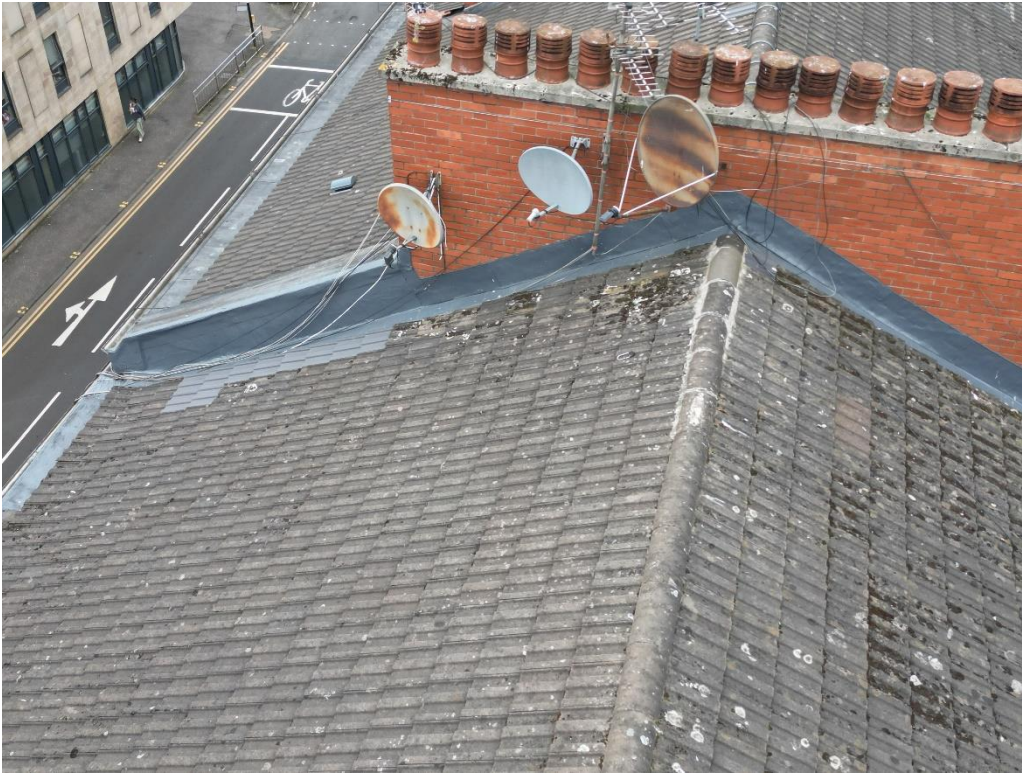
"Painted" skew flashing

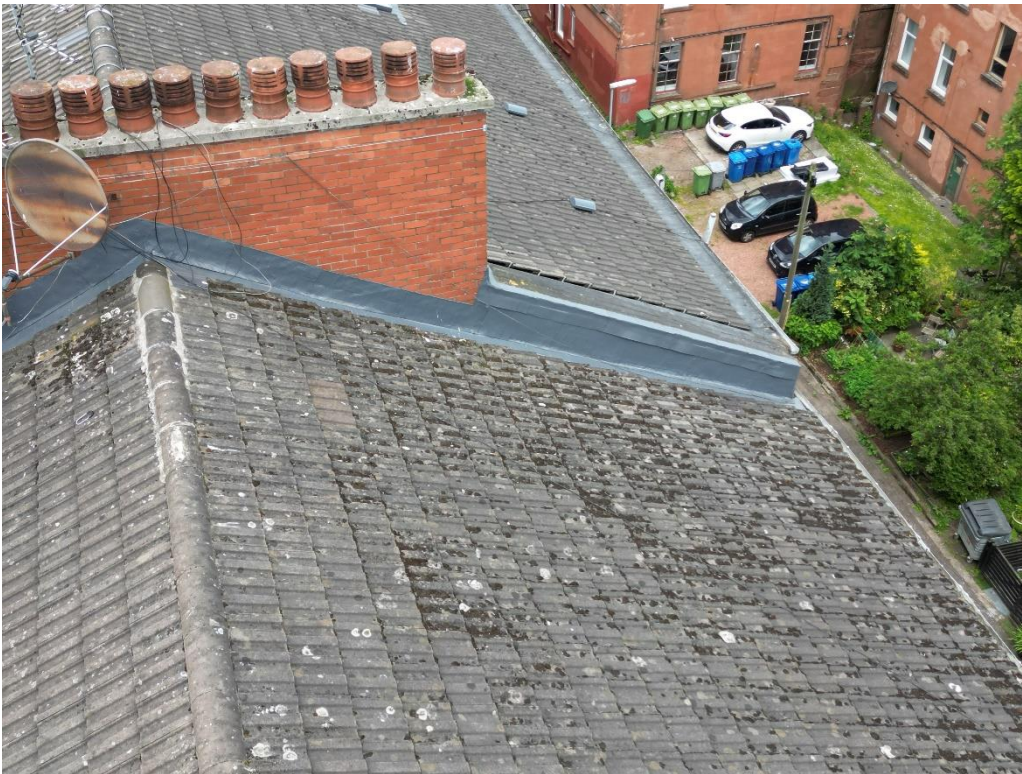
"Painted" rear skew
