# YOUR ONESURVEY HOME REPORT

Flat 1  
22 Lynedoch Street  
Glasgow  
G3 6EU

# SINGLE SURVEY

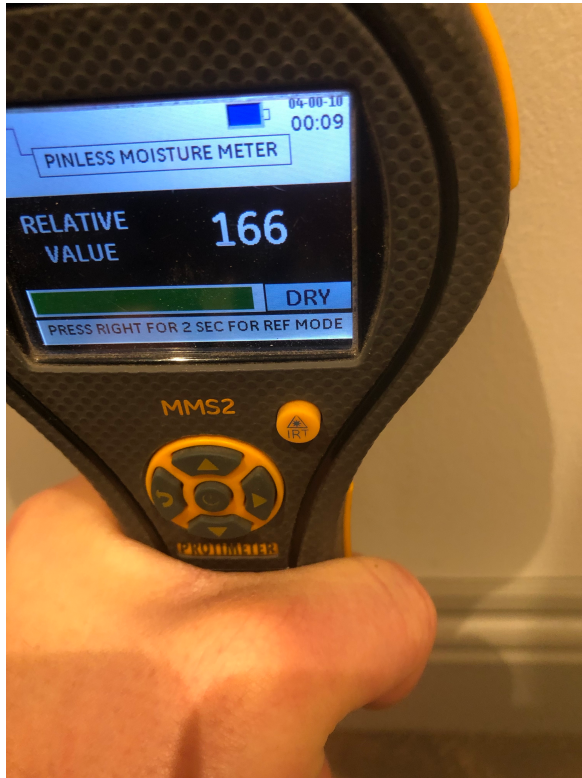
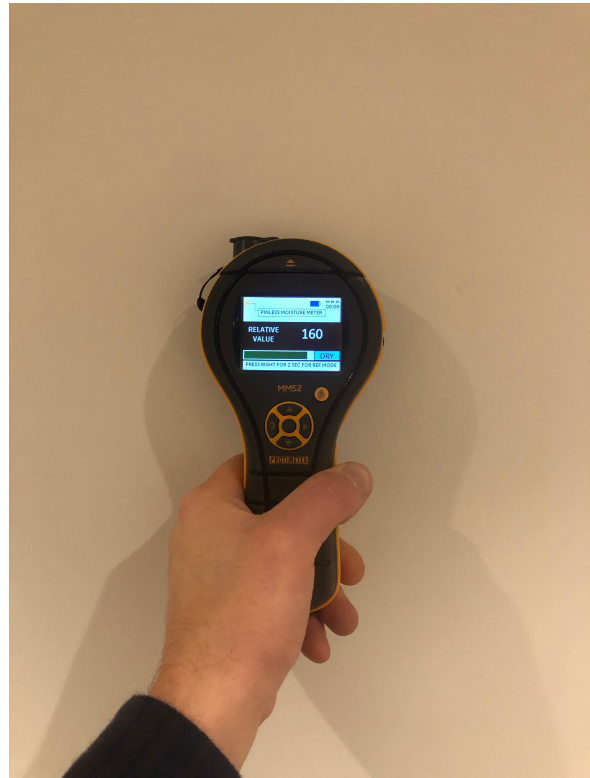
1.0 indicative high and low level readings taken.

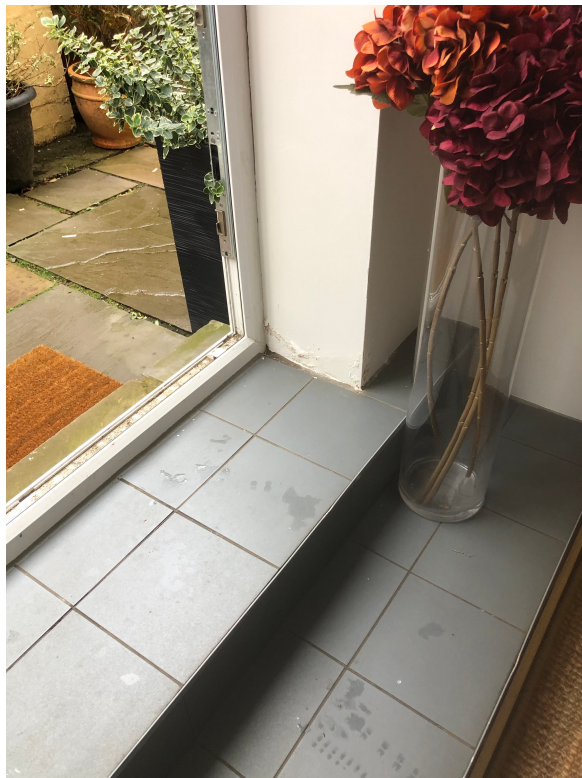
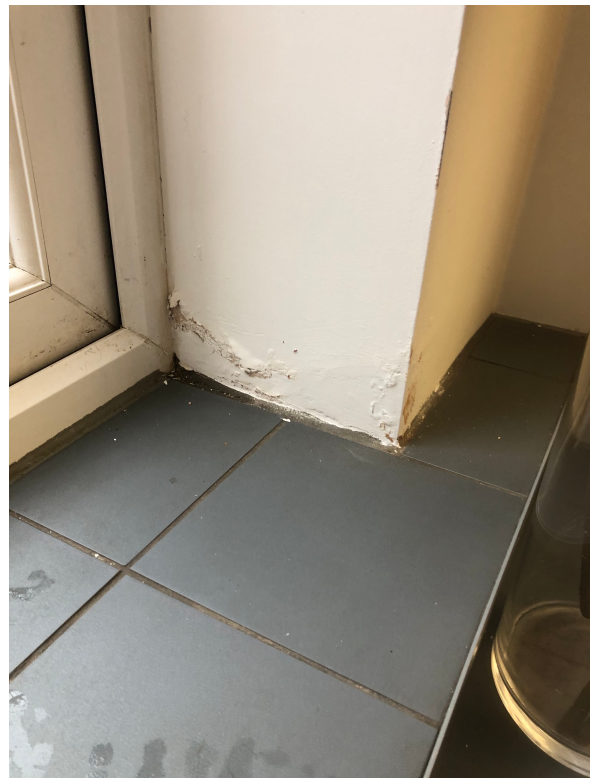
| Notes: | <p>Following the Home Report inspection, Eradakil Limited, inspected the property and have concluded that there is a minor issue of condensation, and bridging due to poor detailing at the side access door. They have provided a quotation of £850 plus VAT to remedy the issue. A copy of their report has been attached as an additional document. The seller has advised that they will carry out the necessary repairs prior to the conclusion of a sale.</p> <p>Previous damp proofing works appear to have been carried out to the property in the past. Any relevant documentation/guarantees should be made available and retained with the Title Deeds.</p> |

1.2 Issue of bridging at the side access doorstep.

We offer to undertake the works as described for the sum of £850 plus VAT. Our offer shall remain open for a period of 120 days from even date. Payment is due upon completion of the works.
