# Home Report

3 Novar Crescent  
Kirkcaldy KY1 1PT

# Single Survey

| Date of Inspection | 27/08/2025 |

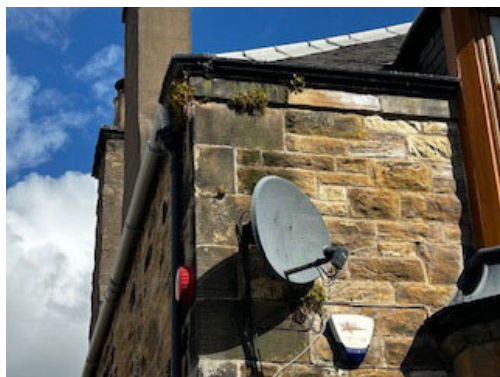
Vegetation growth to stonework below gutter to front left hand corner of property

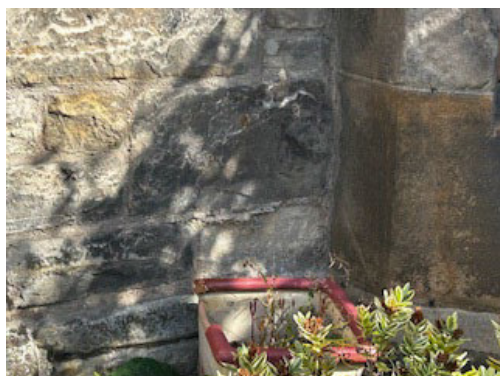
Weathered stonework to front elevation

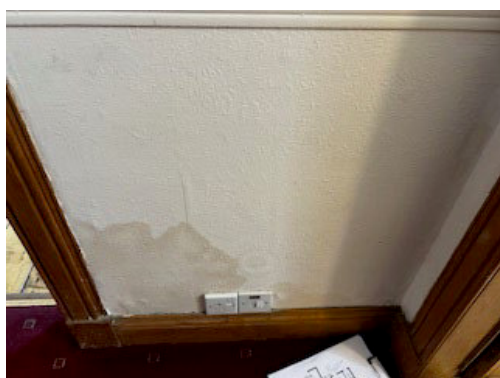
Dampness to wall plaster  
within hall, outside  
bathroom door

It is essential that all necessary external repairs are carried out by a competent Roofing/Building Contractor, to prevent any further possible rain-water ingress.

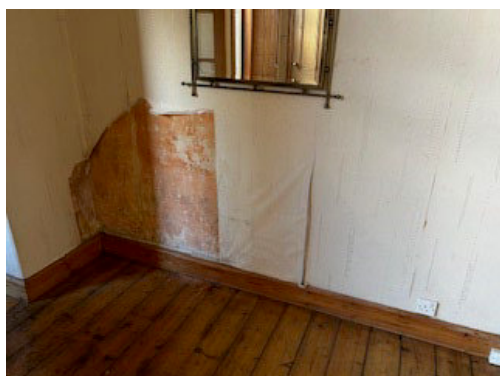
Dampness to wall plaster  
to ground floor room rear  
left – bathroom located on  
opposite side of wall

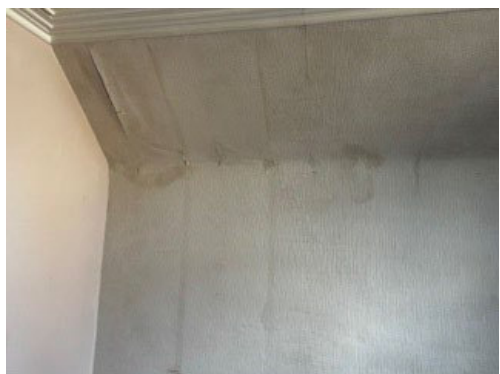
Dampness to wall and  
coombed ceiling fabric to  
1<sup>st</sup> floor room rear left

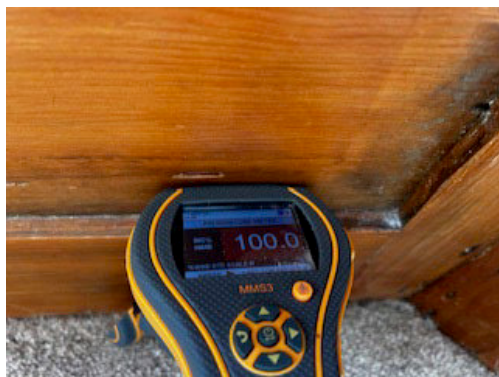
Elevated moisture readings to plywood linings below window to ground floor room front

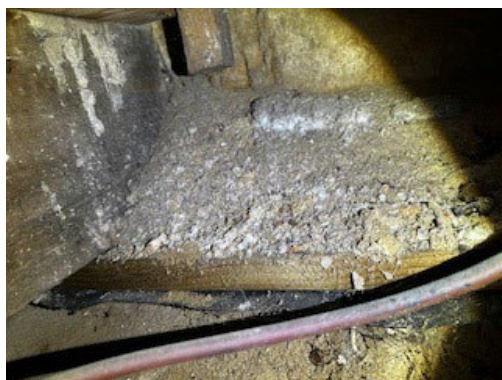
- Wet rot (*Coniophora Puteana*) to the floor joist within the press recess to the front left hand corner of room front. Significant debris build up was noted to the wallplate to this area also.
- The floor within the ground floor bathroom was noted to be significantly wet and partially collapsing. It is assumed that there is a plumbing leak below the floor and the whole floor will need to be removed and renewed.

Significant debris build-up on wallplate to front left hand corner of ground floor room front

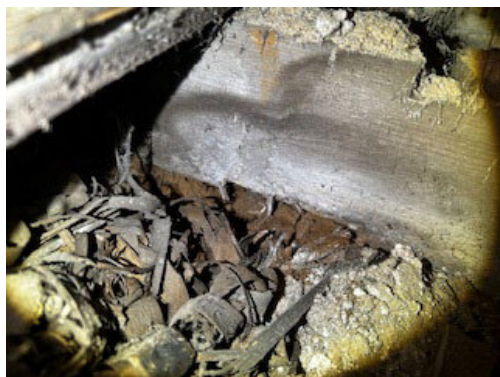
Decay to floor joist within  
press recess to ground  
floor room front

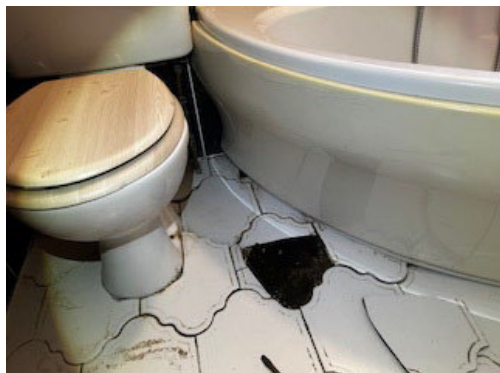
Saturated floor timbers to  
ground floor room rear  
right (bathroom)

Remove floorboards, floor joists and wallplates in entirety. Clear solum, lay polythene DPM and concrete mix. Renew all floor timbers with pre-treated timber and lay new T+G floorboards to match existing.

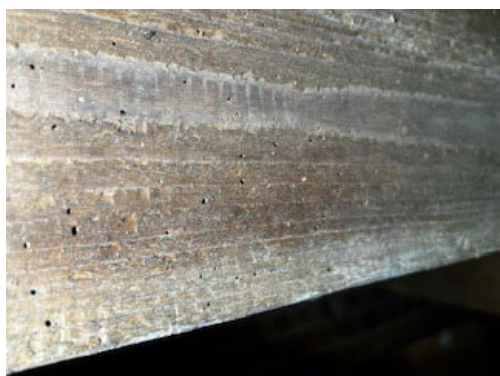
A slight infestation of wood borer (*Anobium punctatum*) was noted to the accessible timbers which was active.

Active woodworm to roof  
timbers within main roof  
void

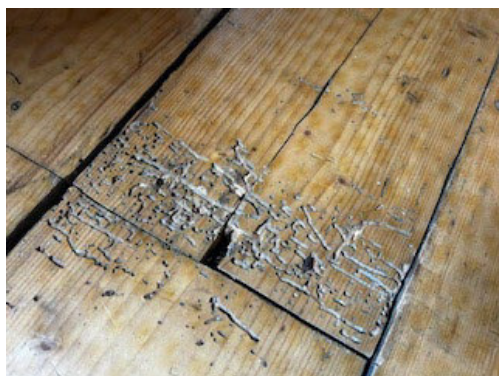
Whilst evidence of past attack by the common furniture beetle was noted to exposed floorboards and exposed timbers within the under stair cupboard, there was no indication of any recent activity where inspection was possible and is considered dormant. If treatments have been carried out by others previously, it is important that you check the validity of any available guarantees.

Historic woodworm to floorboards to ground floor room rear left
