YOUR ONESURVEY
HOME REPORT

21 Windsor Street
Dundee
DD2 1BN

Single Survey

Date of Inspection	06/03/2024
---------------------------	------------

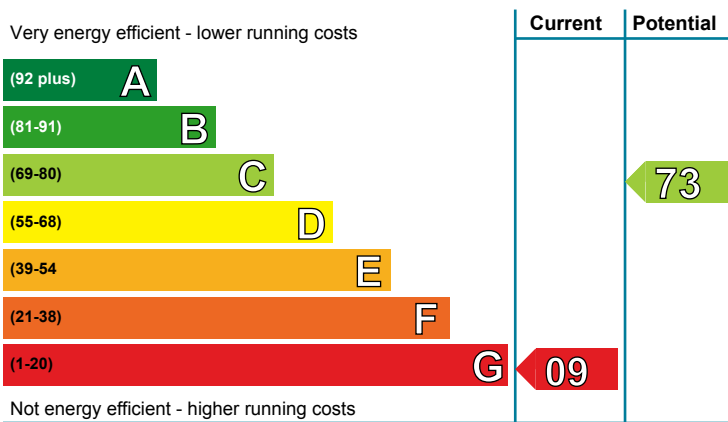
Energy Efficiency Rating

Your current rating is **band G (9)**. The average rating for EPCs in Scotland is **band D (61)**.
