YOUR ONESURVEY  
**HOME REPORT**

3/R  
180 Strathmartine Road  
Dundee  
DD3 8DQ

# SINGLE SURVEY

<b>Prepared by</b>	Blair Ferguson, MRICS Dundee - Allied Surveyors Scotland Ltd
--------------------	---

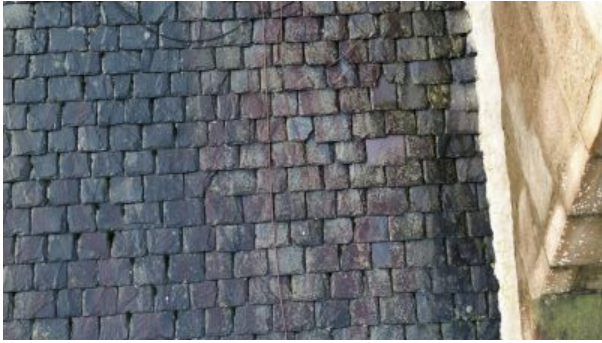
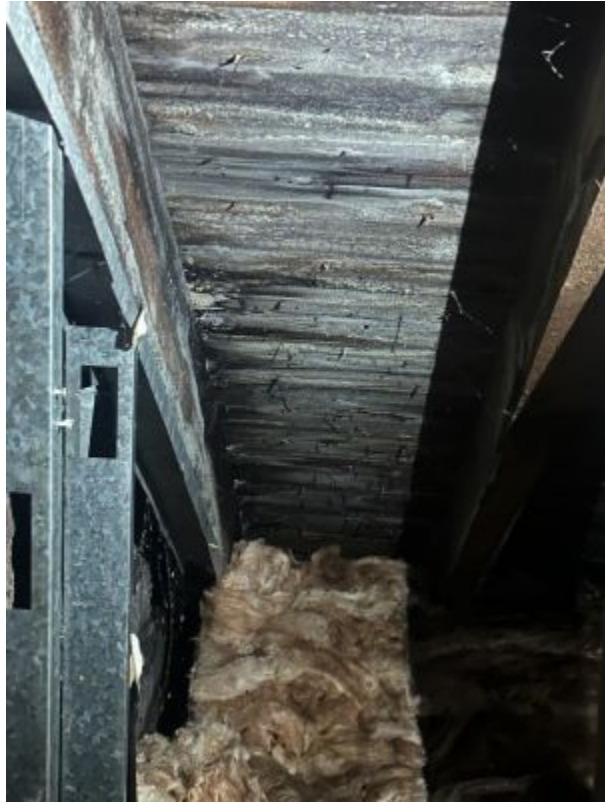
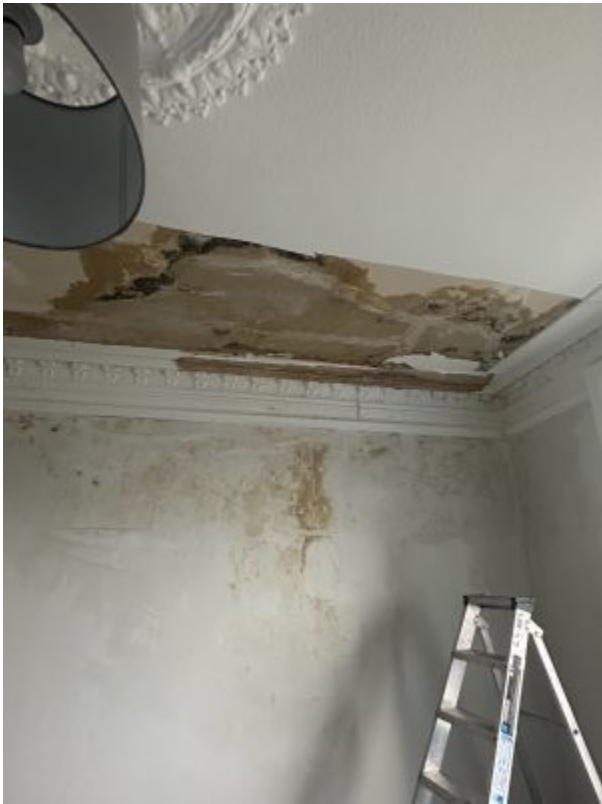
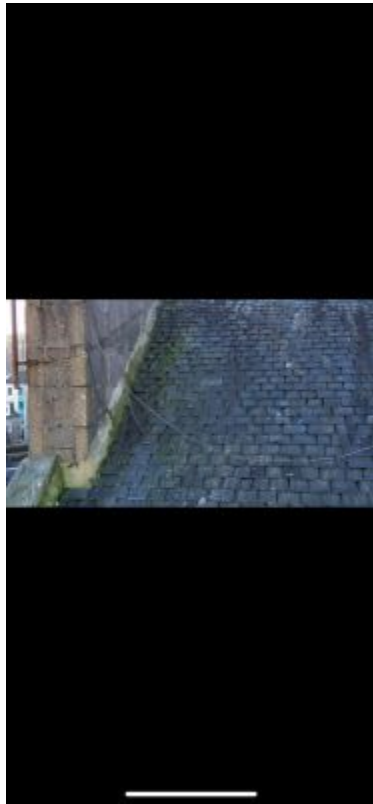
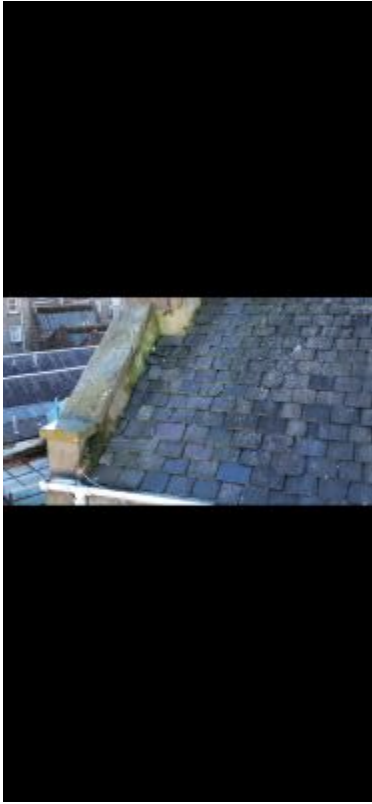
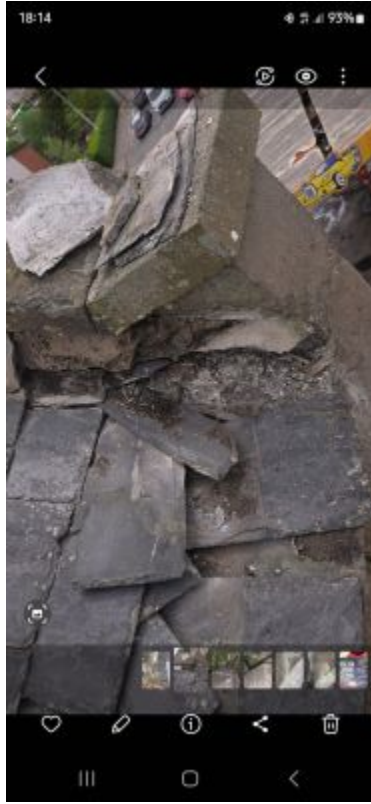
Work at 180 strathmartine road, Dundee

After inspection of the roof materials on this property it is our opinion that the damages have been caused by the recent multiple storms and high winds. This has resulted in slates being lifted and therefore breaking across the heads causing severe water ingress into the property. This has occurred above both flats on the building and we suspect the amount of movement in the slates has lead to cracking of the cement skew above top left flat.
