Scout Hall, Park Drive, Romford, RM1 4LH

TENDER PROFORMA – Romford Scout Hall

Asbestos Management Survey

ELECTRICAL INSTALLATION CONDITION REPORT

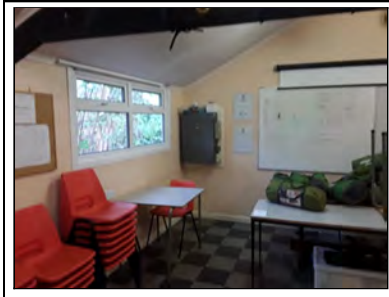
Survey Date:	Lead Surveyor	Survey Type	Floor	Analysis
30 Nov 2021	Wayne Gregory	Management Survey	Ground Floor	No asbestos detected
Building	Room	Item	Quantity	
Building 1-2	B1 main hall G01	No suspect materials found Throughout	0	
Sample No (S,SP,P,As)	Product Type	Surface Treatment	Condition	Accessibility
Visual (P)	N/A	N/A	N/A	N/A

Normal Occupancy	Score	Likelihood of disturbance	Score	Exposure Potential	Score	Maintenance Activity	Score
Main type of activity	N/A	Location	N/A	Number of occupants	N/A	Type of Maintenance	N/A
Average Score		Accessibility	N/A	Frequency of use	N/A	Frequency of maintenance	N/A
		Amount	N/A	Average Time	N/A		
	N/A	Average Score	N/A	Average Score	N/A	Average Score	N/A
Average of Priority	N/A						
Material Assessment Score	N/A						
Recommendation	No further action required

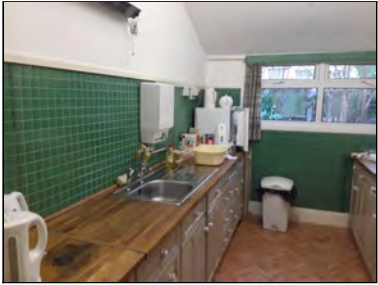
Survey Date:	Lead Surveyor	Survey Type	Floor	Analysis
	30 Nov 2021	Wayne Gregory	Management Survey	Ground Floor	No asbestos detected
	Building	Room	Item	Quantity	
	Building 1-2	B1 kitchen G02	No suspect materials found Throughout	0	
	Sample No (S,SP,P,As)	Product Type	Surface Treatment	Condition	Accessibility
Visual (P)	N/A	N/A	N/A	N/A

Normal Occupancy	Score	Likelihood of disturbance	Score	Exposure Potential	Score	Maintenance Activity	Score
Main type of activity	N/A	Location	N/A	Number of occupants	N/A	Type of Maintenance	N/A
		Accessibility	N/A	Frequency of use	N/A	Frequency of maintenance	N/A
		Amount	N/A	Average Time	N/A		
Average Score	N/A	Average Score	N/A	Average Score	N/A	Average Score	N/A
Average of Priority	N/A						
Material Assessment Score	N/A						
Recommendation	No further action required

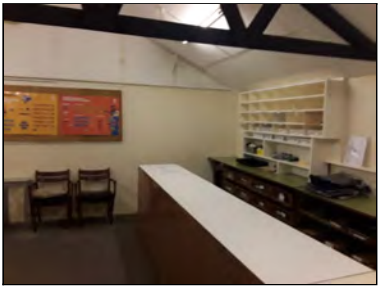
Survey Date:	Lead Surveyor	Survey Type	Floor	Analysis
	30 Nov 2021	Wayne Gregory	Management Survey	Ground Floor	No asbestos detected
	Building	Room	Item	Quantity	
	Building 1-2	B1 shop G03	No suspect materials found Throughout	0	
	Sample No (S,SP,P,As)	Product Type	Surface Treatment	Condition	Accessibility
Visual (P)	N/A	N/A	N/A	N/A

Normal Occupancy	Score	Likelihood of disturbance	Score	Exposure Potential	Score	Maintenance Activity	Score
Main type of activity	N/A	Location	N/A	Number of occupants	N/A	Type of Maintenance	N/A
Average Score		Accessibility	N/A	Frequency of use	N/A	Frequency of maintenance	N/A
		Amount	N/A	Average Time	N/A		
	N/A	Average Score	N/A	Average Score	N/A	Average Score	N/A
Average of Priority	N/A						
Material Assessment Score	N/A						
Recommendation	No further action required

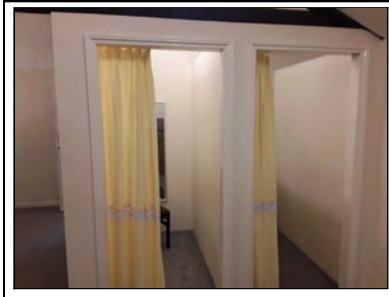
Survey Date:	Lead Surveyor	Survey Type	Floor	Analysis
30 Nov 2021	Wayne Gregory	Management Survey	Ground Floor	No asbestos detected
Building	Room	Item	Quantity	
Building 1-2	B1 change room 1-2 G04	No suspect materials found Throughout	0	
Sample No (S,SP,P,As)	Product Type	Surface Treatment	Condition	Accessibility
Visual (P)	N/A	N/A	N/A	N/A

Normal Occupancy	Score	Likelihood of disturbance	Score	Exposure Potential	Score	Maintenance Activity	Score
Main type of activity	N/A	Location	N/A	Number of occupants	N/A	Type of Maintenance	N/A
Average Score		Accessibility	N/A	Frequency of use	N/A	Frequency of maintenance	N/A
		Amount	N/A	Average Time	N/A		
	N/A	Average Score	N/A	Average Score	N/A	Average Score	N/A
Average of Priority	N/A						
Material Assessment Score	N/A						
Recommendation	No further action required

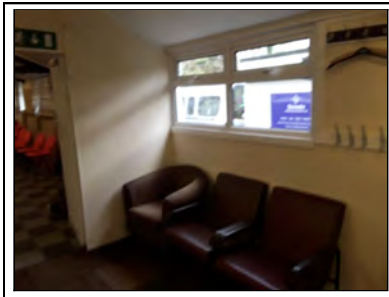
Survey Date:	Lead Surveyor	Survey Type	Floor	Analysis
30 Nov 2021	Wayne Gregory	Management Survey	Ground Floor	No Asbestos Detected
Building	Room	Item	Quantity	
Building 1-2	B1 lobby 1 G05	Asbestos insulation board Walls	16m ²	
Sample No (S,SP,P,As)	Product Type	Surface Treatment	Condition	Accessibility
WG000087 (S)	N/A	N/A	N/A	N/A

Normal Occupancy	Score	Likelihood of disturbance	Score	Exposure Potential	Score	Maintenance Activity	Score
Main type of activity	N/A	Location	N/A	Number of occupants	N/A	Type of Maintenance	N/A
		Accessibility	N/A	Frequency of use	N/A	Frequency of maintenance	N/A
		Amount	N/A	Average Time	N/A		
Average Score	N/A	Average Score	N/A	Average Score	N/A	Average Score	N/A
Average of Priority	N/A						
Material Assessment Score	N/A						
Recommendation	No further action required

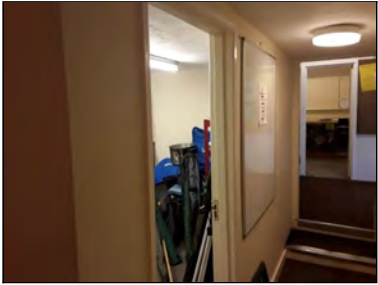
Survey Date:		Lead Surveyor		Survey Type		Floor		Analysis	
	30 Nov 2021		Wayne Gregory		Management Survey		Ground Floor		No Asbestos Detected	
	Building		Room		Item		Quantity			
	Building 1-2		B1 lobby 2 G06		Asbestos insulation board Walls		8m ²			
	Sample No (S,SP,P,As)		Product Type		Surface Treatment		Condition		Accessibility	
As WG000087 (SP)		N/A		N/A		N/A		N/A

Normal Occupancy	Score	Likelihood of disturbance	Score	Exposure Potential	Score	Maintenance Activity	Score
Main type of activity	N/A	Location	N/A	Number of occupants	N/A	Type of Maintenance	N/A
		Accessibility	N/A	Frequency of use	N/A	Frequency of maintenance	N/A
		Amount	N/A	Average Time	N/A		
Average Score	N/A	Average Score	N/A	Average Score	N/A	Average Score	N/A
Average of Priority	N/A						
Material Assessment Score	N/A						
Recommendation	No further action required

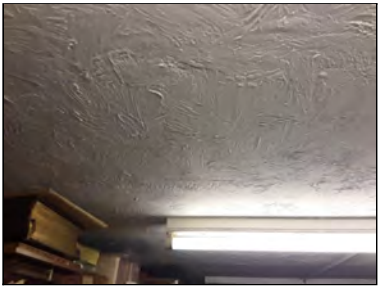
Survey Date:		Lead Surveyor		Survey Type		Floor		Analysis	
	30 Nov 2021		Wayne Gregory		Management Survey		Ground Floor		No Asbestos Detected	
	Building		Room		Item		Quantity			
	Building 1-2		B1 Store 1 G07		Textured coating Ceiling		15m ²			
	Sample No (S,SP,P,As)		Product Type		Surface Treatment		Condition		Accessibility	
	WG000088 (S)		N/A		N/A		N/A		N/A

Normal Occupancy	Score	Likelihood of disturbance	Score	Exposure Potential	Score	Maintenance Activity	Score
Main type of activity	N/A	Location	N/A	Number of occupants	N/A	Type of Maintenance	N/A
Average Score		Accessibility	N/A	Frequency of use	N/A	Frequency of maintenance	N/A
		Amount	N/A	Average Time	N/A		
	N/A	Average Score	N/A	Average Score	N/A	Average Score	N/A
Average of Priority	N/A						
Material Assessment Score	N/A						
Recommendation	No further action required

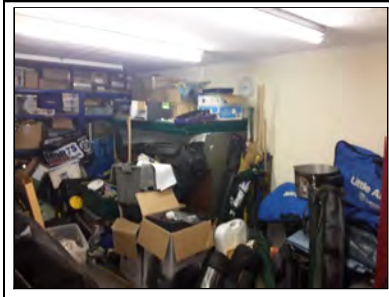
Survey Date:	Lead Surveyor	Survey Type	Floor	Analysis
30 Nov 2021	Wayne Gregory	Management Survey	Ground Floor	No Asbestos Detected
Building	Room	Item	Quantity	
Building 1-2	B1 Store 1 G07	Asbestos insulation board Walls	32m ²	
Sample No (S,SP,P,As)	Product Type	Surface Treatment	Condition	Accessibility
As WG000087 (SP)	N/A	N/A	N/A	N/A

Normal Occupancy	Score	Likelihood of disturbance	Score	Exposure Potential	Score	Maintenance Activity	Score
Main type of activity	N/A	Location	N/A	Number of occupants	N/A	Type of Maintenance	N/A
Average Score		Accessibility	N/A	Frequency of use	N/A	Frequency of maintenance	N/A
		Amount	N/A	Average Time	N/A		
Average of Priority	N/A						
Material Assessment Score	N/A						
Recommendation	No further action required

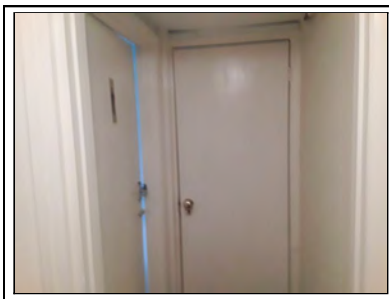
Survey Date:	Lead Surveyor	Survey Type	Floor	Analysis
30 Nov 2021	Wayne Gregory	Management Survey	Ground Floor	N/A
Building	Room	Item	Quantity	
Building 1-2	B1 store 3 G09	Inaccessible	N/A	
Sample No (S,SP,P,As)	Product Type	Surface Treatment	Condition	Accessibility
Visual (P)	N/A	N/A	N/A	N/A

Normal Occupancy	Score	Likelihood of disturbance	Score	Exposure Potential	Score	Maintenance Activity	Score
Main type of activity	N/A	Location	N/A	Number of occupants	N/A	Type of Maintenance	N/A
		Accessibility	N/A	Frequency of use	N/A	Frequency of maintenance	N/A
		Amount	N/A	Average Time	N/A		
Average Score	N/A	Average Score	N/A	Average Score	N/A	Average Score	N/A
Average of Priority	N/A						
Material Assessment Score	N/A						
Recommendation	Inspection Required

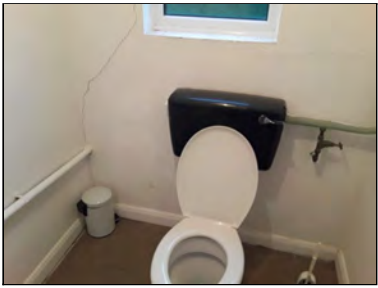
Survey Date:		Lead Surveyor		Survey Type		Floor		Analysis	
	30 Nov 2021		Wayne Gregory		Management Survey		Ground Floor		Amosite (2)	
	Building		Room		Item		Quantity			
	Building 1-2		B1 WC 1 G10		Toilet cistern Fixed to wall		1no.			
	Sample No (S,SP,P,As)		Product Type		Surface Treatment		Condition		Accessibility	
	WG000089 (S)		Reinforced Composite (1)		Completely Sealed (0)		Good Condition (0)		Easily disturbed (2)

Normal Occupancy	Score	Likelihood of disturbance	Score	Exposure Potential	Score	Maintenance Activity	Score
Main type of activity	0	Location	1	Number of occupants	1	Type of Maintenance	0
		Accessibility	2	Frequency of use	3	Frequency of maintenance	0
		Amount	1	Average Time	0		
Average Score	0	Average Score	2	Average Score	2	Average Score	0
Average of Priority	4						
Material Assessment Score	3						
Recommendation	D - No Attention Required, Label

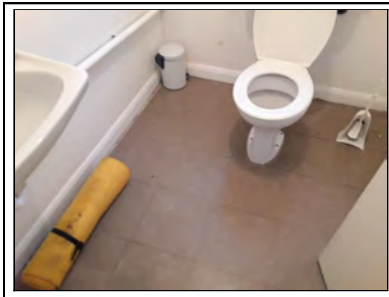
Survey Date:	Lead Surveyor	Survey Type	Floor	Analysis
30 Nov 2021	Wayne Gregory	Management Survey	Ground Floor	Chrysotile (1)
Building	Room	Item	Quantity	
Building 1-2	B1 WC 1 G10	Green floor tiles Floor	3m ²	
Sample No (S,SP,P,As)	Product Type	Surface Treatment	Condition	Accessibility
WG000090 (S)	Reinforced Composite (1)	Completely Sealed (0)	Good Condition (0)	Easily disturbed (2)

Normal Occupancy	Score	Likelihood of disturbance	Score	Exposure Potential	Score	Maintenance Activity	Score
Main type of activity	0	Location	1	Number of occupants	1	Type of Maintenance	0
		Accessibility	2	Frequency of use	3	Frequency of maintenance	0
		Amount	2	Average Time	0		
Average Score	0	Average Score	2	Average Score	2	Average Score	0
Average of Priority	4						
Material Assessment Score	2						
Recommendation	D - No Attention Required, Label

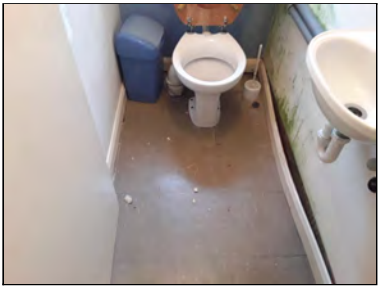
Survey Date:		Lead Surveyor		Survey Type		Floor		Analysis	
	30 Nov 2021		Wayne Gregory		Management Survey		Ground Floor		Chrysotile (1)	
	Building		Room		Item		Quantity			
	Building 1-2		B1 WC 2 G11		Green floor tiles Floor		2m ²			
	Sample No (S,SP,P,As)		Product Type		Surface Treatment		Condition		Accessibility	
	As WG000090 (SP)		Reinforced Composite (1)		Completely Sealed (0)		Good Condition (0)		Easily disturbed (2)

Normal Occupancy	Score	Likelihood of disturbance	Score	Exposure Potential	Score	Maintenance Activity	Score
Main type of activity	0	Location	1	Number of occupants	1	Type of Maintenance	0
		Accessibility	2	Frequency of use	3	Frequency of maintenance	0
		Amount	2	Average Time	0		
Average Score	0	Average Score	2	Average Score	2	Average Score	0
Average of Priority	4						
Material Assessment Score	2						
Recommendation	D - No Attention Required, Label

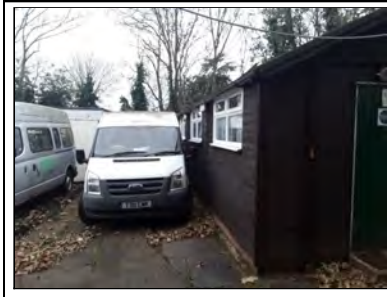
Survey Date:	Lead Surveyor	Survey Type	Floor	Analysis
30 Nov 2021	Wayne Gregory	Management Survey	External	No asbestos detected
Building	Room	Item	Quantity	
Building 1-2	B1 All elevations E01	No suspect materials found Surfaces only	0	
Sample No (S,SP,P,As)	Product Type	Surface Treatment	Condition	Accessibility
Visual (P)	N/A	N/A	N/A	N/A

Normal Occupancy	Score	Likelihood of disturbance	Score	Exposure Potential	Score	Maintenance Activity	Score
Main type of activity	N/A	Location	N/A	Number of occupants	N/A	Type of Maintenance	N/A
		Accessibility	N/A	Frequency of use	N/A	Frequency of maintenance	N/A
		Amount	N/A	Average Time	N/A		
Average Score	N/A	Average Score	N/A	Average Score	N/A	Average Score	N/A
Average of Priority	N/A						
Material Assessment Score	N/A						
Recommendation	No further action required

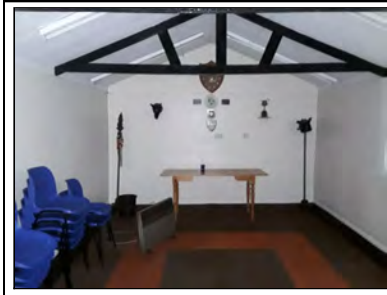
Survey Date:	Lead Surveyor	Survey Type	Floor	Analysis
30 Nov 2021	Wayne Gregory	Management Survey	Ground Floor	No asbestos detected
Building	Room	Item	Quantity	
Building 1-2	B2 meeting room G02	No suspect materials found Surfaces only	0	
Sample No (S,SP,P,As)	Product Type	Surface Treatment	Condition	Accessibility
Visual (P)	N/A	N/A	N/A	N/A

Normal Occupancy	Score	Likelihood of disturbance	Score	Exposure Potential	Score	Maintenance Activity	Score
Main type of activity	N/A	Location	N/A	Number of occupants	N/A	Type of Maintenance	N/A
Average Score	N/A	Accessibility	N/A	Frequency of use	N/A	Frequency of maintenance	N/A
		Amount	N/A	Average Time	N/A		
Average of Priority	N/A						
Material Assessment Score	N/A						
Recommendation	No further action required
