Home Report

Single Survey

Property address	29 Townhead Kilmaurs Kilmarnock KA3 2SR
Customer	Estate of Archibald Johnston
Customer address	29 Townhead Kilmaurs Kilmarnock KA3 2SR
Prepared by	Shepherd Chartered Surveyors
Date of inspection	03/07/2025

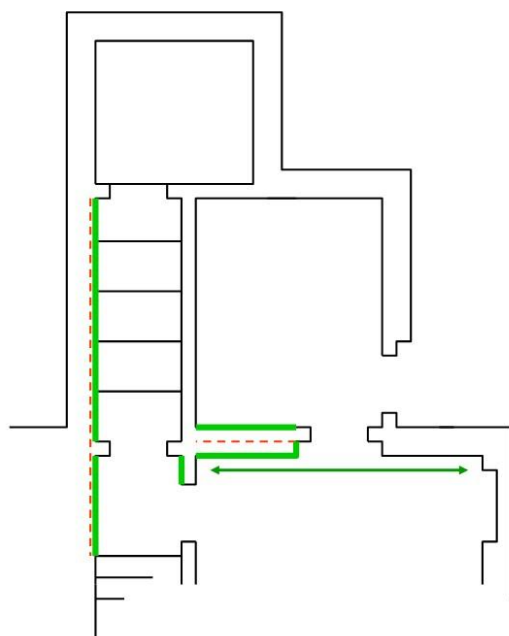
Part Ground Floor Plan

Evidence of infestation by common furniture beetle (*Anobium punctatum*) was noted.

Chemical DPC		Renew flooring, deafening and joist sections		Clear, treat and seal solum		Renew lintel
	Membrane/ reline and plaster - approx 1.0m high		Renew joist sections		Renew ceiling		Renew beam
	Membrane/ reline and plaster - full height		Radiator (others)		Inspect sub-floor		Inspect/ treat lintel
