Asbestos Survey Report & Register

Survey Type:	Management Survey (with MA only)
Site:	Jillscot, 56 Bar Hill, Madeley, Crewe, Cheshire, CW3 9QD
Surveyor(s):	Tom Marshall
Contract:	J009120
Survey Date:	23 Apr 2024
Report Date:	8 May 2024
Re-inspection Due:	23rd April 2025
Client:	Berrys, 42 Headlands

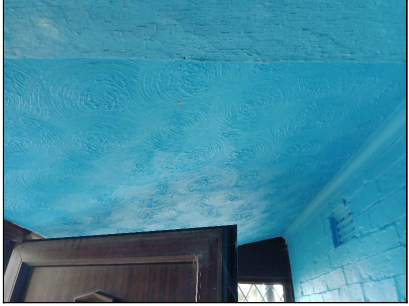
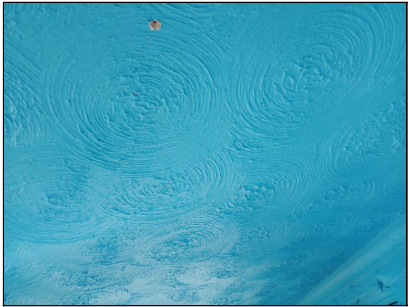
Contract No: J009120	Client: Berrys	Item No: 1	
Site Jillscot, 56 Bar Hill, Madeley, Crewe, Cheshire		Survey Date: 23 Apr 2024	
Building:	Jillscot, 56 bar hill, Crewe

Floor:	Ground Floor		
Room Area:	001 Lobby		
Description	Textured coating		
Quantity	2m ²

Accessibility	Easily disturbed		
Product Type:	Textured Coating (1)		
Damage Extent	Low Damage (1)		
Surface Treatment	Sealed (1)	Re-inspection Due	N/A
Asbestos Type:	No Asbestos Detected	Sample Ref:	EA000474 (S)
Material Assessment:		Risk Score - N/A No Asbestos Detected	
Comment: To plasterboard pitched roof above.			
Recommendations: No further action required

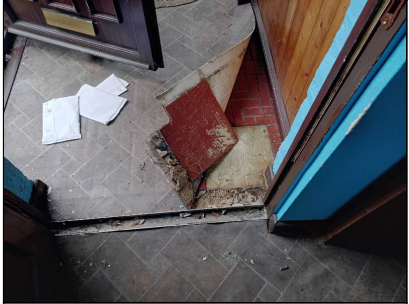
Contract No: J009120	Client: Berrys	Item No: 2	
Site Jillscot, 56 Bar Hill, Madeley, Crewe, Cheshire		Survey Date: 23 Apr 2024	
Building:	Jillscot, 56 bar hill, Crewe

Floor:	Ground Floor		
Room Area:	001 Lobby		
Description	Bitumen residue		
Quantity	2m ²

Accessibility	Occasionally likely to be disturbed		
Product Type:	Bituminous Product (1)		
Damage Extent	Low Damage (1)		
Surface Treatment	Sealed (0)	Re-inspection Due	23rd April 2025
Asbestos Type:	Chrysotile (1)	Sample Ref:	EA000475 (S)
Material Assessment:	Risk Score - 3 Very Low

Comment: Beneath linoleum.			
Recommendations: Manage The identified asbestos containing material should be managed in accordance with current legislation. For adequate management asbestos materials must be in a good condition and products other than cement and composite materials should be sealed and or protected. As such should the identified asbestos containing material be damaged then it will require repair and for materials other than cement and composites it will require encapsulation and or protection. Where asbestos materials are beyond repair they should be removed. Although labelling and or signage are not a legal requirement it should be considered to avoid accidental damage.

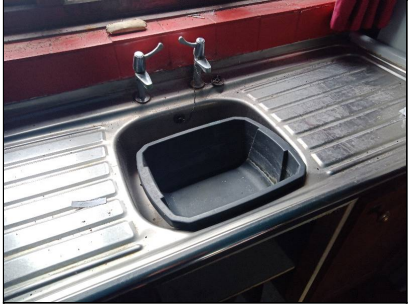
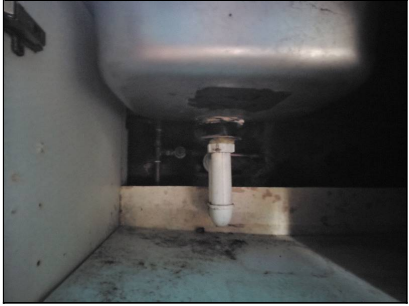
Contract No: J009120	Client: Berrys	Item No: 3	
Site Jillscot, 56 Bar Hill, Madeley, Crewe, Cheshire		Survey Date: 23 Apr 2024	
Building:	Jillscot, 56 bar hill, Crewe

Floor:	Ground Floor		
Room Area:	002 Kitchen		
Description	Bitumen pad		
Quantity	1no.

Accessibility	Easily disturbed		
Product Type:	Bituminous Product (1)		
Damage Extent	Low Damage (1)		
Surface Treatment	Sealed (0)	Re-inspection Due	N/A
Asbestos Type:	No Asbestos Detected	Sample Ref:	EA000476 (S)
Material Assessment:	Risk Score - N/A No Asbestos Detected		
Comment: To underside of metal sink.			
Recommendations: No further action required

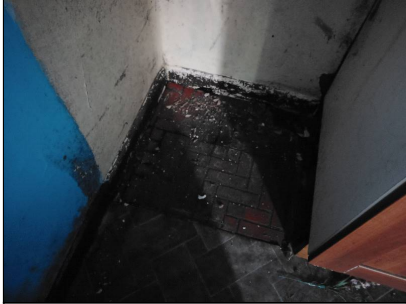
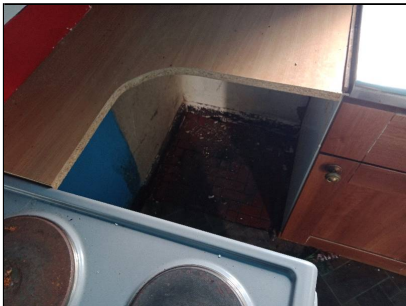
Contract No: J009120	Client: Berrys	Item No: 4	
Site Jillscot, 56 Bar Hill, Madeley, Crewe, Cheshire		Survey Date: 23 Apr 2024	
Building:	Jillscot, 56 bar hill, Crewe

Floor:	Ground Floor		
Room Area:	002 Kitchen		
Description	Bitumen residue beneath linoleum		
Quantity	12m ²

Accessibility	Occasionally likely to be disturbed		
Product Type:	Bituminous Product (1)		
Damage Extent	Low Damage (1)		
Surface Treatment	Sealed (0)	Re-inspection Due	23rd April 2025
Asbestos Type:	Chrysotile (1)	Sample Ref:	As EA000475 (SP)
Material Assessment:	Risk Score - 3 Very Low

Comment: Includes under stairs cupboard.			
Recommendations: Manage The identified asbestos containing material should be managed in accordance with current legislation. For adequate management asbestos materials must be in a good condition and products other than cement and composite materials should be sealed and or protected. As such should the identified asbestos containing material be damaged then it will require repair and for materials other than cement and composites it will require encapsulation and or protection. Where asbestos materials are beyond repair they should be removed. Although labelling and or signage are not a legal requirement it should be considered to avoid accidental damage.

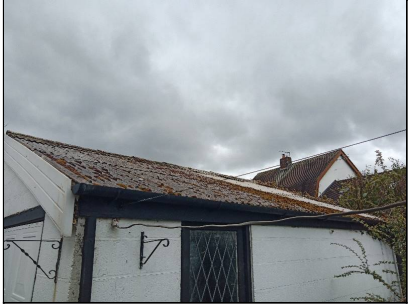
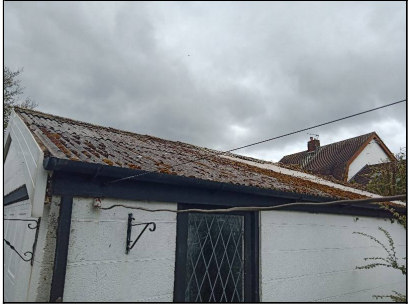
Contract No: J009120	Client: Berrys	Item No: 5	
Site Jillscot, 56 Bar Hill, Madeley, Crewe, Cheshire		Survey Date: 23 Apr 2024	
Building:	Jillscot, 56 bar hill, Crewe

Floor:	External		
Room Area:	External garage		
Description	Corrugated cement sheeting to garage pitched roof.		
Quantity	60m ²

Accessibility	Occasionally likely to be disturbed		
Product Type:	Cement Product (1)		
Damage Extent	Medium Damage (2)		
Surface Treatment	Unsealed (1)	Re-inspection Due	N/A
Asbestos Type:	No Asbestos Detected	Sample Ref:	EA000477 (S)
Material Assessment:	Risk Score - N/A No Asbestos Detected		
Comment: Small breakage.			
Recommendations: No further action required

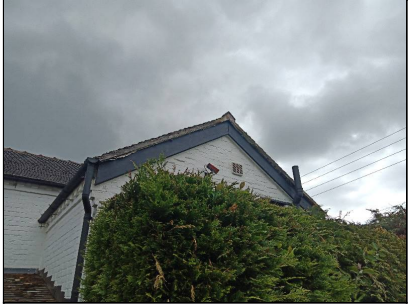
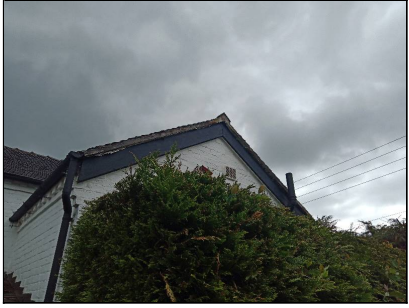
Contract No: J009120	Client: Berrys	Item No: 6	
Site Jillscot, 56 Bar Hill, Madeley, Crewe, Cheshire		Survey Date: 23 Apr 2024	
Building:	Jillscot, 56 bar hill, Crewe

Floor:	External		
Room Area:	External garage		
Description	Cement undercloak		
Quantity	8lm

Accessibility	Usually inaccessible or unlikely to be disturbed		
Product Type:	Cement Product (1)		
Damage Extent	Medium Damage (2)		
Surface Treatment	Unsealed (1)	Re-inspection Due	23rd April 2025
Asbestos Type:	Crocidolite (or unknown) (3)	Sample Ref:	Visual (P)
Material Assessment:	Risk Score - 7 Medium

Comment: To externals. Undercloak in poor condition and material falling away from roof.			
Recommendations: Encapsulate and Manage The identified asbestos containing material should be managed in accordance with current legislation. For adequate management asbestos materials must be in a good condition and products other than cement and composite materials should be sealed and or protected. As such should the identified asbestos containing material be damaged then it will require repair and for materials other than cement and composites it will require encapsulation and or protection. Where asbestos materials are beyond repair they should be removed. Although labelling and or signage are not a legal requirement it should be considered to avoid accidental damage.
