## Church Farm House Hilperton.

### **Current renovations**

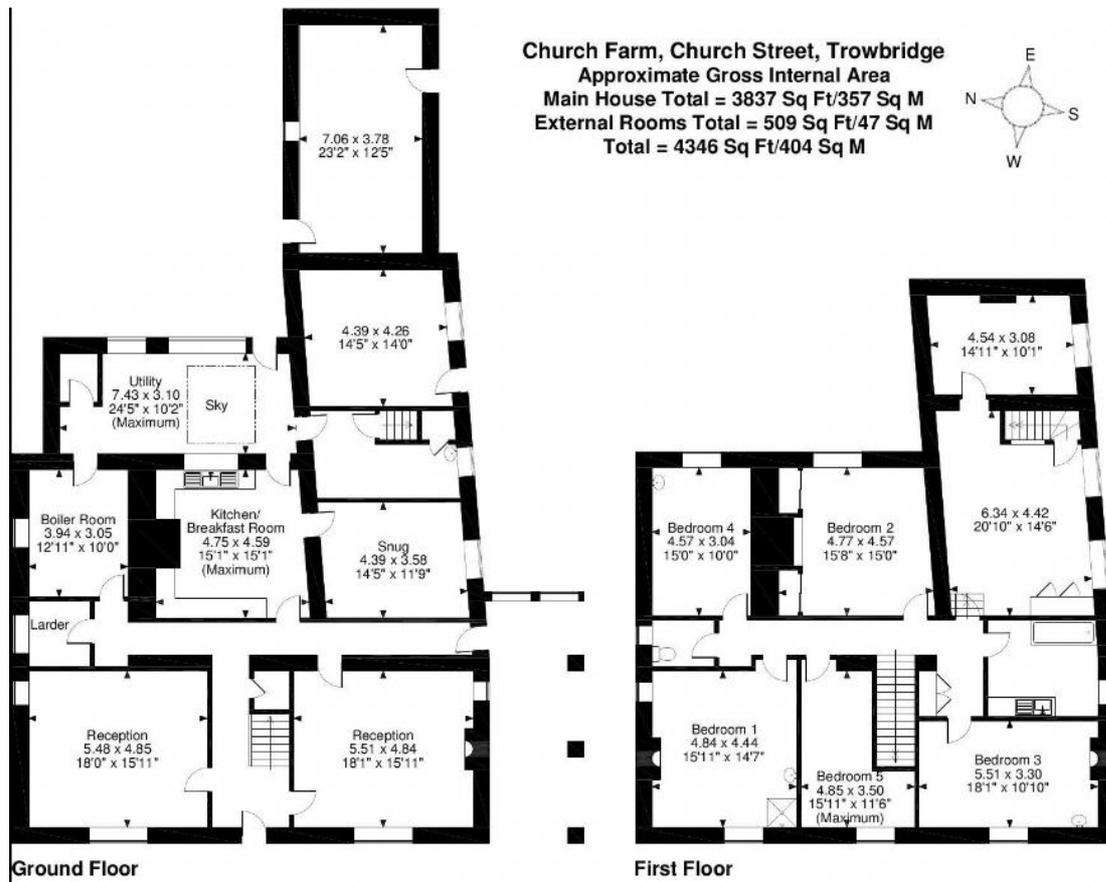
Below is the original layout of the property.

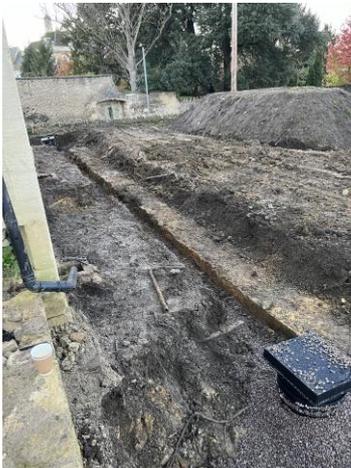
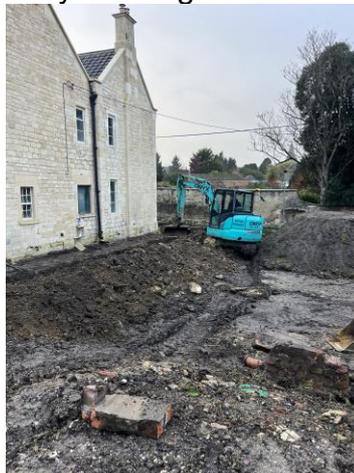
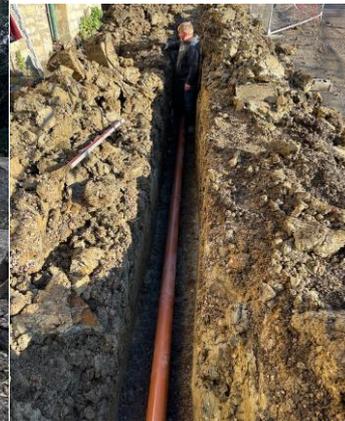
## Ground Works

On original purchase the house had 1 internal toilet and 1 external toilet fed to and old clay piped combined storm and sewage system on the north side of the house.

The house still supports a combined system (signed off by building control) which has been significantly upgraded. The whole drainage and sewage system was removed and replaced with new plastic pipes that feeds 2 main sewer outlets on the north and south of the house. There are now 5 separate outlets from the house designed to service 2 kitchens, utility room, 3 en-suites, family bathroom and 9 storm drains from the roof and a perforated pipe drainage system around the barn. The system has been signed off by building control.
