Macaulay,
Warden Place,
Forres,
Morayshire,
IV36 1NR

Home Report

Single Survey

Property Address	Macaulay, Warden Place, Forres, Morayshire, IV36 1NR
Reference	1008417
Customer Name	Matthew Howell
Date of Inspection	11th April 2025
Surveyor's name, qualifications and office	Michael McDonald BLE, MRICS DM Hall LLP Chartered Surveyors 27 High Street Elgin IV30 1EE Tel: 01343 548501 email: elginresidential@dmhall.co.uk
Prepared By	DM Hall LLP

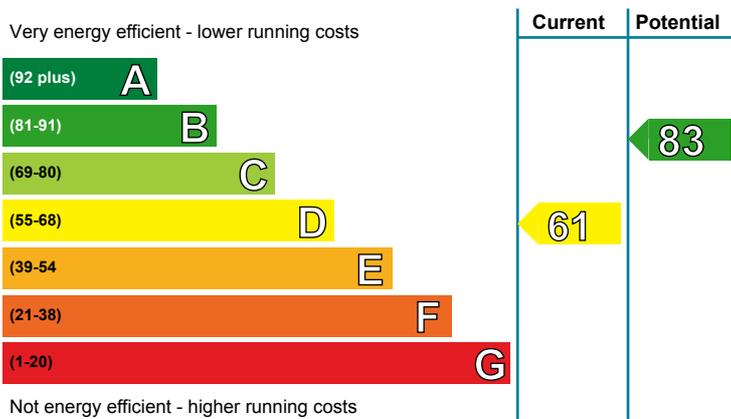
Energy Efficiency Rating

This graph shows the current efficiency of your home, taking into account both energy efficiency and fuel costs. The higher this rating, the lower your fuel bills are likely to be.

Your current rating is **band D (61)**. The average rating for EPCs in Scotland is **band D (61)**.
