# Home Report

## Survey Report on:

25 Wood Street,  
Catrine,  
Mauchline,  
Ayrshire,  
KA5 6RJ

1st April 2025

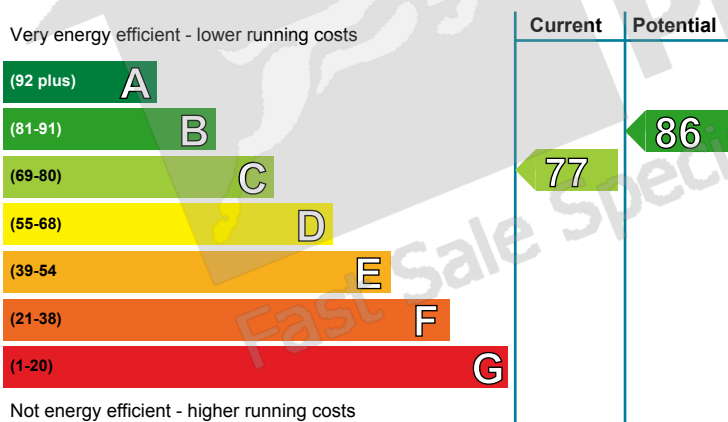
## Energy Efficiency Rating

This graph shows the current efficiency of your home, taking into account both energy efficiency and fuel costs. The higher this rating, the lower your fuel bills are likely to be.

Your current rating is **band C (77)**. The average rating for EPCs in Scotland is **band D (61)**.

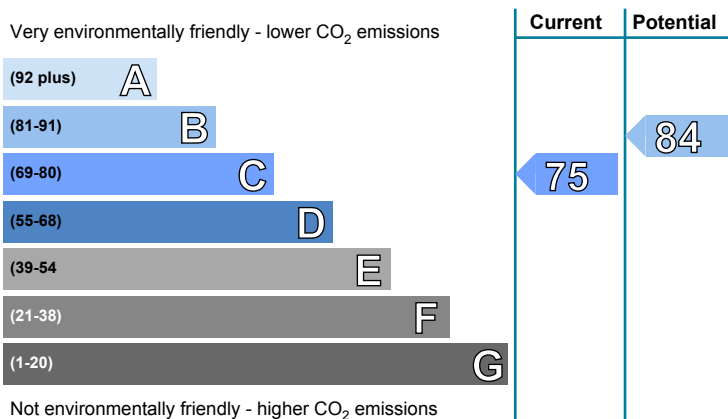
## Environmental Impact (CO<sub>2</sub>) Rating

This graph shows the effect of your home on the environment in terms of carbon dioxide (CO<sub>2</sub>) emissions. The higher the rating, the less impact it has on the environment.
