Home Report

Property address	Rockvale Brighouse Borgue Kirkcudbright DG6 4TS
Customer	Mr Gordon Sproat
Customer address	Rockvale Brighouse Borgue Kirkcudbright DG6 4TS
Prepared by	Shepherd Chartered Surveyors
Date of inspection	13/08/2024

Williamson & Henry
3 St Cuthbert Street
Kirkcudbright
DG6 4DJ

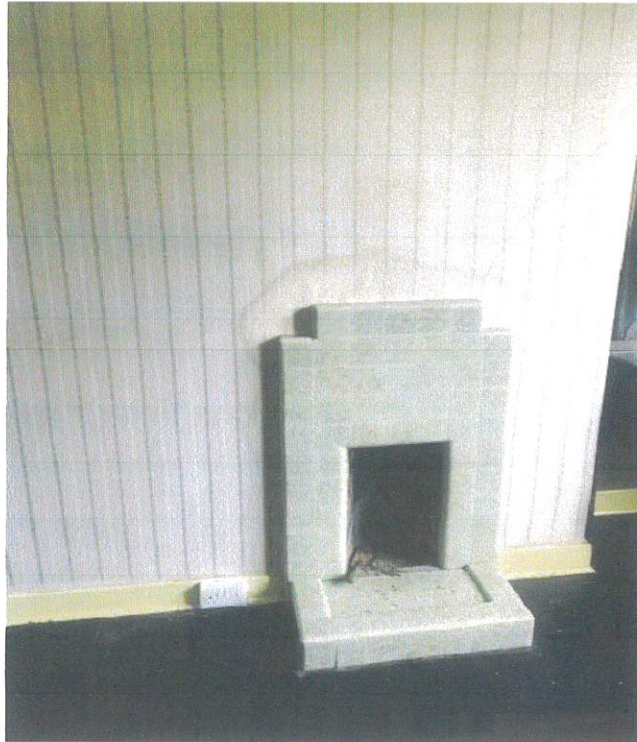
Damp around fireplace.

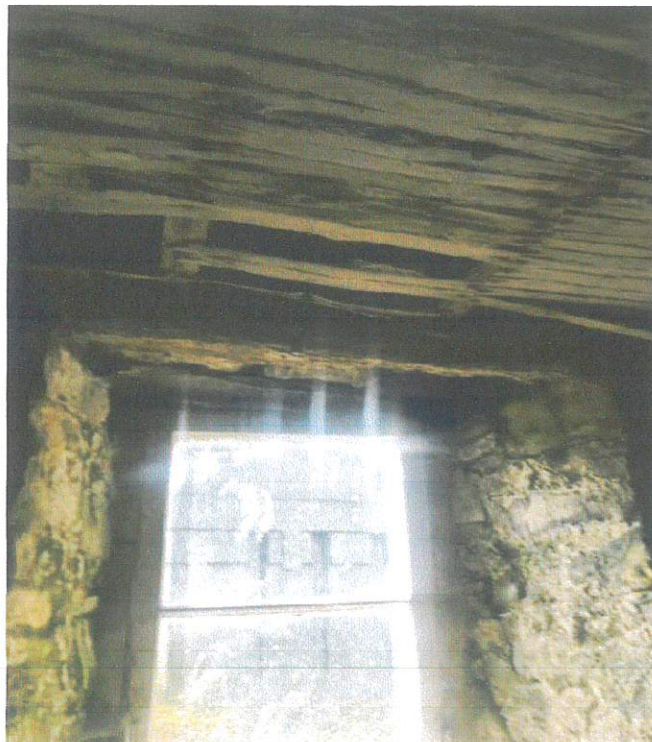
Rot to timber lintels and ceiling joists.

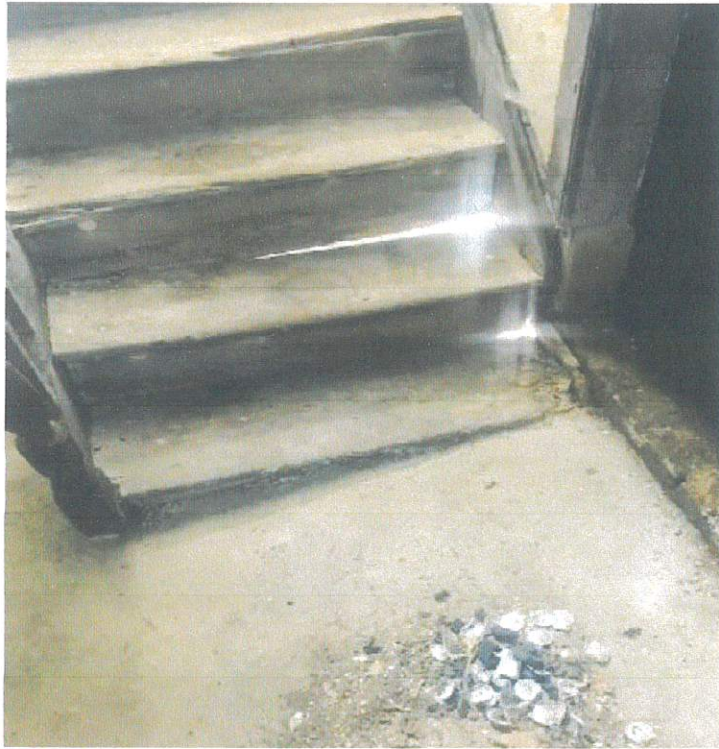
Rot to bottom of timber stair at basement level.

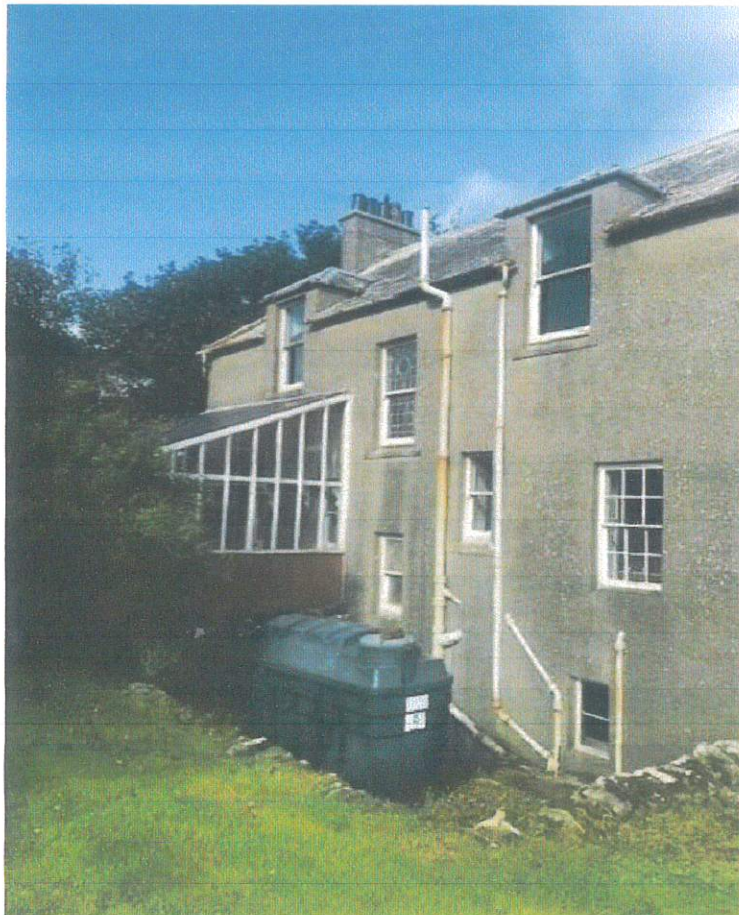
Rear elevation with chimney.
