Your survey report

38 Lon Y Deri, Cardiff, CF14 6JP

11 June 2024

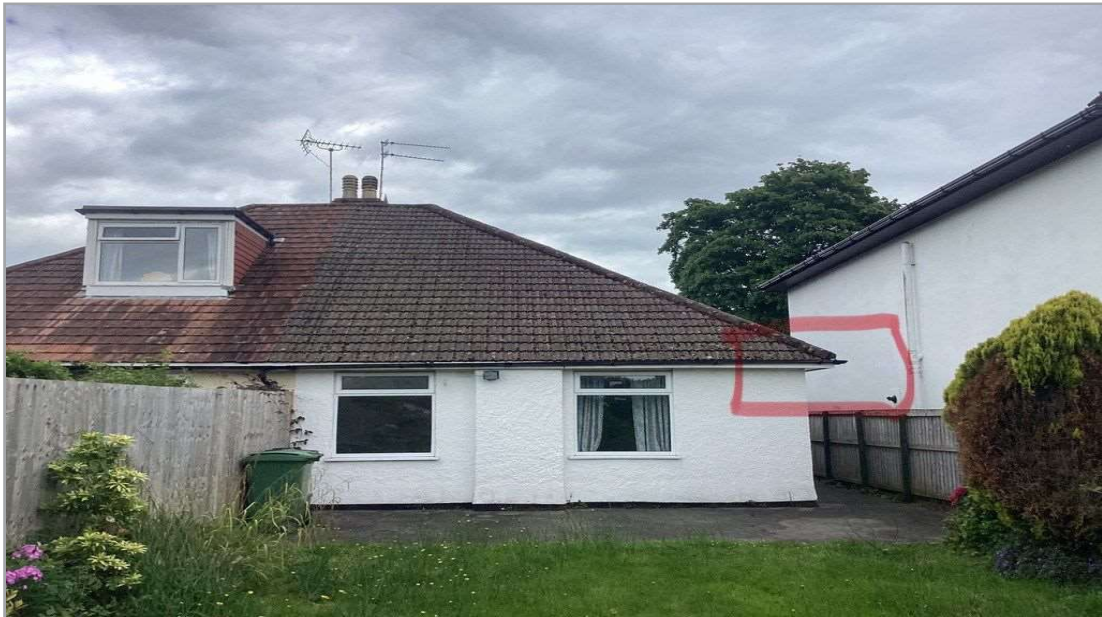
The roof covering appears in acceptable condition, despite being weathered and a little uneven in places. No essential repairs appear needed however ridge tiles at the rear hipped slope require further investigation as they appear to have slipped. The covering should be regularly inspected and maintained in good condition as any minor disrepair could lead to leakage and consequential timber frame decay.

Check roof tiles

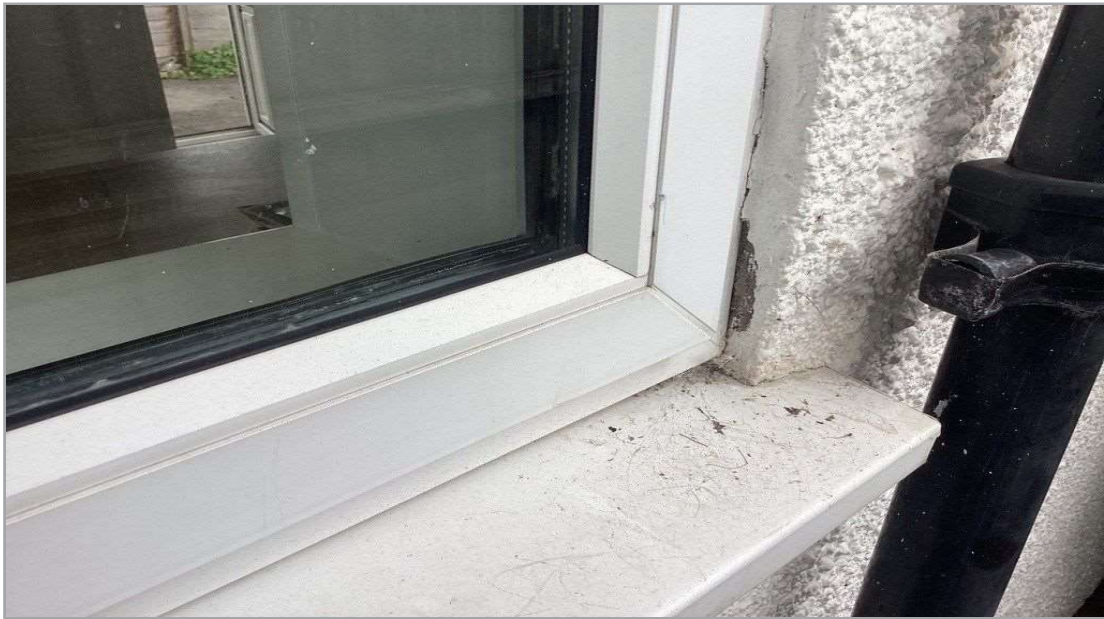
The junction between window frames and surrounding masonry is frequently a source of water penetration particularly during persistent wet weather conditions. It is important that the sealing material that protects these joints is regularly checked and maintained in good condition.

Failing sealant to joints

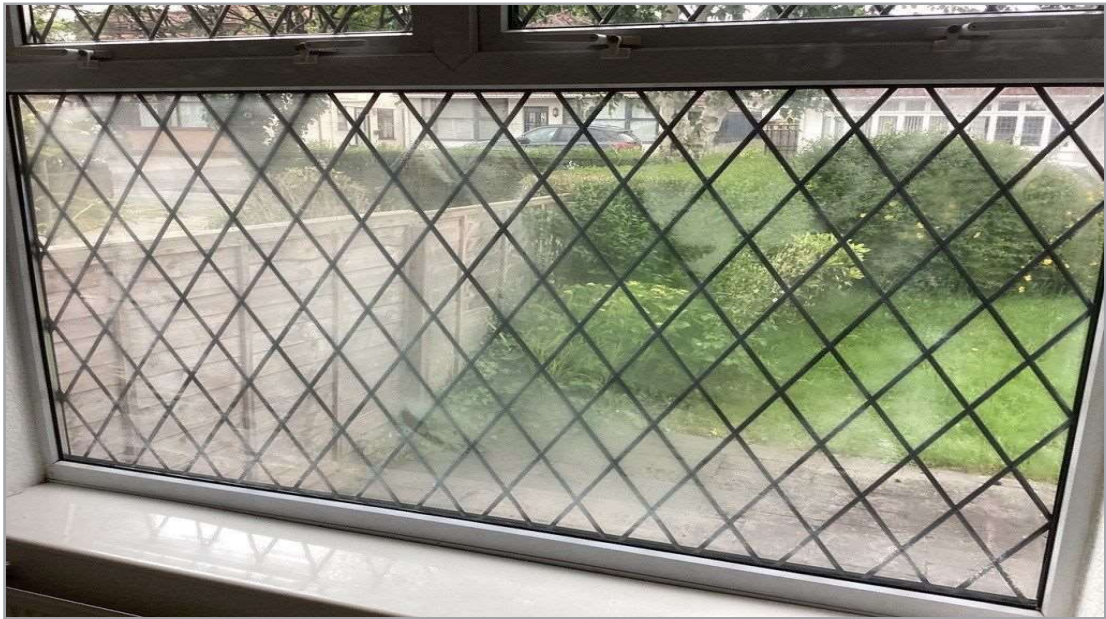
Overall the window units are weathered in places, displaying some failed fittings due to wear and tear and some units display misting. Despite this, they appear satisfactorily weathertight for now. Hence, the quality of sealed unit, older double glazed window units varies and no assurances can be given concerning long-term durability.

Misting front window unit

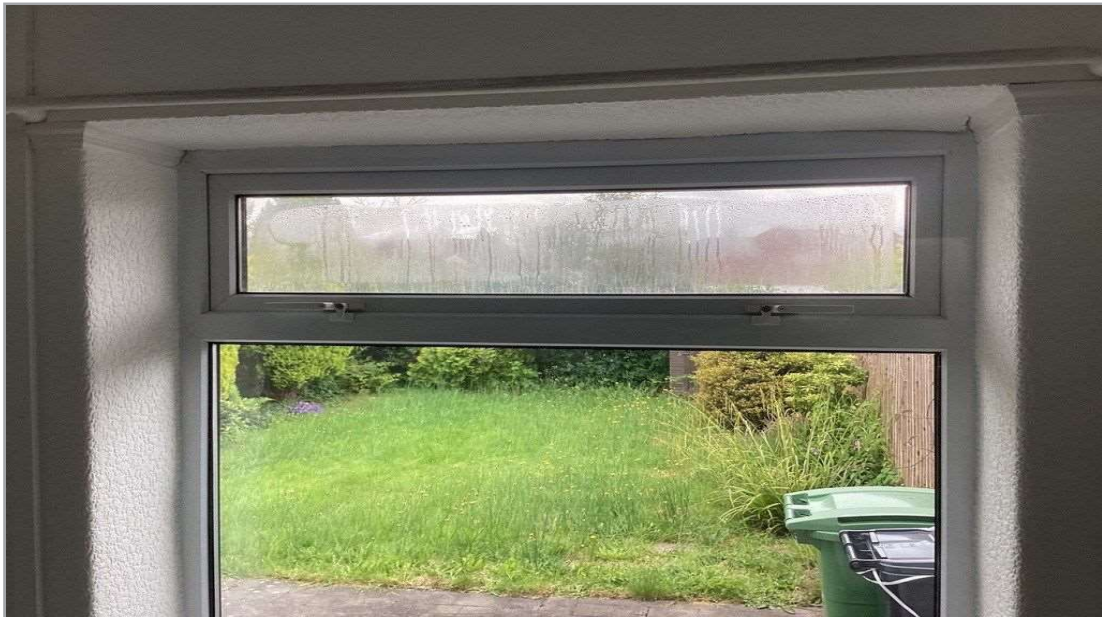
Misting - rear window unit

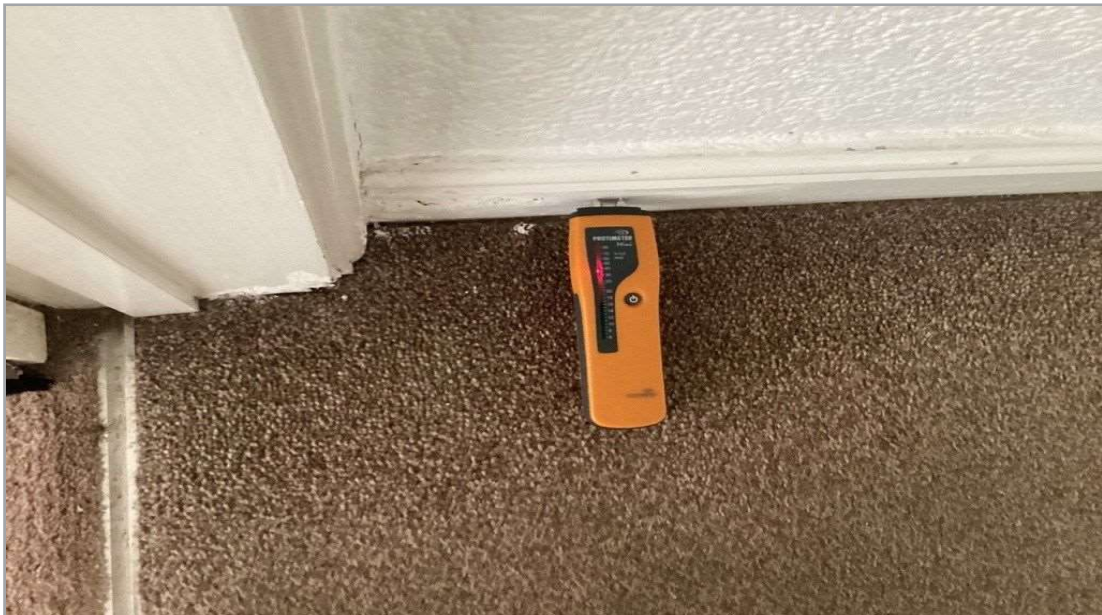
Opposite side of bathroom wall

The walls and partitions are on the whole in satisfactory structural order. Some elevated dampness, whilst not visible to the eye, was observed to a number of areas around the ground floor perimeter walls using a damp meter, particularly those areas adjacent to the bathroom. This can be seen in the skirting at low level and probably goes hand in hand with associated dampness in the floor in this zone. Often in such cases the defect can only be determined by an intrusive inspection and a process of elimination.

Damp remediation work can be costly, disruptive and sometimes involve at least partial replacement of wall plasters. You could instruct a specialist timber and damp surveyor to investigate the cause and consequently heed the advice offered. As stated earlier we believe the dampness displayed in the skirting is due to prolonged leaking from the original shower/bath installation and whilst this now appears resolved the damp is not. 2

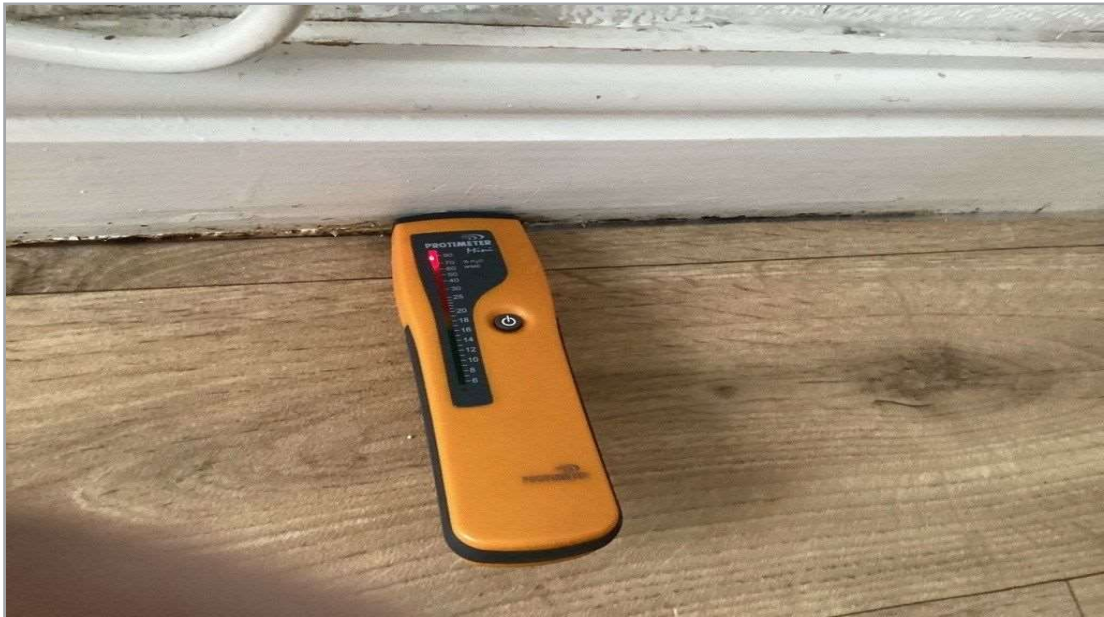
Similar

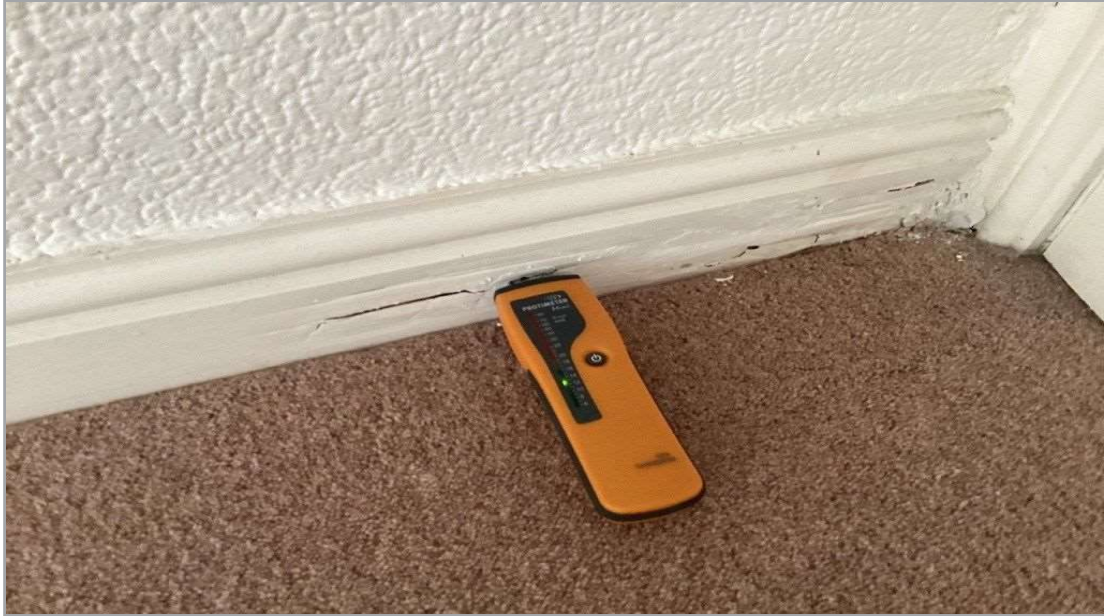
Opposite of bathroom wall and timber rot in skirting behind living room door

Woodwork requires regular maintenance and decoration. As we did observe some mild wood rot to the timber skirting, this needs to be investigated further. Whilst we did not observe any obvious signs of wood-boring beetle in the joinery we could see; properties such as this one are susceptible to occasional attack. Evidence of wood-beetles could be discovered when the property is either refurbished or fixtures and covers removed. Should an outbreak be found, spot treatment may be necessary.

In light of the observations under the previous heading referring to the damp and timber rot in the skirting, we would advise lifting the coverings to check the floor surfaces for damp and defects.
