## **STRUCTURAL INSPECTION REPORT**

Pine Cone Cottage

September 2021

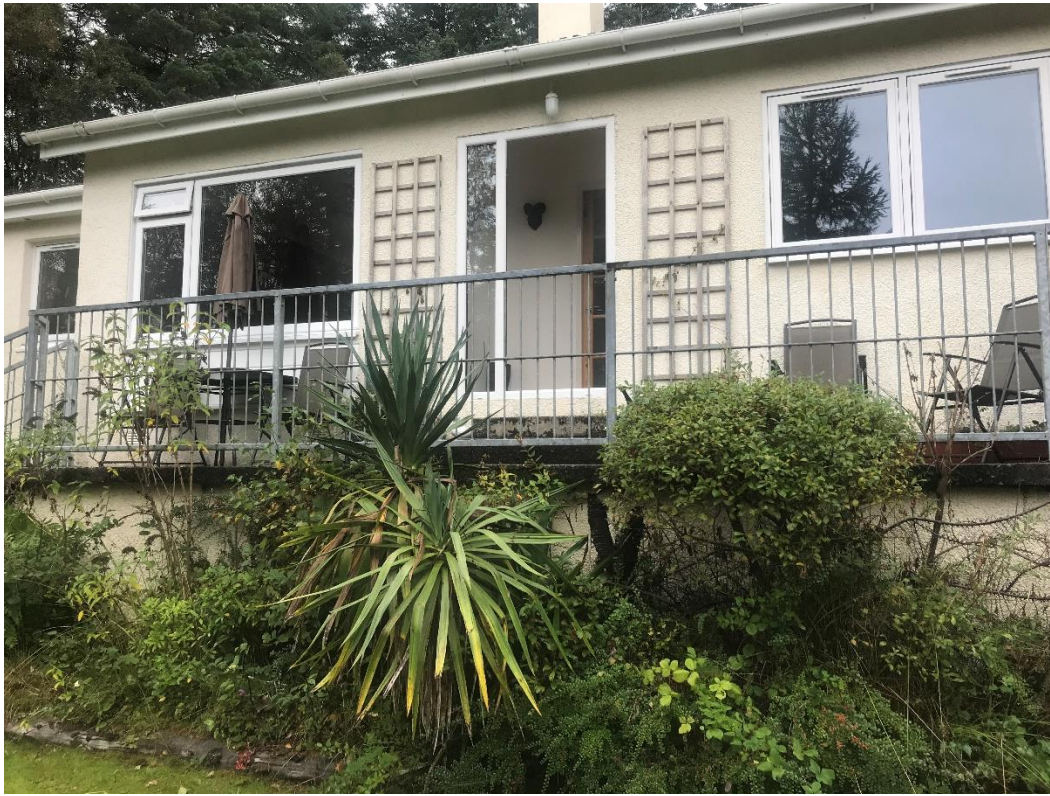
5.1.1.3 0.5mm vertical crack, below threshold to main door.

5.1.1.4 Hairline cracking, vertical, either side of lintel over main door.

Figure 1 Front elevation

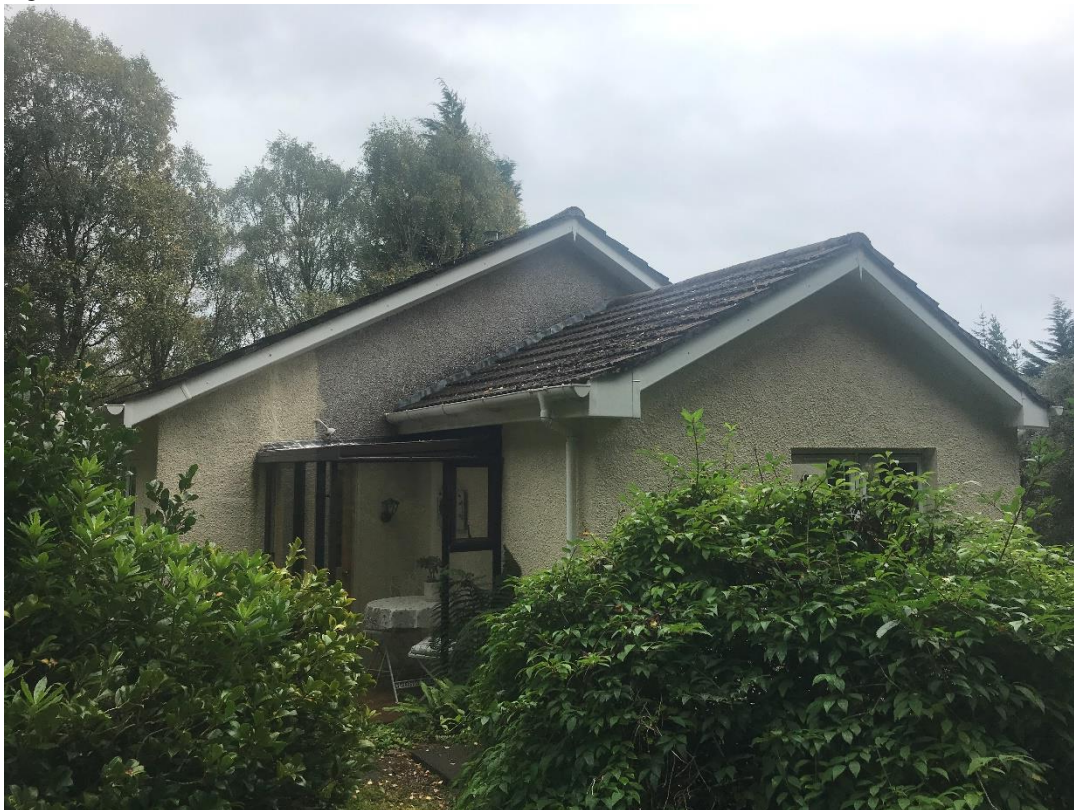
5.1.1.8 Minor cracks to render, since repaired, above entrance door.

Figure 2 Left elevation

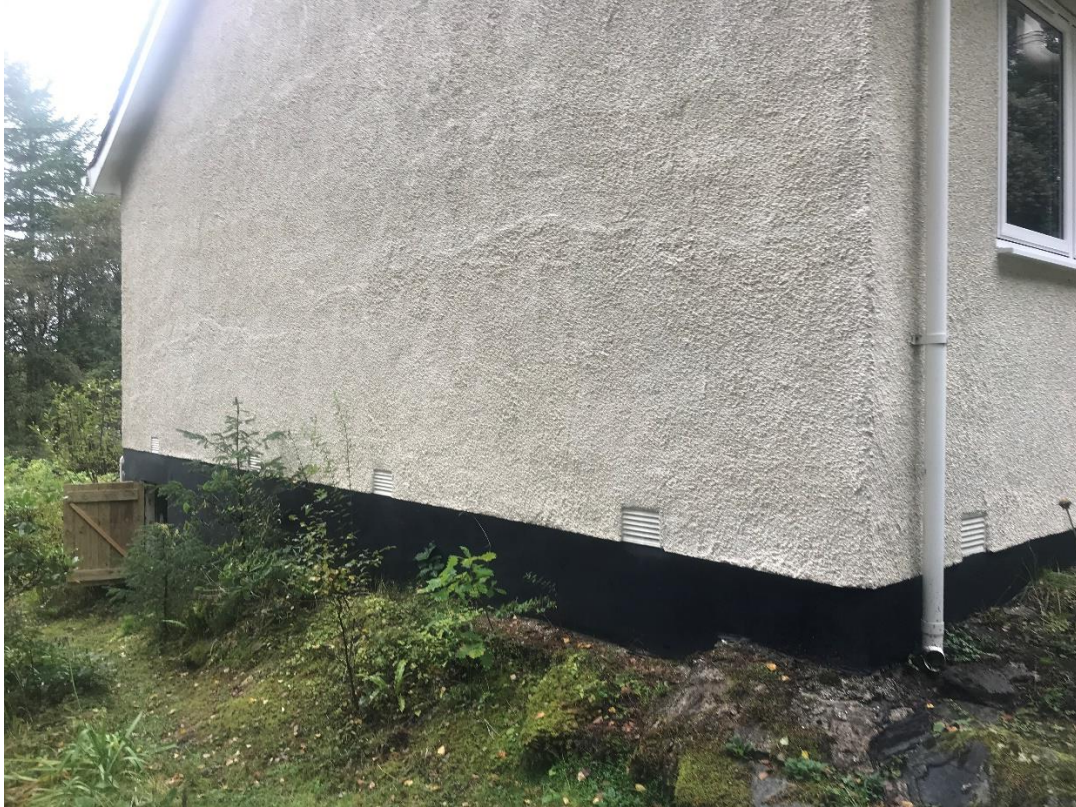
Figure 3 Right elevation

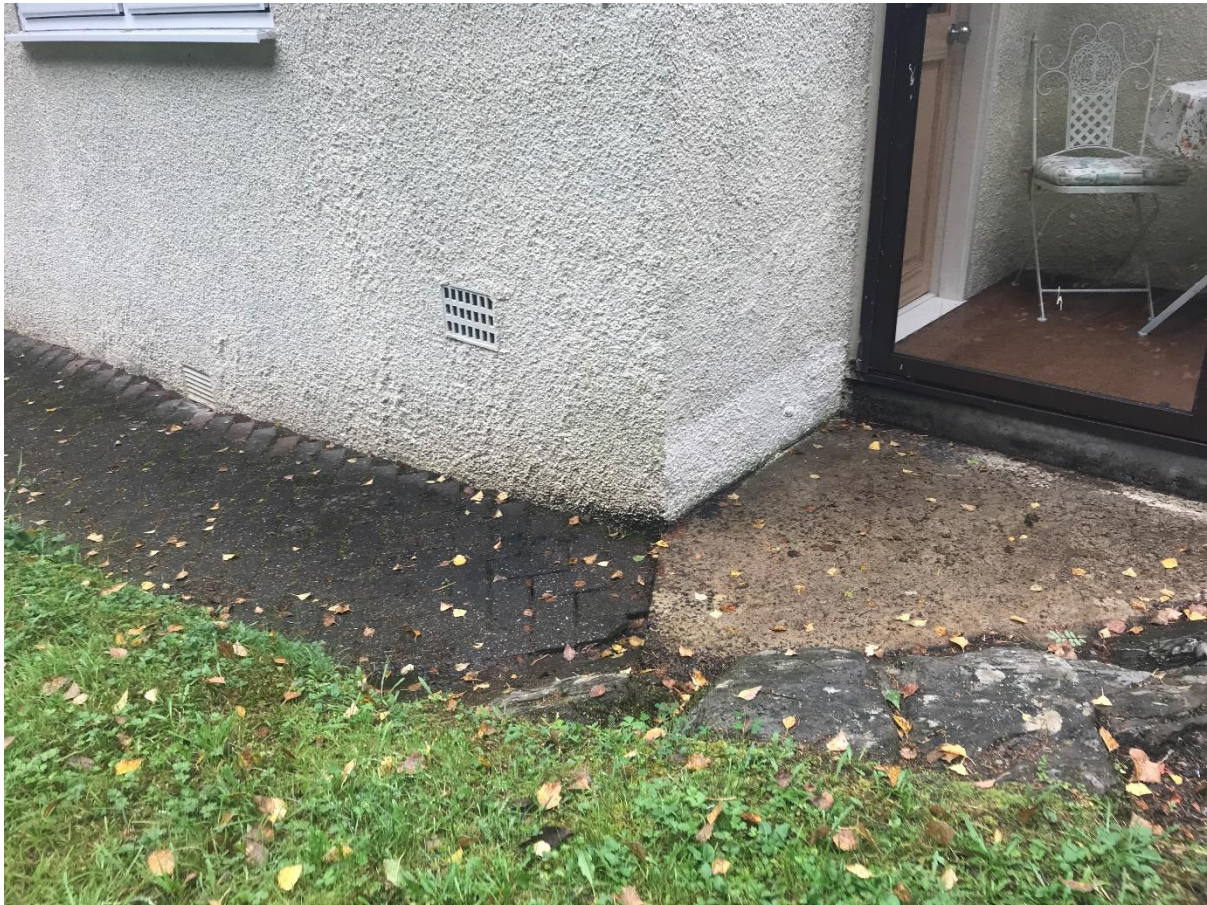
The monoblock and concrete paving at the rear is too high, risking the damp proof course being bridged, resulting in damp timbers. This should be lowered by about 100mm.

Figure 4 High external ground level at rear. This should be lowered.

In summary, the property is structurally sound and its condition looks to be above average when compared with other Dorrans. The shrinkage cracks should ideally be filled to prevent water ingress and ventilation added to the roof void. As noted above, the ground level at the rear should be lowered slightly to preserve the function of the damp proof course.

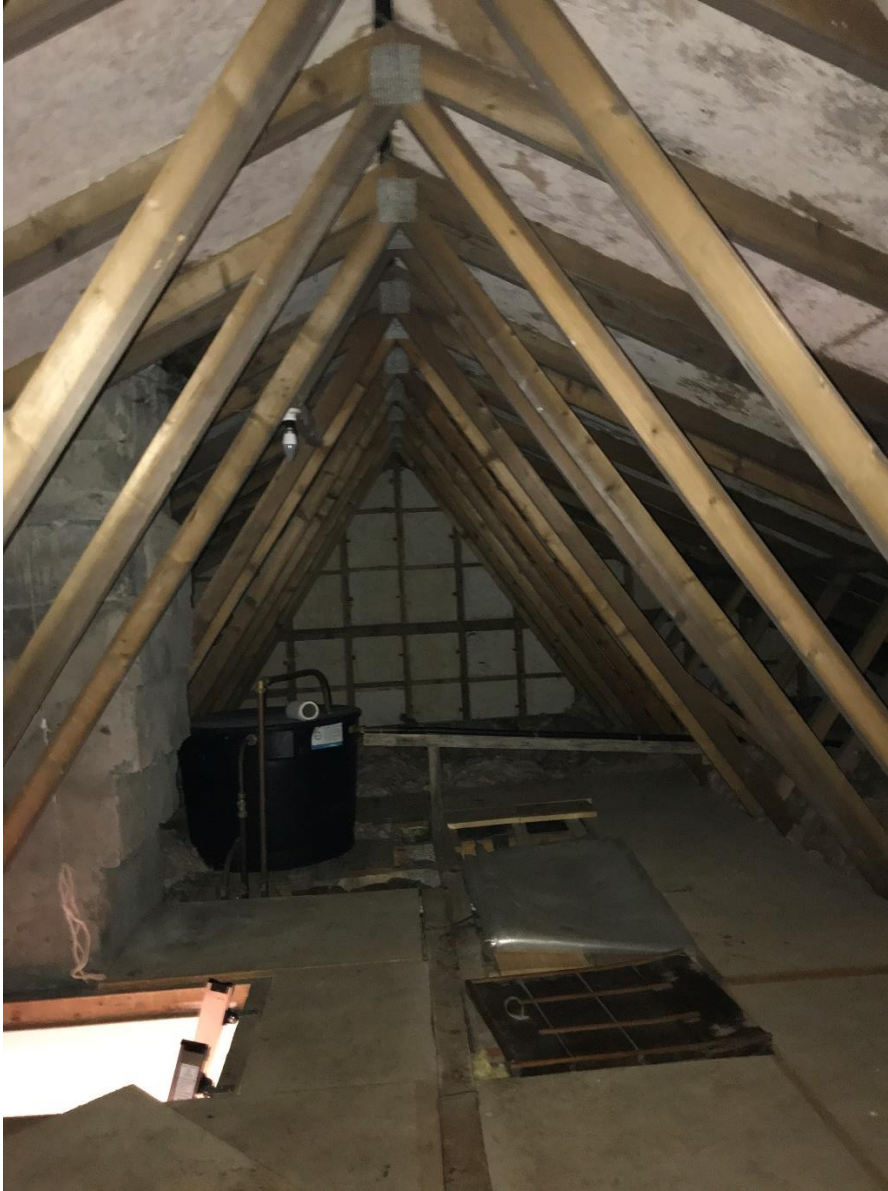
- 5.2.1.1 No signs of structural distress or structural defects to roof structure.
- 5.2.1.2 No excessive deflection where ceiling joists' splices are unsupported below in living room.
- 5.2.1.3 Structural timbers in acceptable order. Some sagging of sarking but this is not structurally relevant. Some typical decay to bridling at chimney due to leaking flashing but not excessive.
- 5.2.1.4 Steel restraint straps and bolts in acceptable order.
- 5.2.1.5 No signs of any significant woodworm or recent activity on timbers inspected.

Figure 5 General view of roof void, with fink trusses and exposed gable spandrel panels

A key preventive measure in slowing the rate of carbonation is preventing water ingress via hairline cracking. Therefore, ensuring cracks are sealed as soon as possible is important maintenance. Improving ventilation to the roof void is also recommended, as this will help to manage condensation, which also contributes to carbonation. This is normally required in any roof that has a cold void above the insulation.

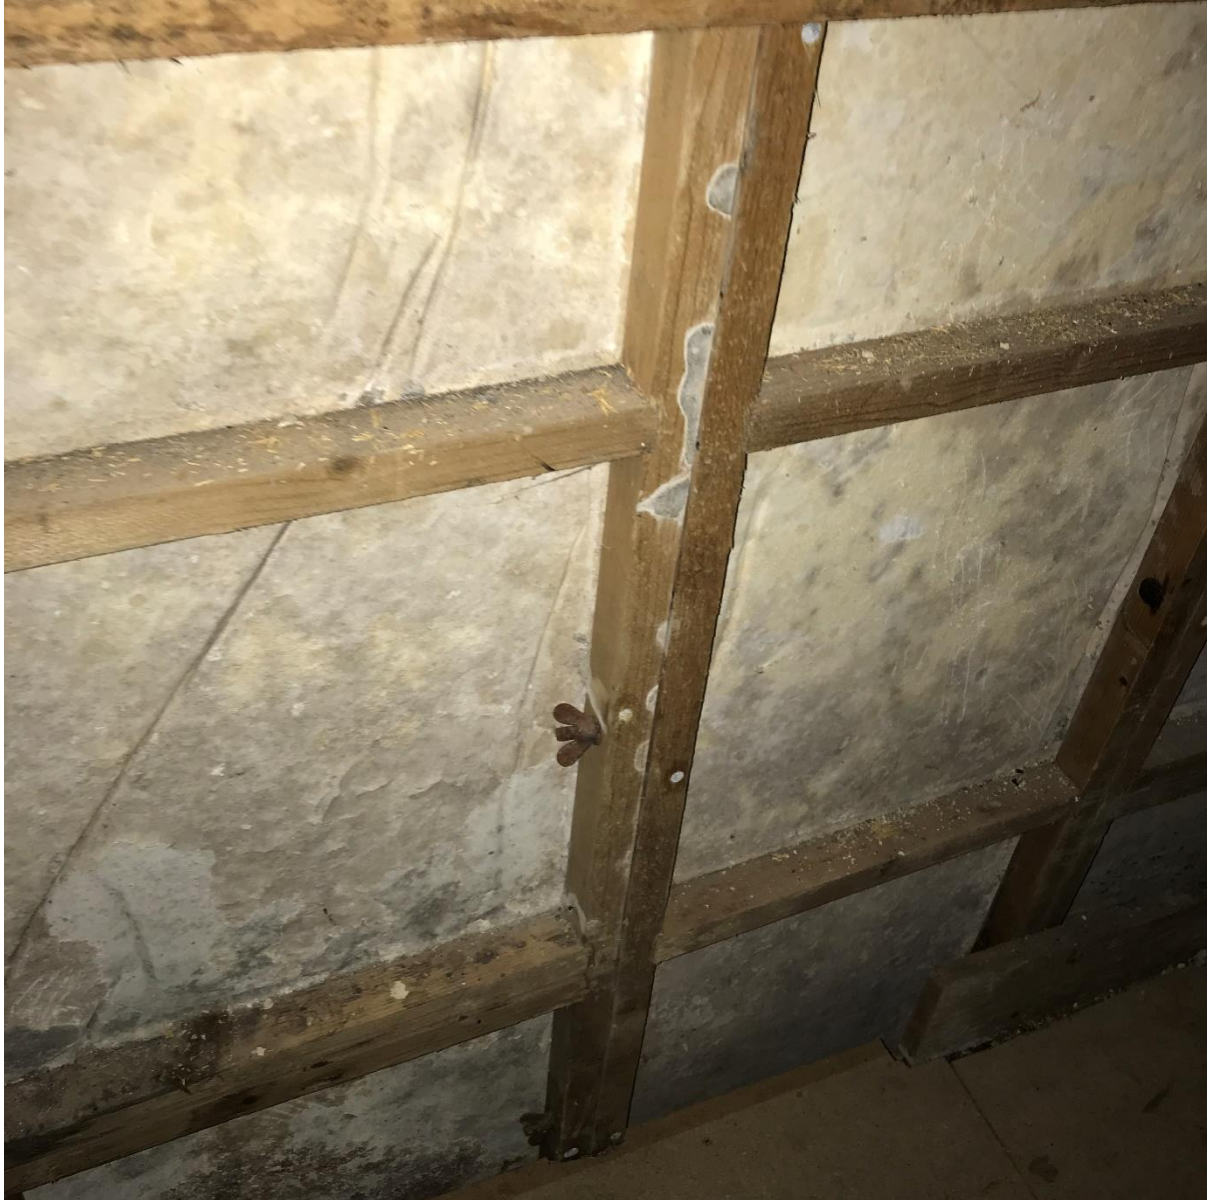
Figure 6 Close up of spandrel panel showing timbers and bolting arrangement.

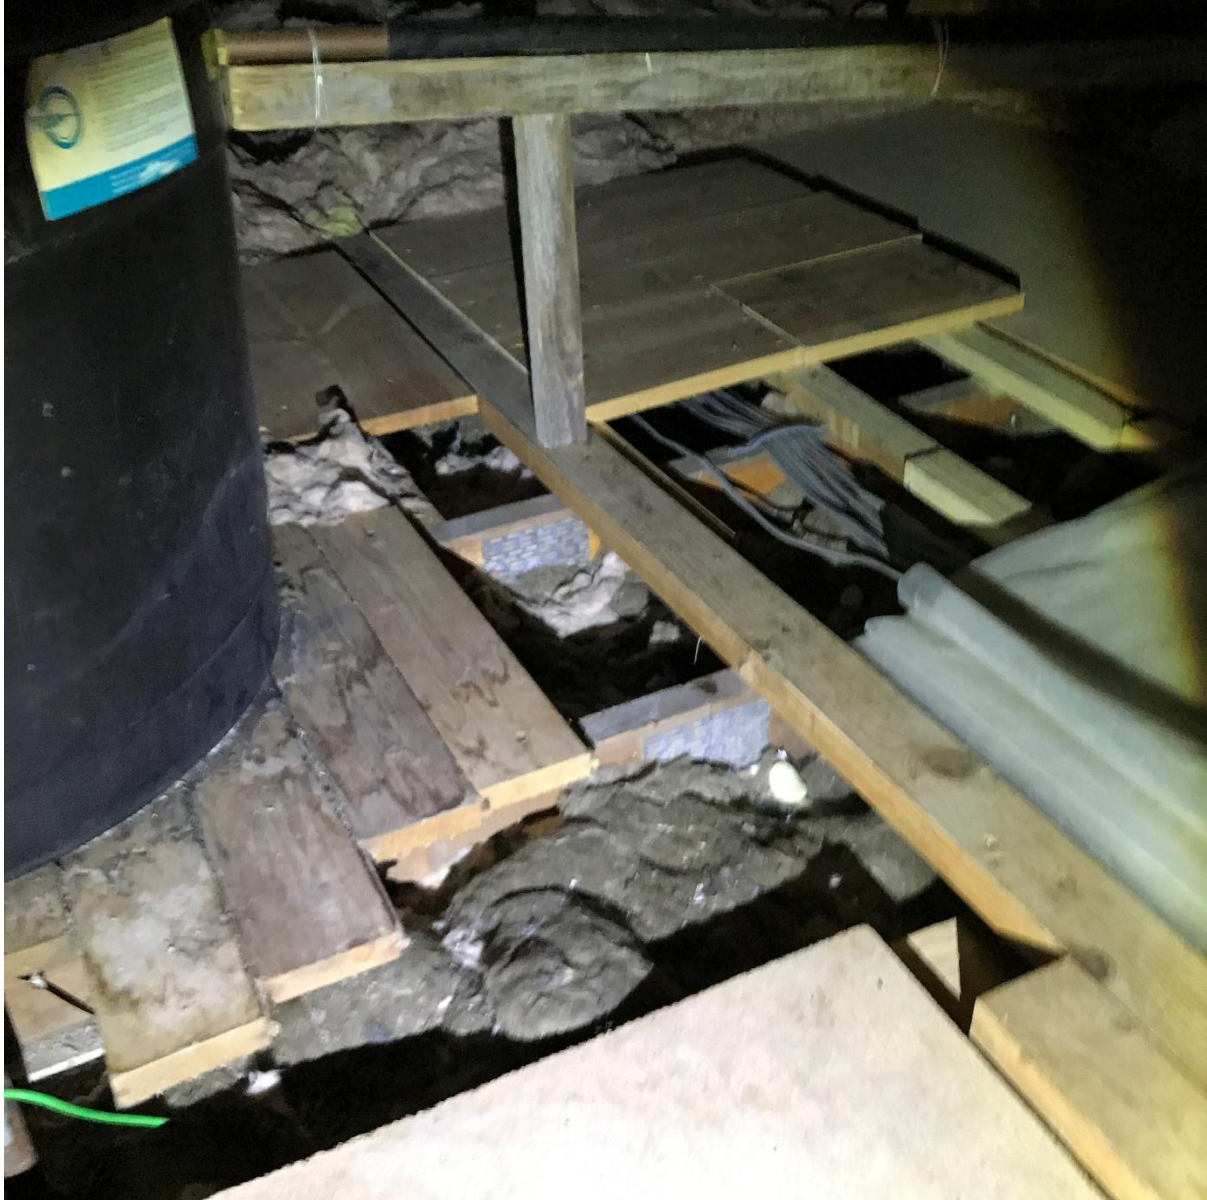
Figure 7 Spliced ceiling joists in acceptable condition.

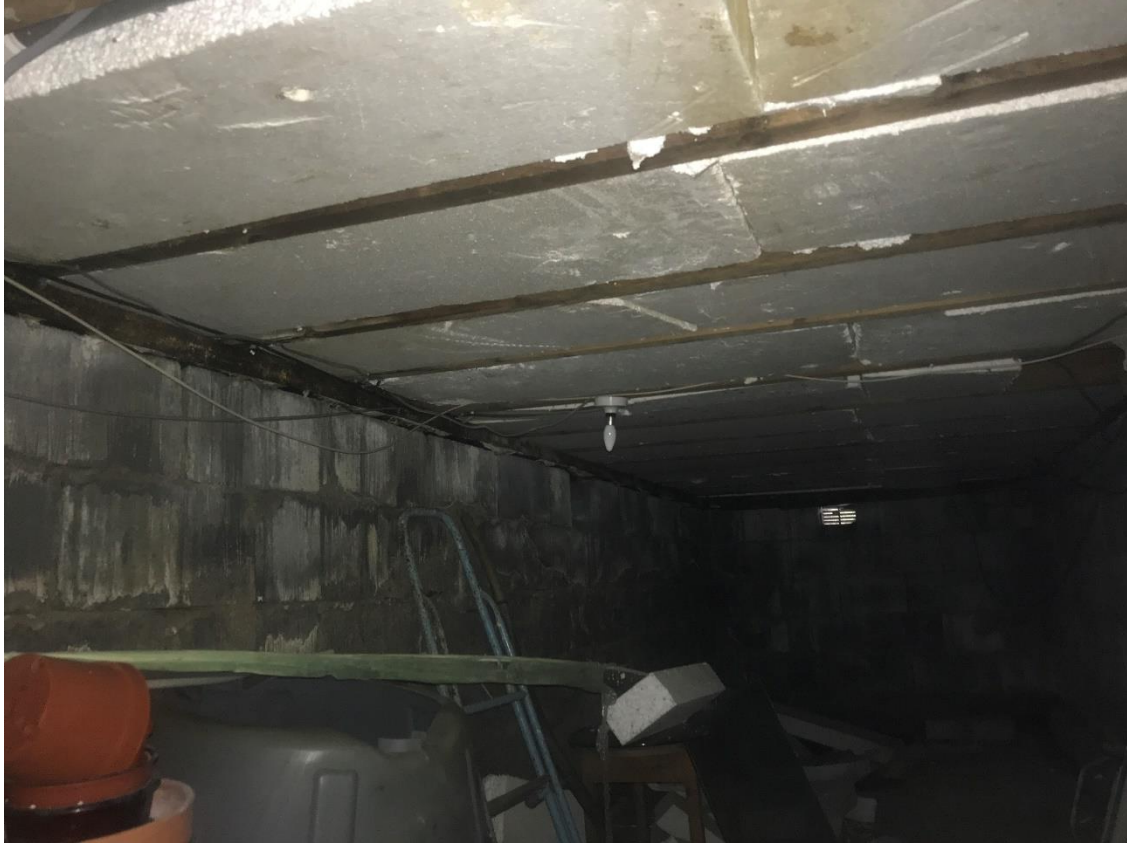
Figure 8 Typical view of floor void, with polystyrene insulation fitted between floor joists.

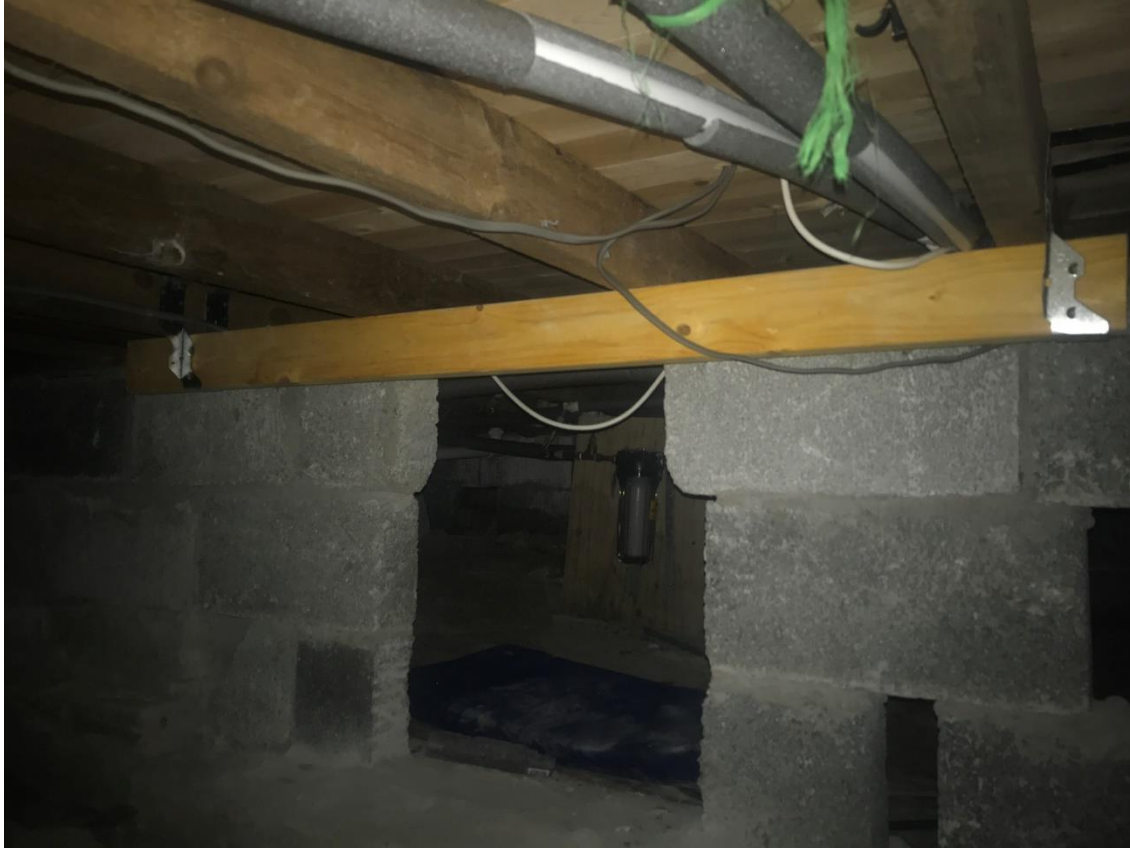
Figure 9 The original sleeper wall did not have concrete lintels installed. Instead, timbers have been used to lintel over. No excessive deflection was noted to the floor structure and this is considered acceptable.

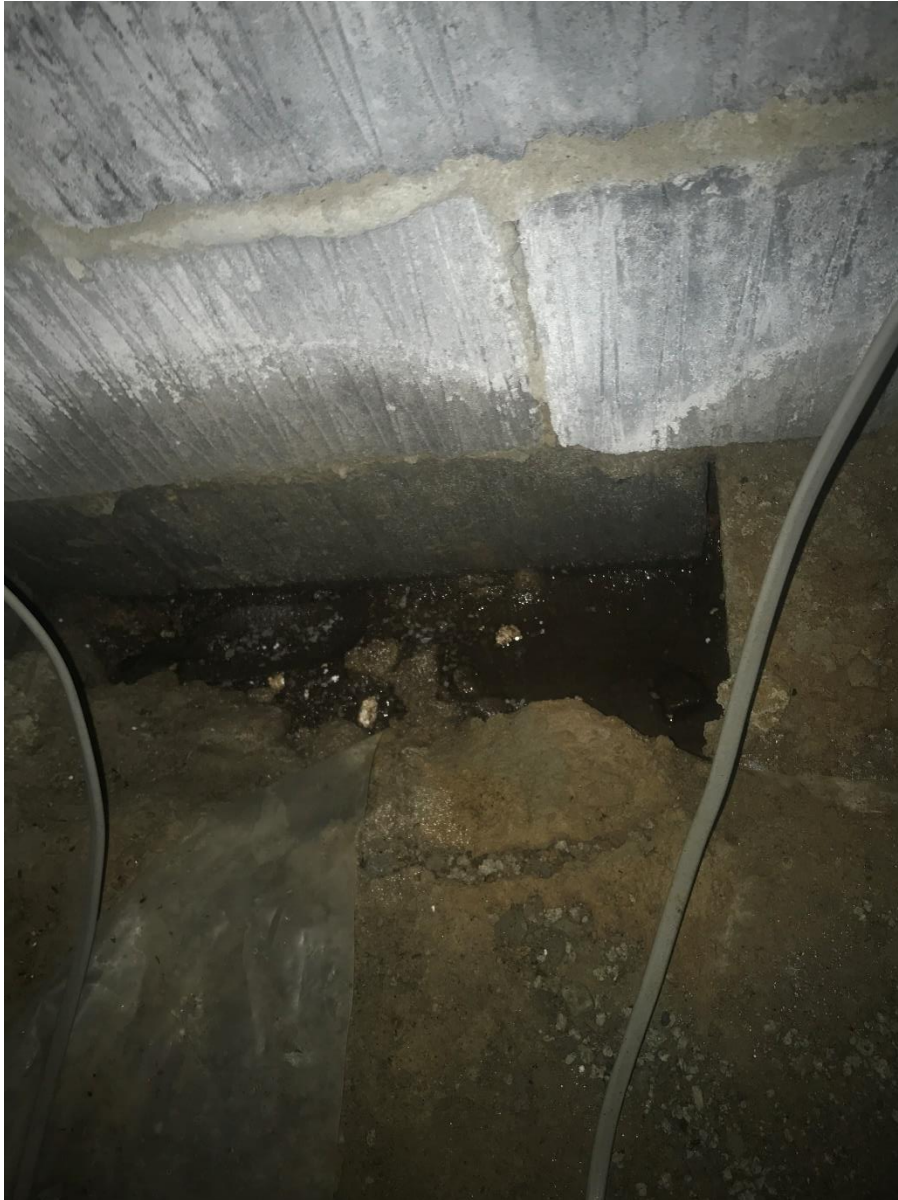
Figure 10 Small void acting as a sump, with a small amount of water noted.

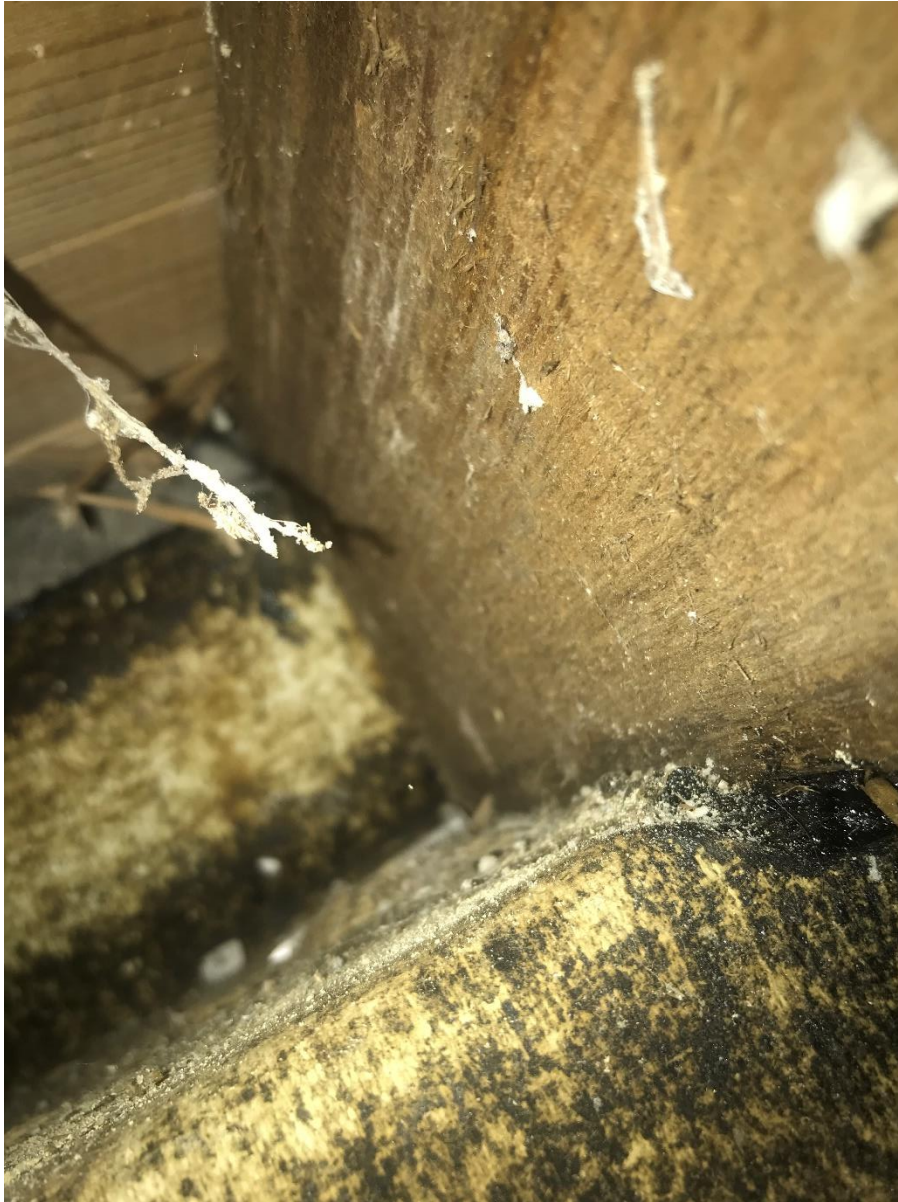
Figure 11 Bearing ends of timber floor joists in good order, with damp proof courses installed below.
