Attic Flat,  
27 Lochnell Street,  
Lochgilphead,  
Argyll,  
PA31 8JL

# Home Report

# Single Survey

## Survey Report on:

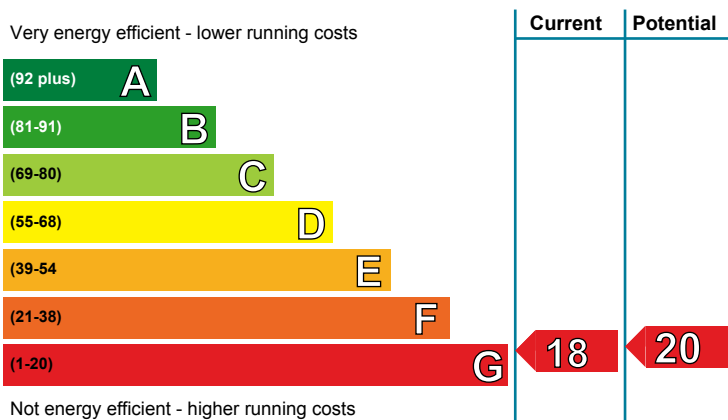
## Energy Efficiency Rating

Your current rating is **band G (18)**. The average rating for EPCs in Scotland is **band D (61)**.
