# YOUR ONESURVEY HOME REPORT

6 Front Street  
Inver, Tain  
IV20 1RY

# SINGLE SURVEY

**STRUCTURAL INSPECTION REPORT**

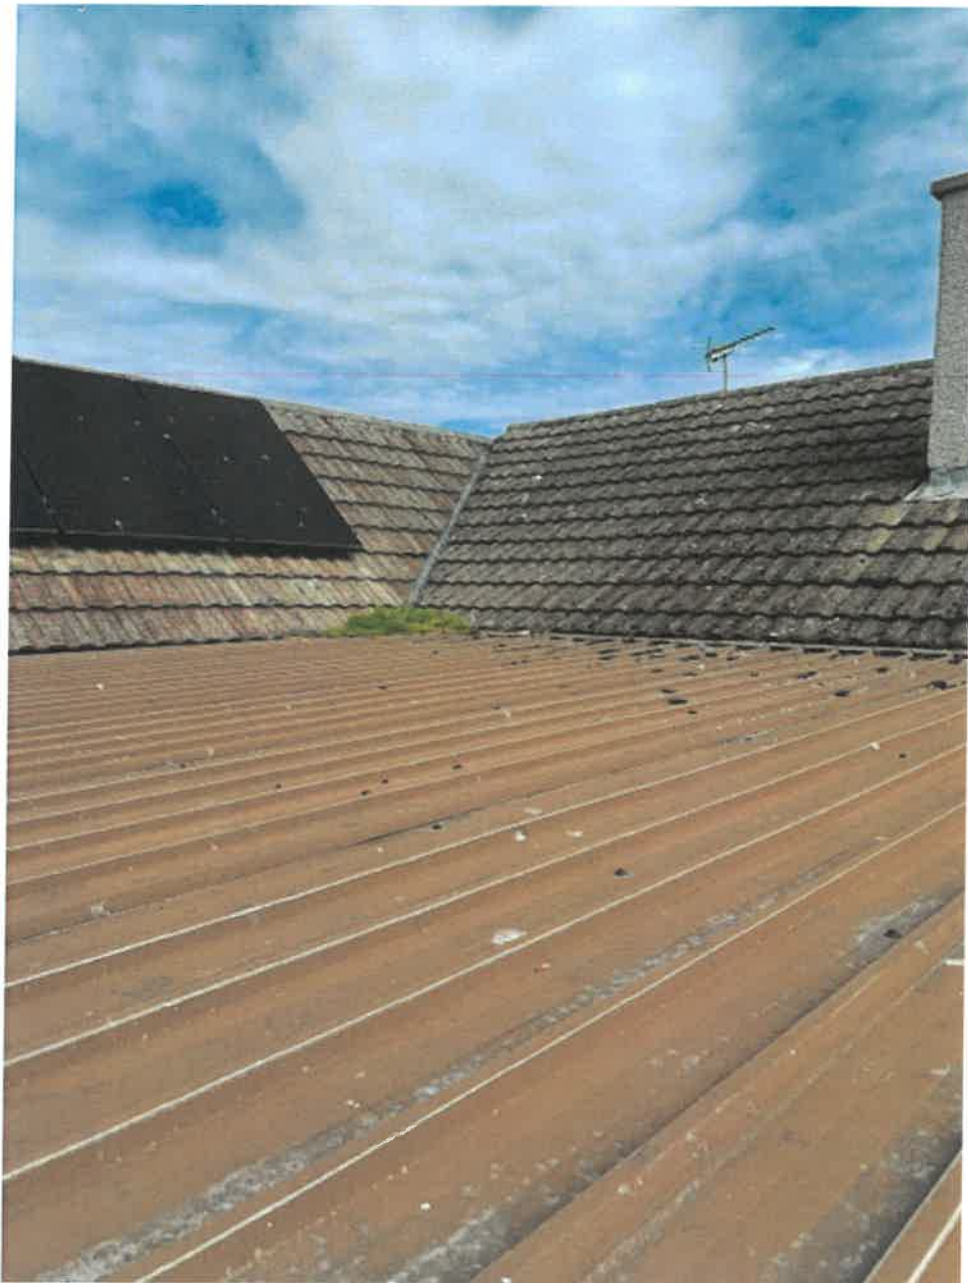
Vegetation Build up.

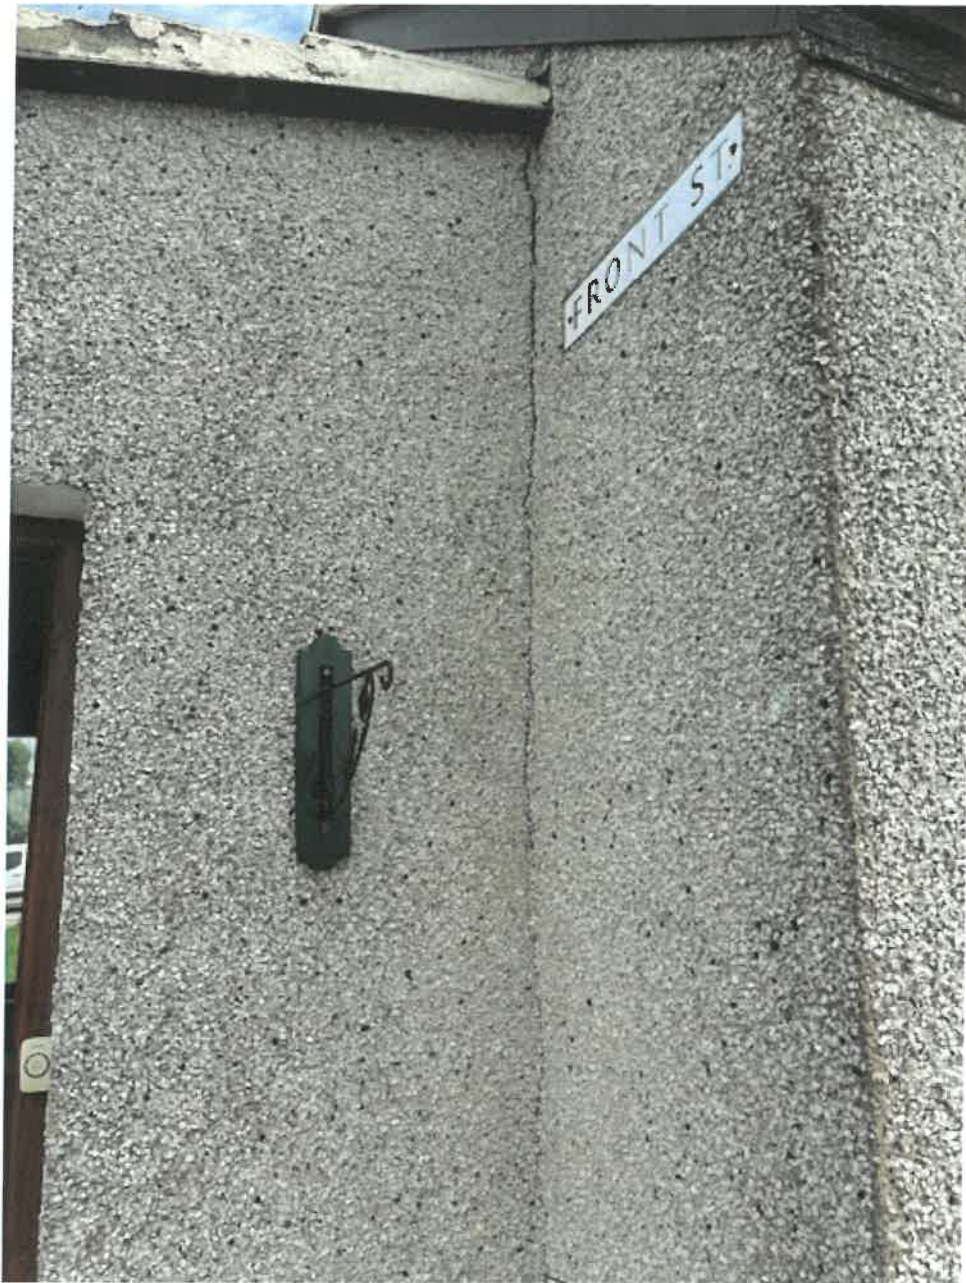
MOVEMENT CRACKS ①

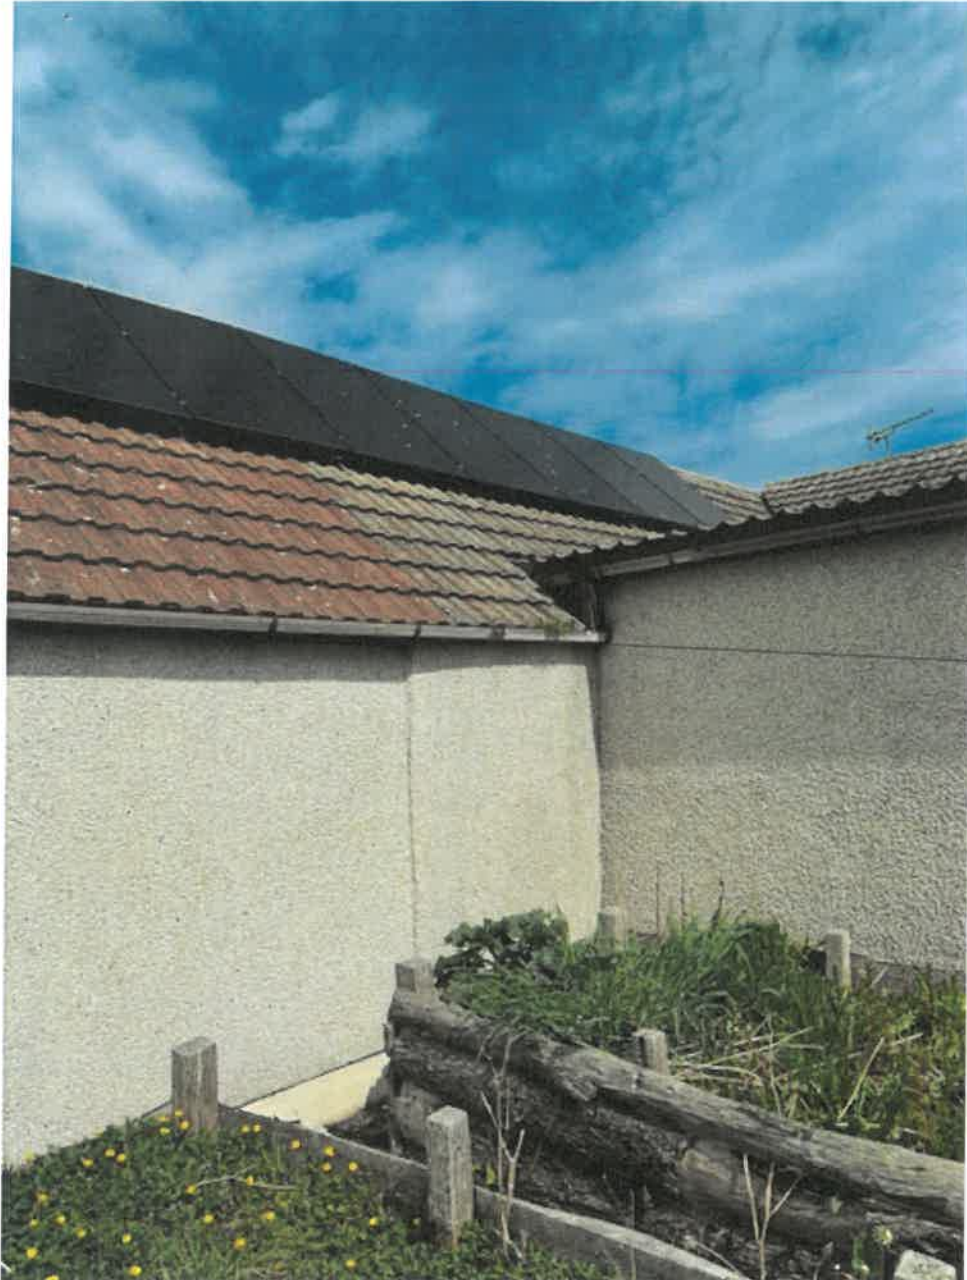
rainwater  
Poorly fitted, lack of  
brackets etc

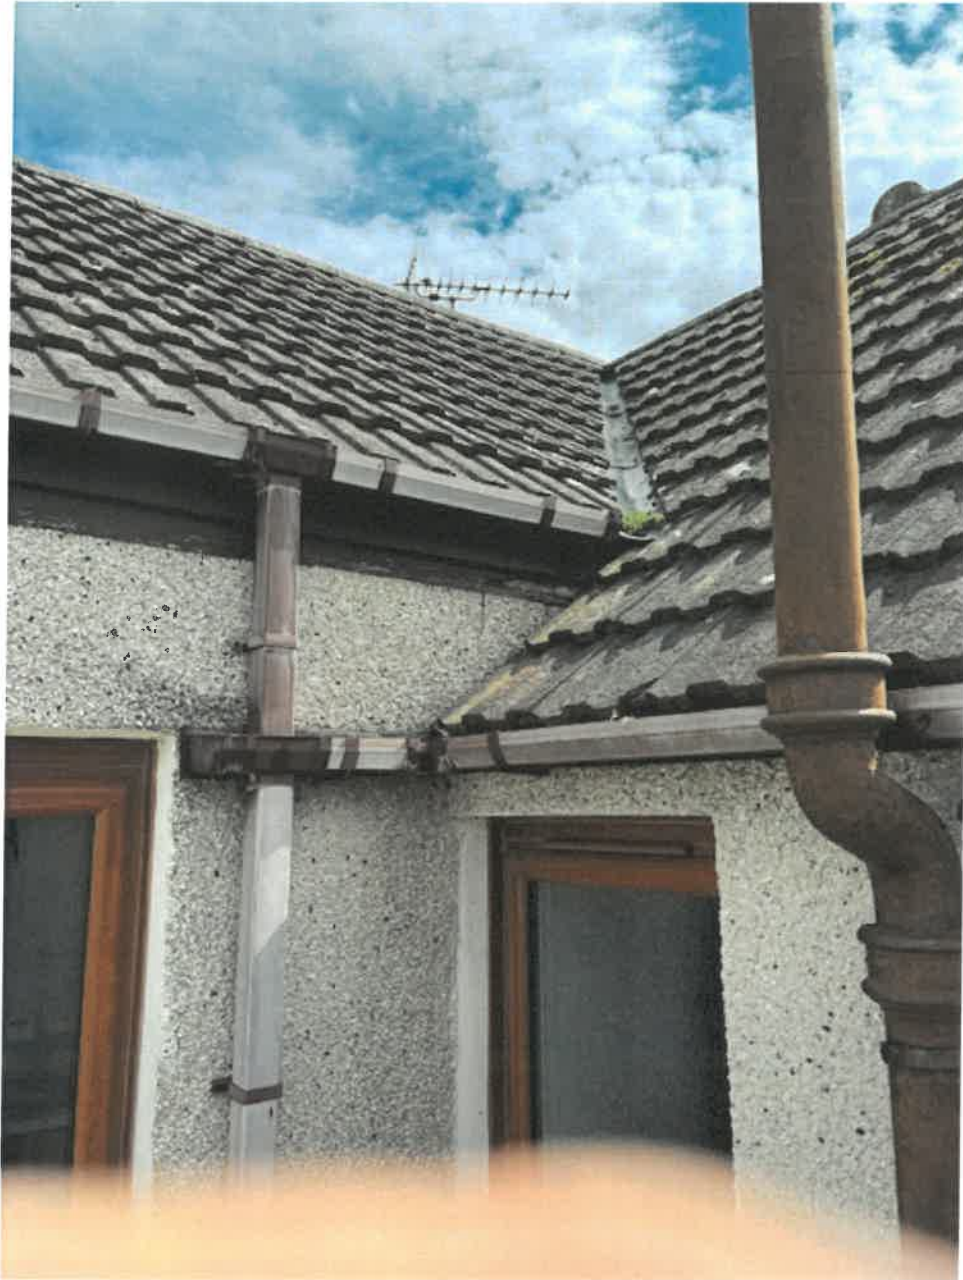
② Rainwater  
poor condition

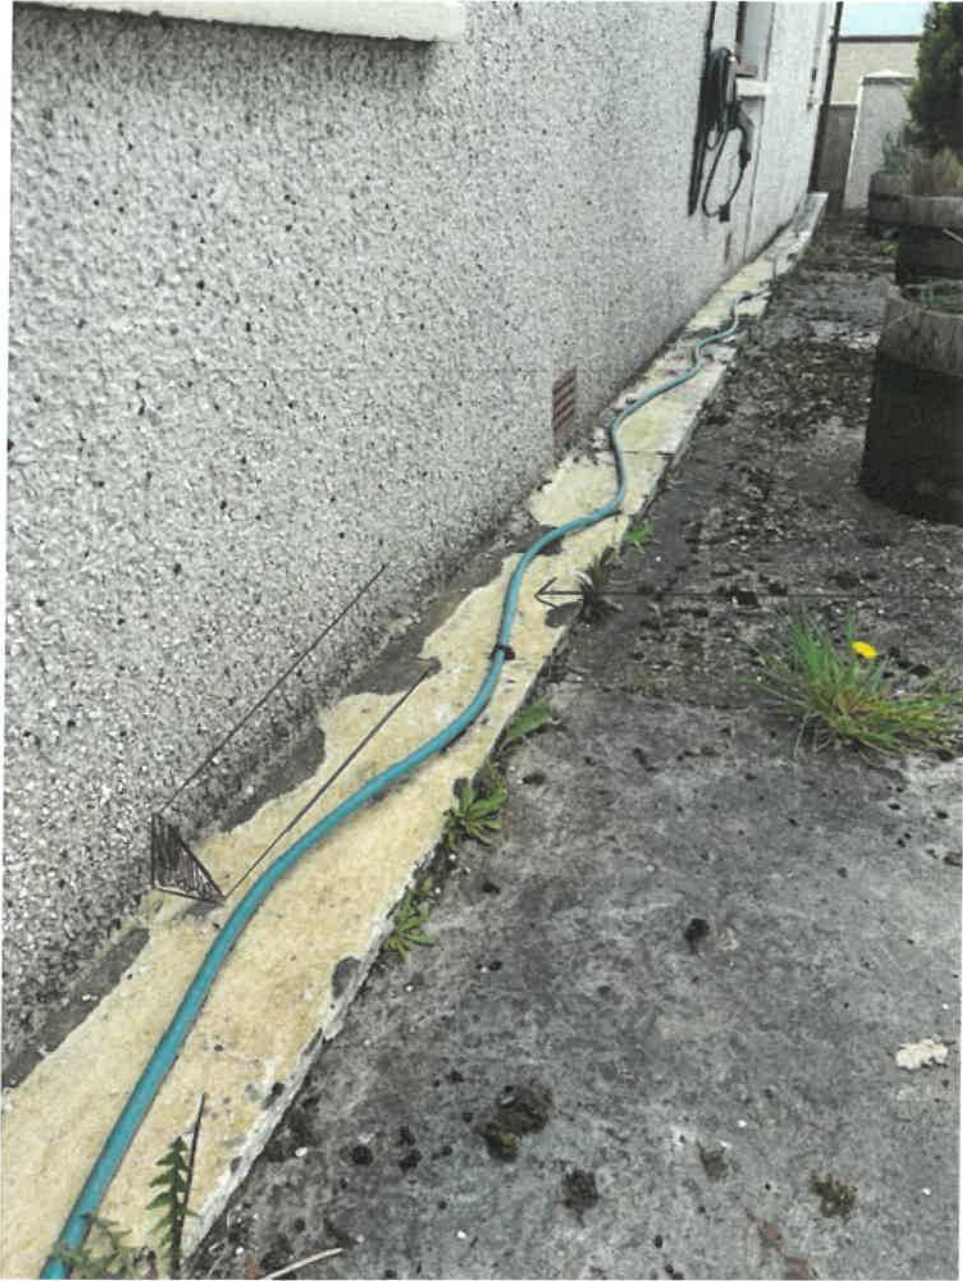
Concrete  
Plinth

ADD CEMENT FILLER  
TO IMPROVE WATER  
AWAY FROM BUILDING

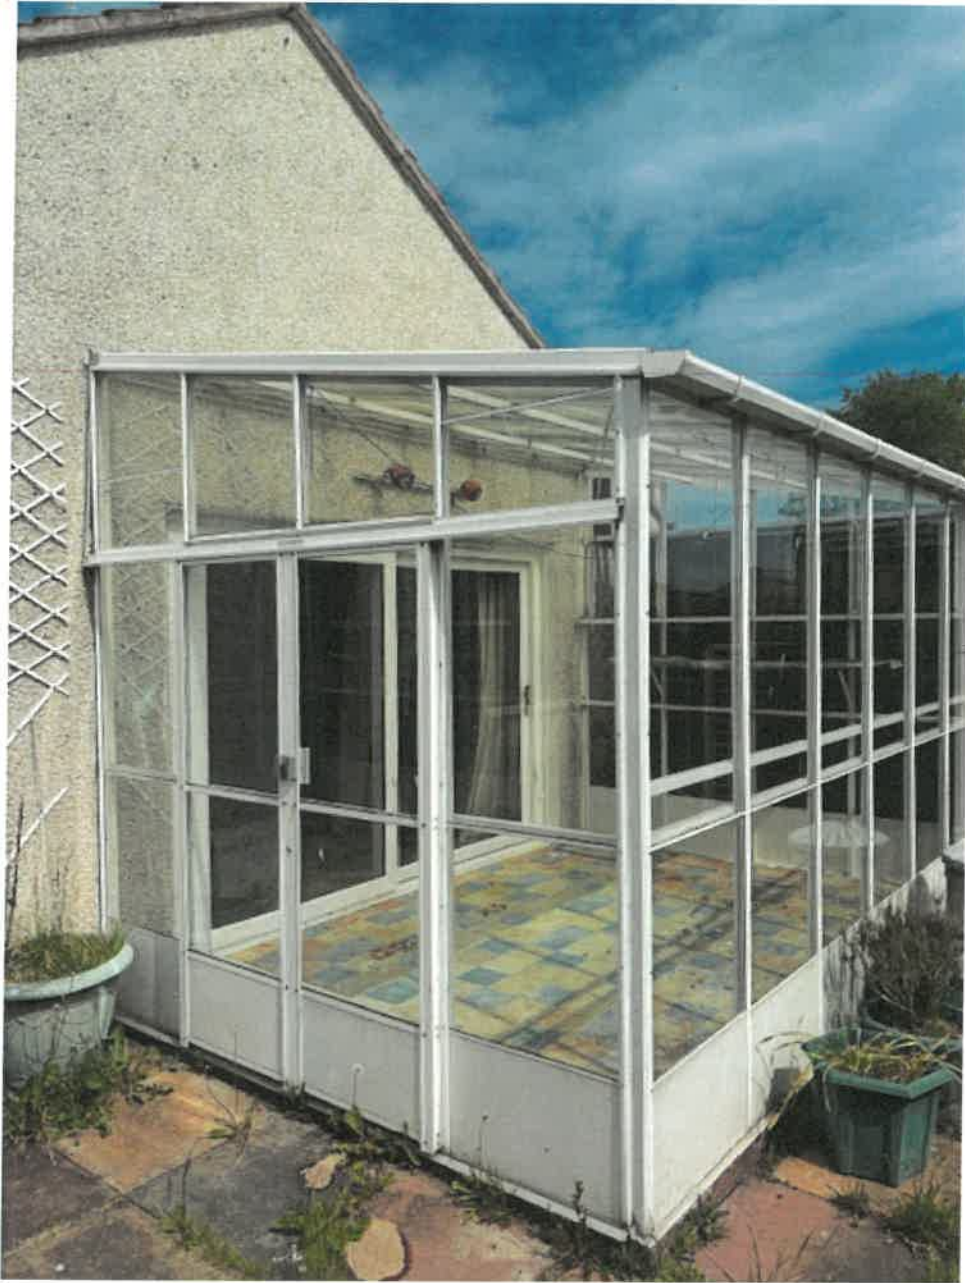
NO COMMENT  
NOT Affecting  
The Building

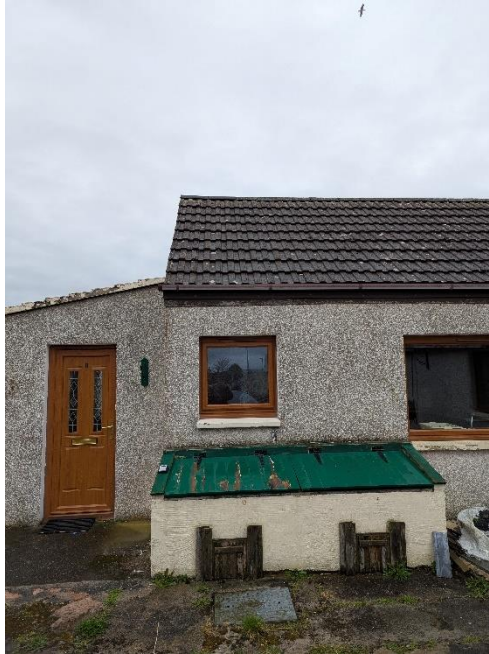
Photograph 1 – Cracking to window adjacent to front door

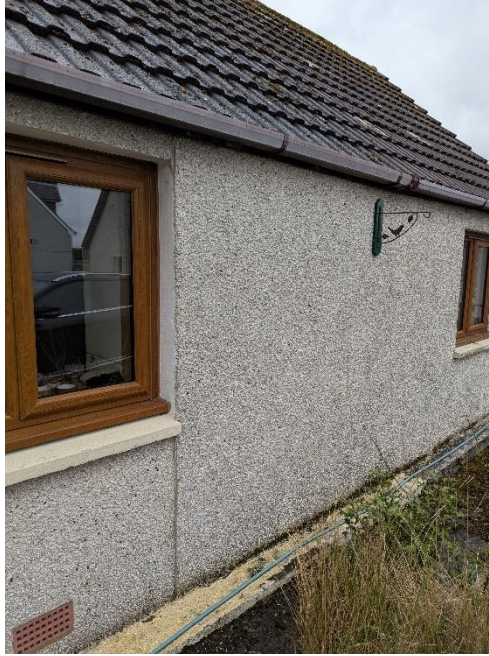
Photograph 3 – Joint in render at front elevation

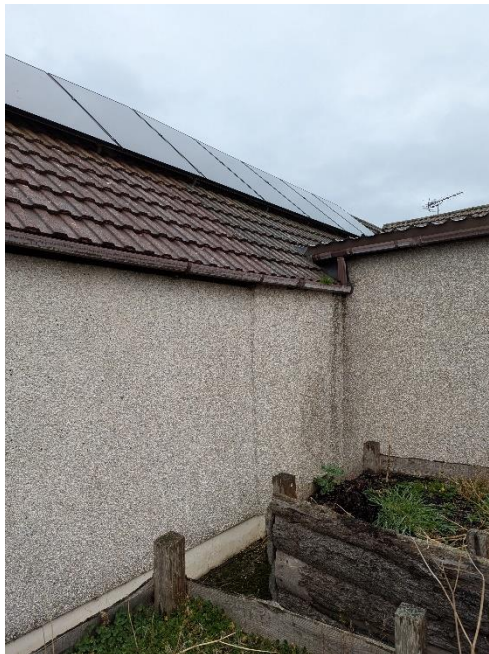
Photograph 4 – Joint in render at rear elevation

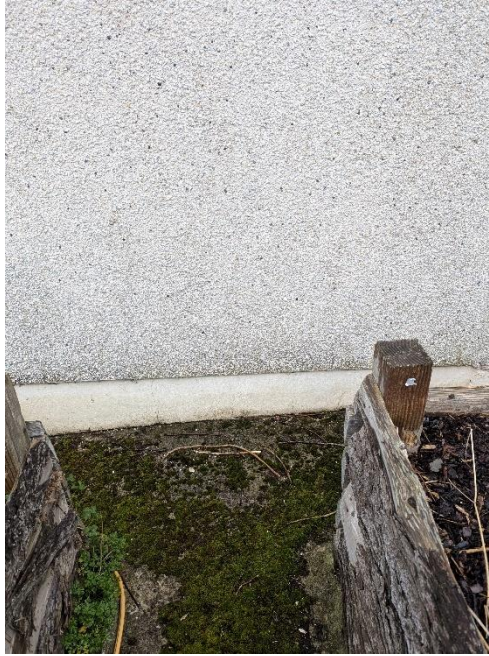
Photograph 5 – Hairline cracks to underbuild skim coat at rear elevation (3.9)

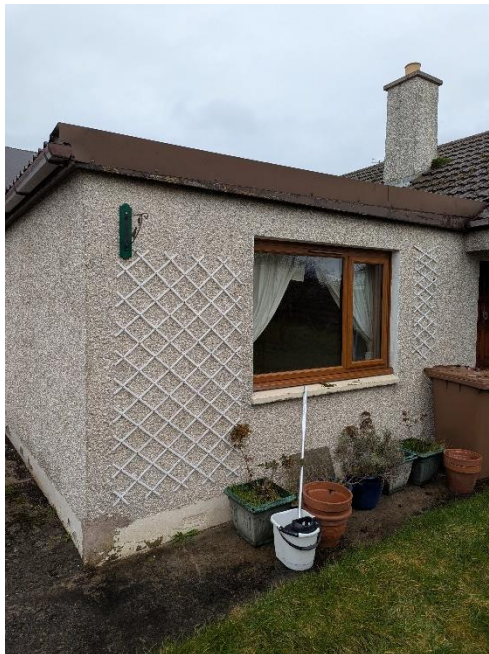
Photograph 6 – Hairline cracks to underbuild skim coat at rear elevation (3.12)

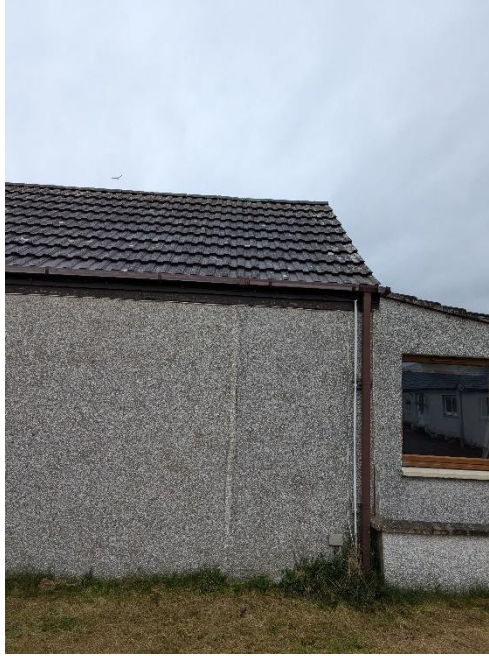
Photograph 7 – Cracking to elevation adjacent to neighbouring property

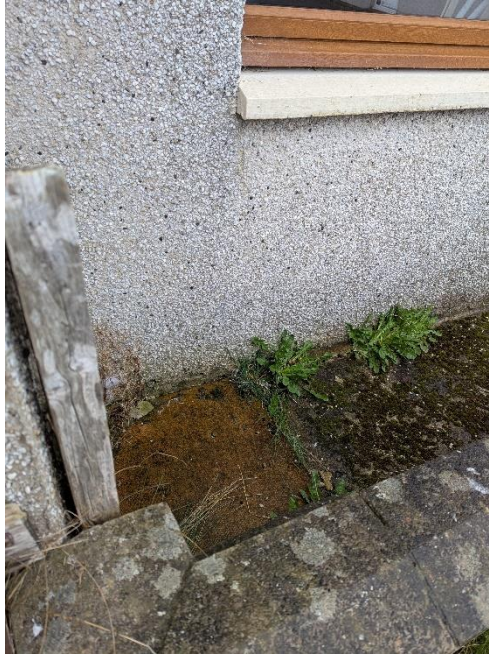
Photograph 9 – Concrete slab 1m north of external crack

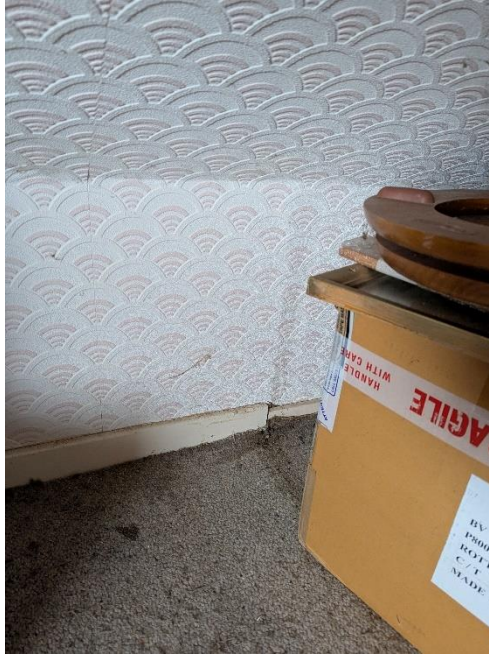
Photograph 11 – Small indentation at loft space

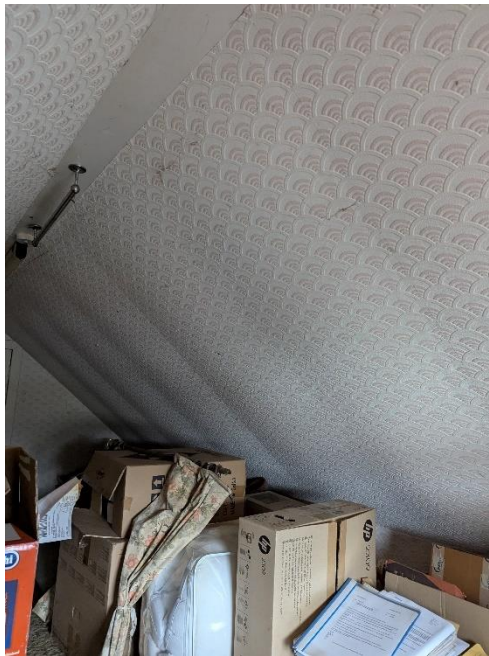
Photograph 12 – Sagging between rafters in loft

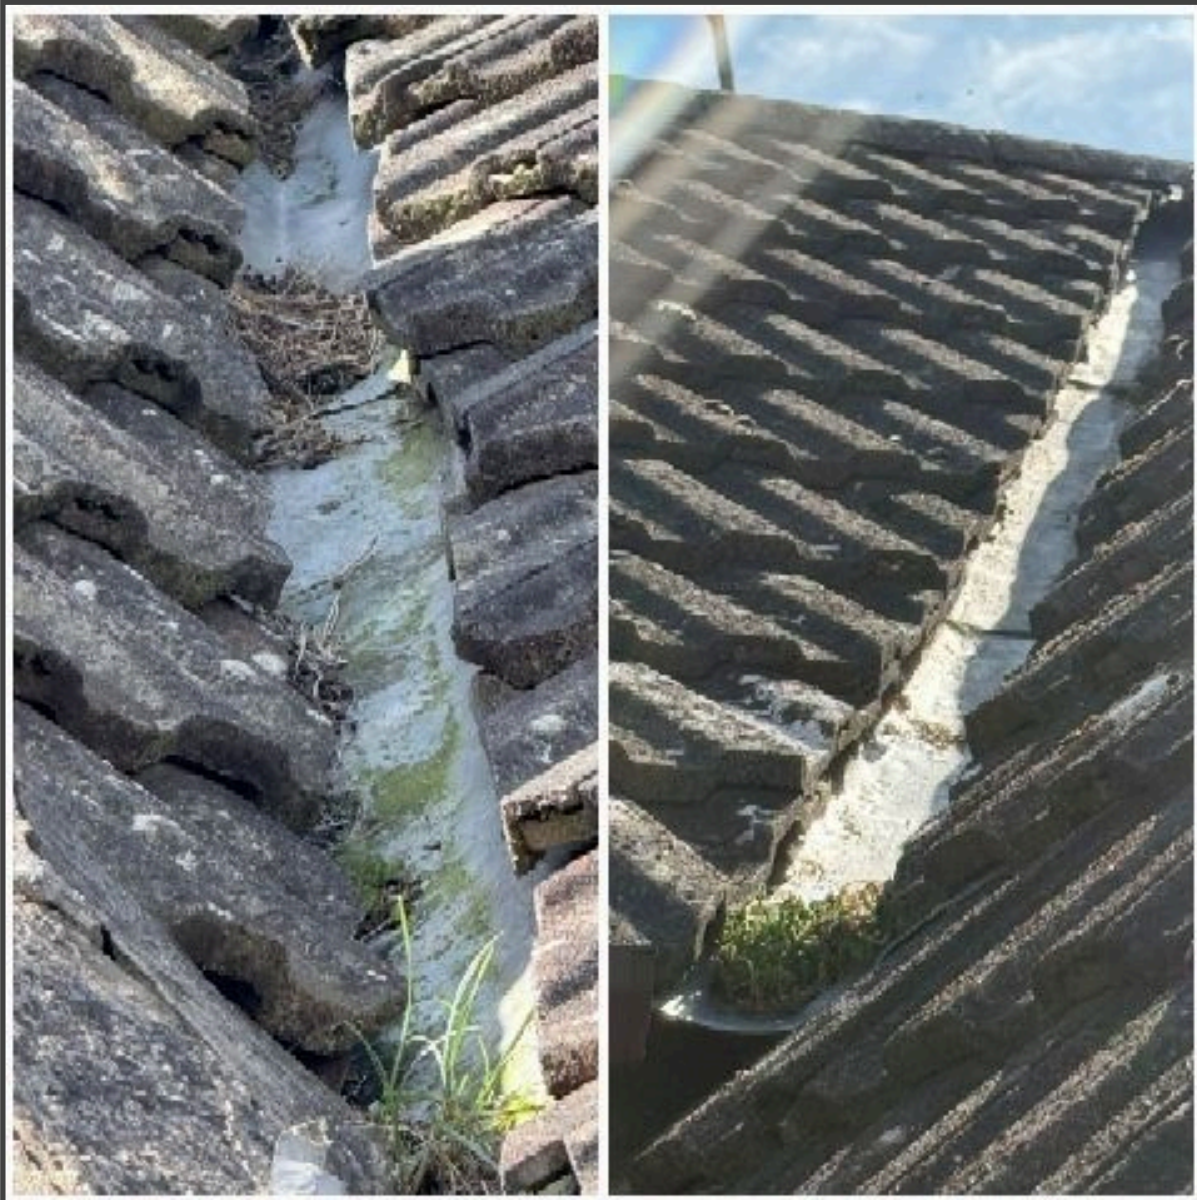
- Defective roof coverings

Defective roof coverings were noted to the left and right elevation which may allow for moisture penetration.

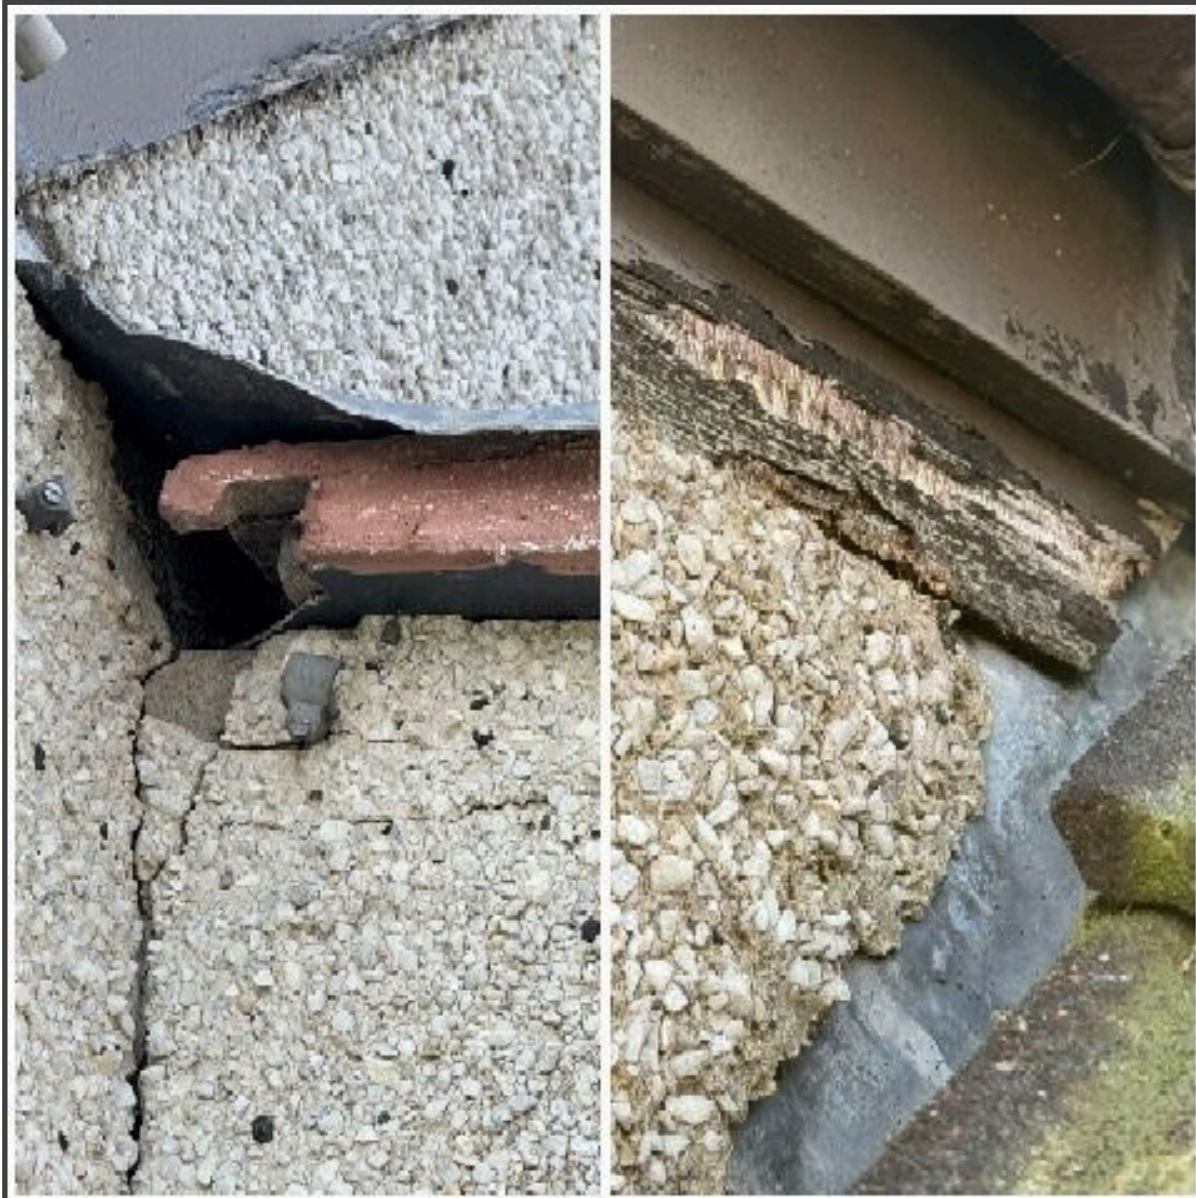
- **Cracked and broken external rendering**

Cracked and/or broken render was noted to the left and right elevation which may allow for moisture penetration.

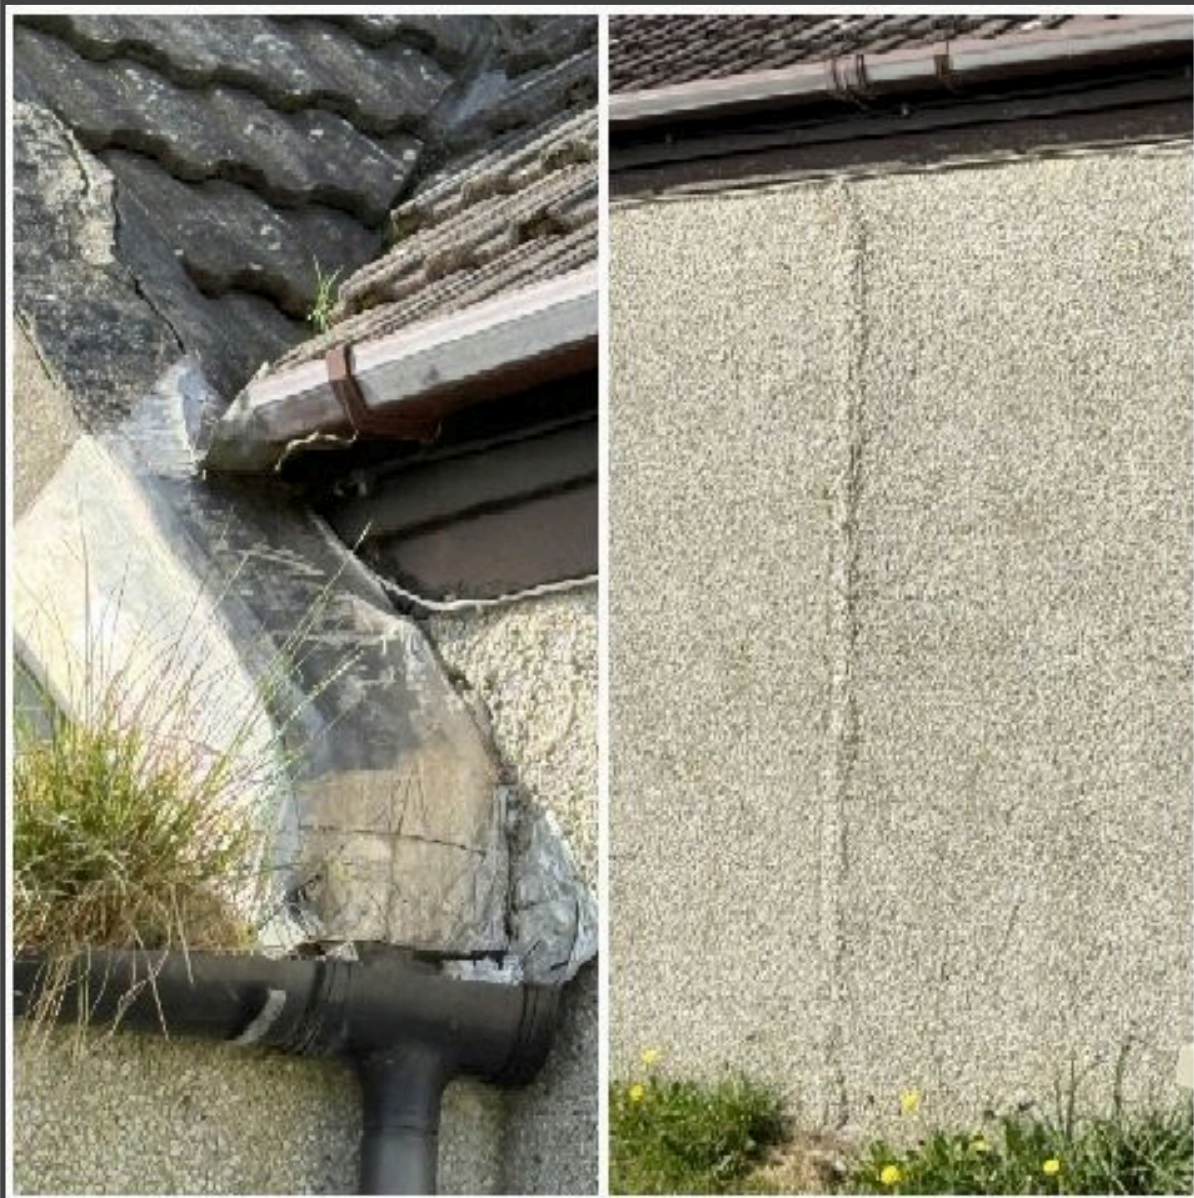
- Other defects

- Previous repairs appear to be apparent to the render and the roof coverings which may have previously allowed for moisture penetration.

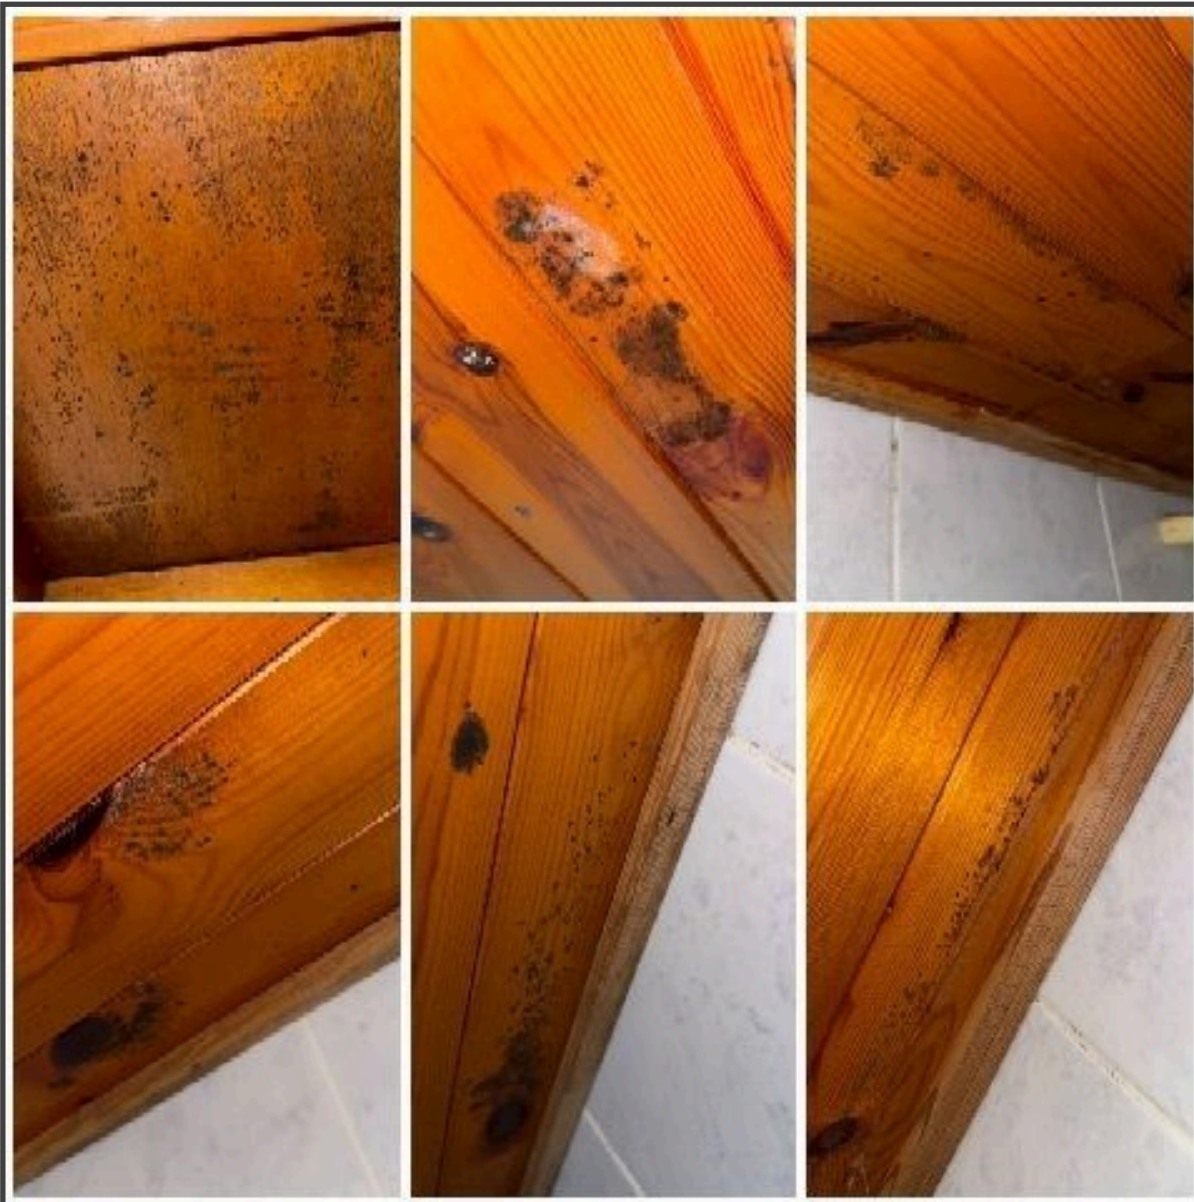
Evidence of mould was located on the ceiling surfaces within the WC. Due to the property being vacant with no appropriate ventilation or heating being carried out at this time, this is to be expected. It is suspected once the property is no longer vacant and appropriate heating and ventilation is being utilised throughout the property, these issues may subside.

However, if these issues continue to persist, it would be recommended for the ventilation sources throughout the property to be upgraded to a built in humidistat extractor fan (cyfans) which will automatically turn on or adjust their speed based on the humidity levels, therefore reducing the risk of condensation and mould developing.
