24043 – Pier House, Harbour Road, Brora

STRUCTURAL INSPECTION REPORT

**FLEMING ENGINEERING LIMITED
BLACK ISLE BUSINESS CENTRE
85 HIGH STREET
FORTROSE
IV10 8TX**

JUNE 2024

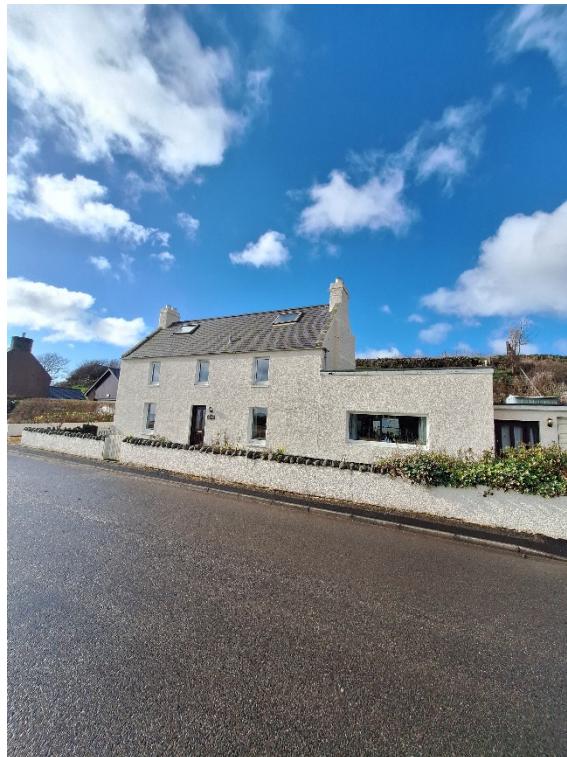
Photograph 1 – North Elevation

3.2 This elevation fronts onto Harbour Road and has roughcast render finish. There are 2No. entrance doors, 1No. garage door and 6No. windows on this elevation, with 2No. roof windows.

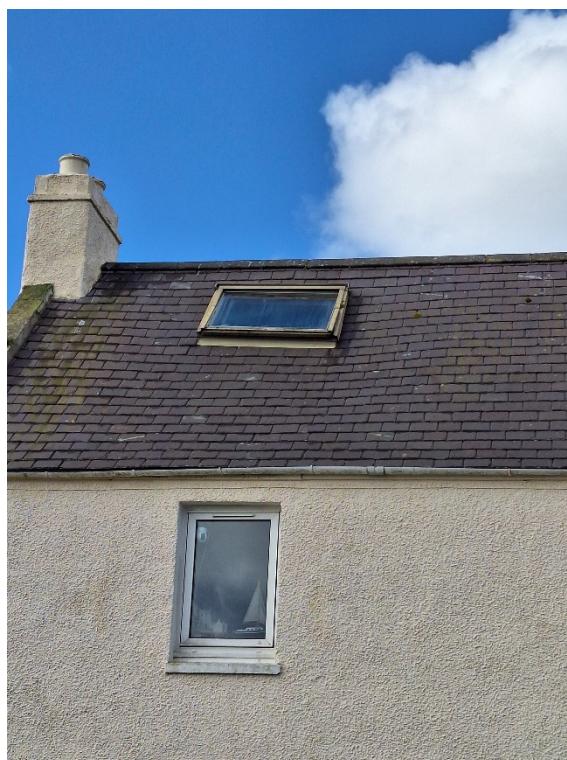
3.3 Sagging in the roof was visible to the roof structure around the roof lights. The roof light on the left-hand side appeared to be sagging further.

4.3 Sagging to the roof structure was observed around the roof light windows. It was noted that there had been no strengthening to the rafters either side of the roof lights.

- 5.1 The main purpose of the inspection and report was to provide guidance regarding the condition of the existing attic roof structure at the existing roof lights.
- 5.2 The sagging to the roof structure in particular to the roof light supports is of concern and should be addressed.

Photograph 2 – Sagging to the roof around the rooflights

As for remedial works, we would recommend installing additional steel strengthening to the existing rafters either side of the roof lights to stabilise the roof. We would also recommend doubling up the existing roof rafters and install new ceiling ties. Please refer to the attached drawing SK01 & SK02 for a description of the works and typical construction details.

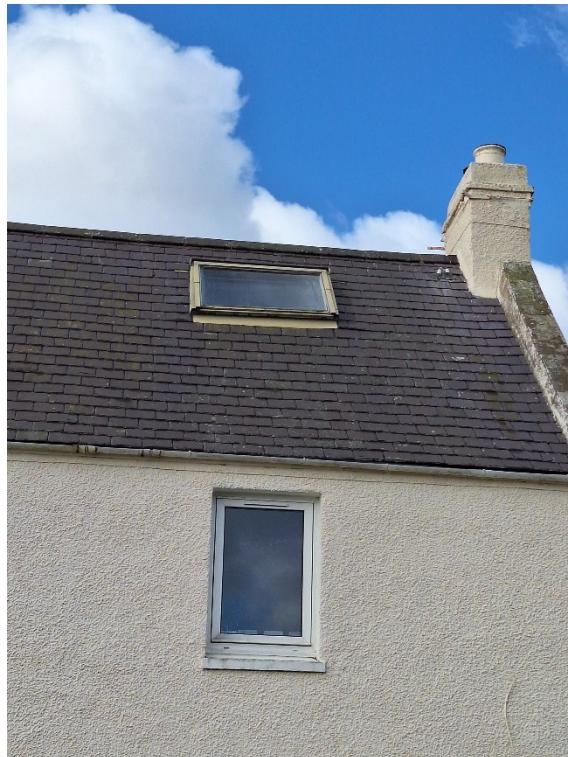
Photograph 2 – Sagging to the roof around the rooflights

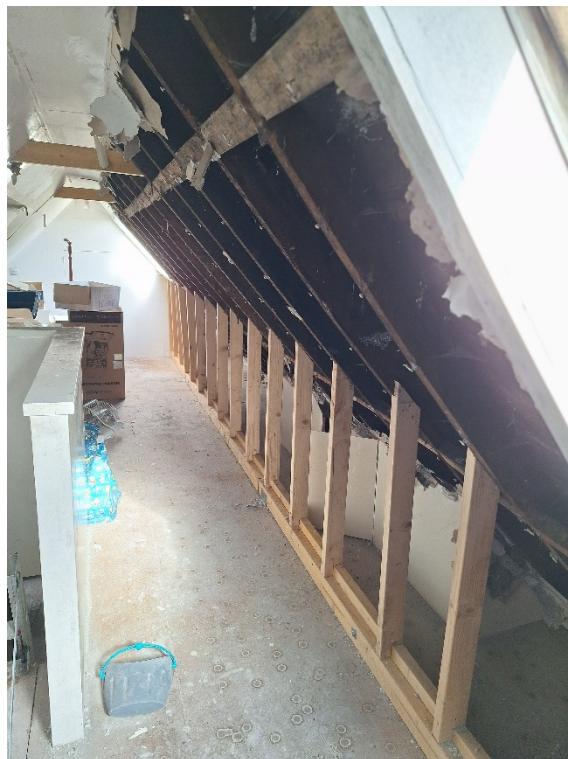
4.2 On entering the attic space, some of the finishes had been removed and a temporary timber support has been constructed between the underside of the rafters and floor joists.

Photograph 4 – Existing attic space with temporary roof propping

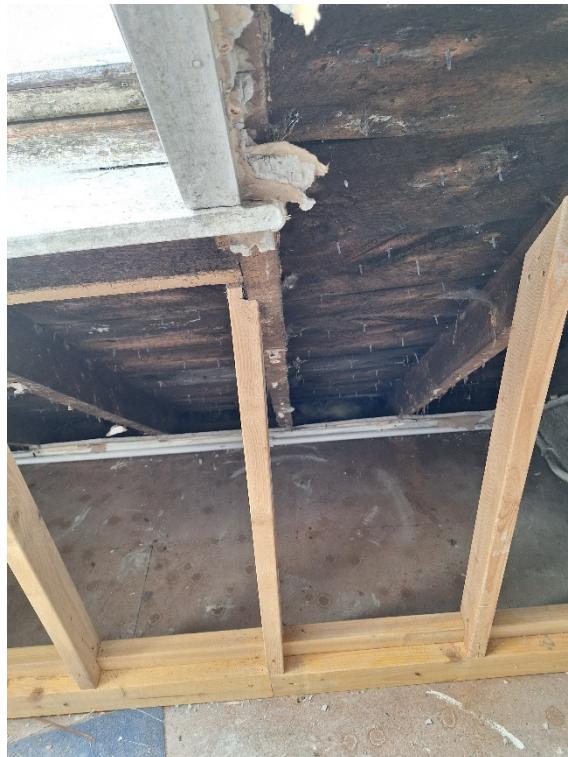
Photograph 5 – Roof light trimmers

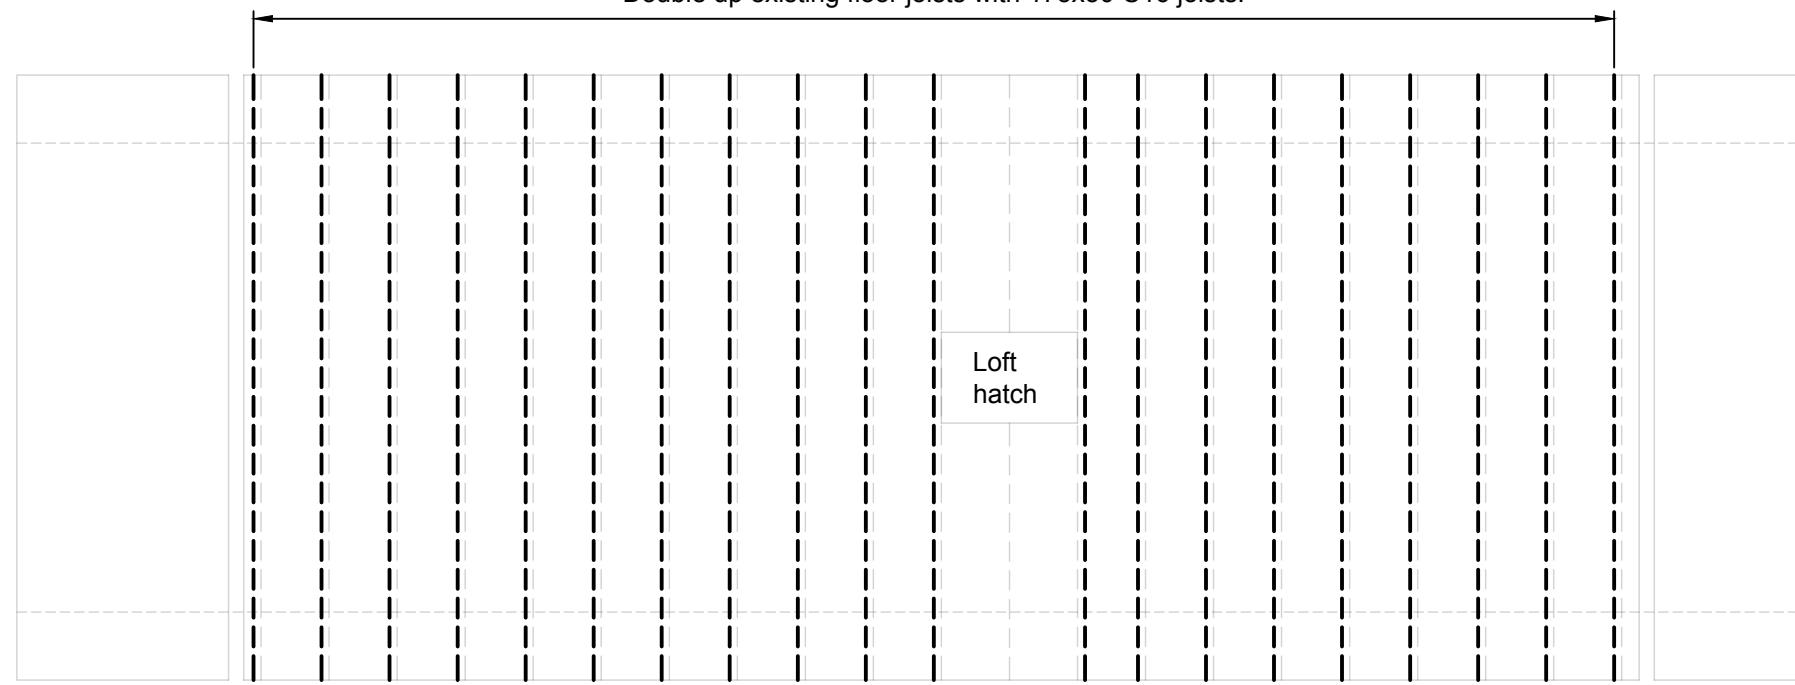
ATTIC FLOOR LAYOUT

4.4 Where floorboards had been partially removed, some of the attic floor joists appeared to have loss of section towards the joist ends.

- 5.3 The loss of section to the existing attic floor joists is of concern, we would therefore recommend doubling up the existing floor joists. Please refer to the attached drawing SK01 for a description of the works.
