Home Report

24 Whytehouse Avenue
Kirkcaldy KY1 1UW

Single Survey

Property Address	24 Whytehouse Avenue Kirkcaldy KY1 1UW
Customer	Irene Keppie & Lynn Ward
Prepared by	Graham + Sibbald Property Consultants Limited
Date of Inspection	25/03/2026

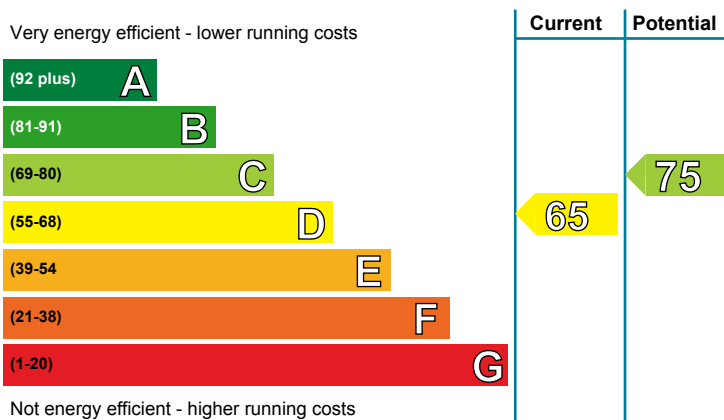
Energy Efficiency Rating

Your current rating is **band D (65)**. The average rating for EPCs in Scotland is **band D (61)**.
