Asbestos Survey Report 16/07/2025

Management Asbestos Survey For Xenia Estates Ltd

J317876

Rede House
Corporation Road
Middlesbrough
TS1 1LY

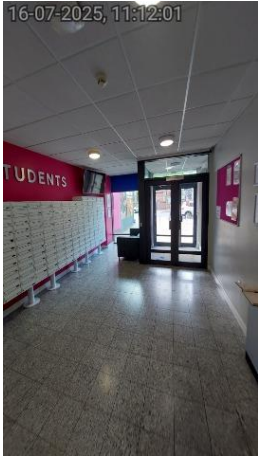
Material Assessment Ref	S001 –	
Building	Main	
Floor	Ground	
Room	Reception	
Position	Ceiling, Walls & Floor	
Component	Ceiling, Walls & Floor	
Accessibility	N/A	
Lab	In-House Database	
Next Inspection	No further action required	
Material Risk	0 (VL)	
Priority Risk	N/A	
Quantity	Num	
Survey Type	Management	
Action	No further action required	
Product Type	Not Selected	
Asbestos Type	Non suspect material	
Surface Treatment	Not Selected	
Condition	Not Selected	
Recommendations	No further action required	
Comments	Stone tiles on concrete, plaster walls, non-asbestos ceiling tiles, metal mail boxes, metal door and window surrounds.

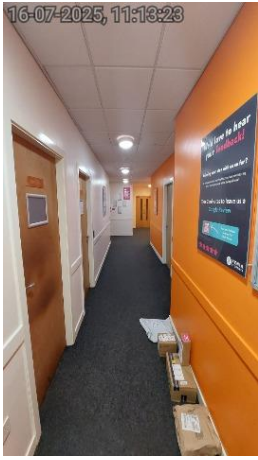
Material Assessment Ref	S002 –	
Building	Main	
Floor	Ground	
Room	Hallway 1	
Position	Ceiling, Walls & Floor	
Component	Ceiling, Walls & Floor	
Accessibility	N/A	
Lab	In-House Database	
Next Inspection	No further action required	
Material Risk	0 (VL)	
Priority Risk	N/A	
Quantity	Num	
Survey Type	Management	
Action	No further action required	
Product Type	Not Selected	
Asbestos Type	Non suspect material	
Surface Treatment	Not Selected	
Condition	Not Selected	
Recommendations	No further action required	
Comments	Carpet on concrete, plaster walls, non-asbestos ceiling tiles.

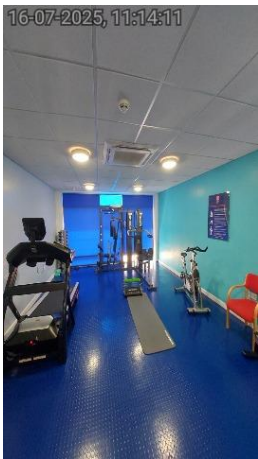
Material Assessment Ref	S003 –	
Building	Main	
Floor	Ground	
Room	Gymnasium	
Position	Ceiling, Walls & Floor	
Component	Ceiling, Walls & Floor	
Accessibility	N/A	
Lab	In-House Database	
Next Inspection	No further action required	
Material Risk	0 (VL)	
Priority Risk	N/A	
Quantity	Num	
Survey Type	Management	
Action	No further action required	
Product Type	Not Selected	
Asbestos Type	Non suspect material	
Surface Treatment	Not Selected	
Condition	Not Selected	
Recommendations	No further action required	
Comments	Rubber tiles on concrete, plaster walls, non-asbestos ceiling tiles.

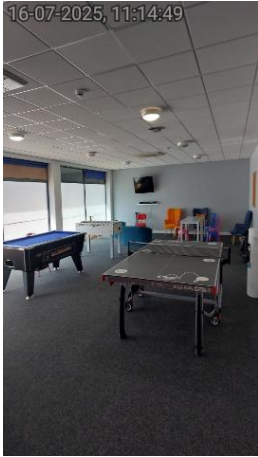
Material Assessment Ref	S004 –	
Building	Main	
Floor	Ground	
Room	Games Room	
Position	Ceiling, Walls & Floor	
Component	Ceiling, Walls & Floor	
Accessibility	N/A	
Lab	In-House Database	
Next Inspection	No further action required	
Material Risk	0 (VL)	
Priority Risk	N/A	
Quantity	Num	
Survey Type	Management	
Action	No further action required	
Product Type	Not Selected	
Asbestos Type	Non suspect material	
Surface Treatment	Not Selected	
Condition	Not Selected	
Recommendations	No further action required	
Comments	Carpet on concrete, plaster walls, non-asbestos ceiling tiles.

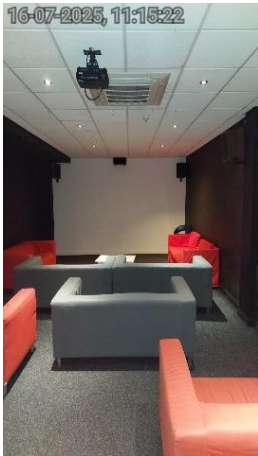
Material Assessment Ref	S005 –	
Building	Main	
Floor	Ground	
Room	Study	
Position	Ceiling, Walls & Floor	
Component	Ceiling, Walls & Floor	
Accessibility	N/A	
Lab	In-House Database	
Next Inspection	No further action required	
Material Risk	0 (VL)	
Priority Risk	N/A	
Quantity	Num	
Survey Type	Management	
Action	No further action required	
Product Type	Not Selected	
Asbestos Type	Non suspect material	
Surface Treatment	Not Selected	
Condition	Not Selected	
Recommendations	No further action required	
Comments	Carpet on concrete, plaster walls, non-asbestos ceiling tiles.

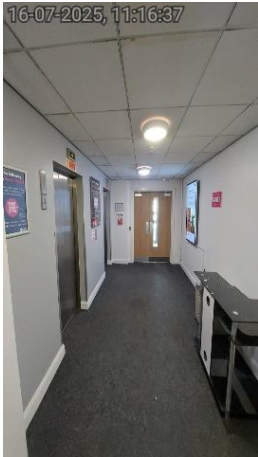
Material Assessment Ref	S006 –	
Building	Main	
Floor	Ground	
Room	Lift Lobby	
Position	Ceiling, Walls & Floor	
Component	Ceiling, Walls & Floor	
Accessibility	N/A	
Lab	In-House Database	
Next Inspection	No further action required	
Material Risk	0 (VL)	
Priority Risk	N/A	
Quantity	Num	
Survey Type	Management	
Action	No further action required	
Product Type	Not Selected	
Asbestos Type	Non suspect material	
Surface Treatment	Not Selected	
Condition	Not Selected	
Recommendations	No further action required	
Comments	Carpet on concrete, plaster walls, non-asbestos ceiling tiles, metal lift doors.

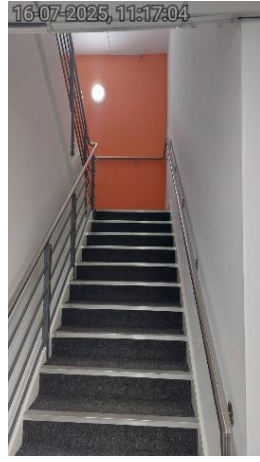
Material Assessment Ref	S007 –	
Building	Main	
Floor	Ground/First	
Room	Landing & Stairs	
Position	Ceiling, Walls & Floor	
Component	Ceiling, Walls & Floor	
Accessibility	N/A	
Lab	In-House Database	
Next Inspection	No further action required	
Material Risk	0 (VL)	
Priority Risk	N/A	
Quantity	Num	
Survey Type	Management	
Action	No further action required	
Product Type	Not Selected	
Asbestos Type	Non suspect material	
Surface Treatment	Not Selected	
Condition	Not Selected	
Recommendations	No further action required	
Comments	Carpet on concrete, plaster walls, concrete ceiling, metal hand rail, rubber stair treads.

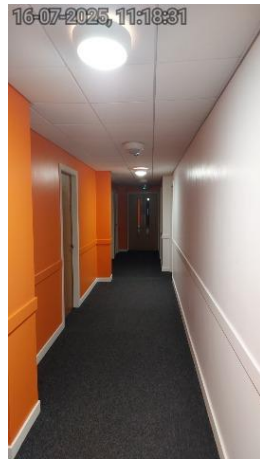
Material Assessment Ref	S009 –	
Building	Main	
Floor	First	
Room	Hallway 2	
Position	Ceiling, Walls & Floor	
Component	Ceiling, Walls & Floor	
Accessibility	N/A	
Lab	In-House Database	
Next Inspection	No further action required	
Material Risk	0 (VL)	
Priority Risk	N/A	
Quantity	Num	
Survey Type	Management	
Action	No further action required	
Product Type	Not Selected	
Asbestos Type	Non suspect material	
Surface Treatment	Not Selected	
Condition	Not Selected	
Recommendations	No further action required	
Comments	Carpet on concrete, plaster walls, non-asbestos ceiling tiles.

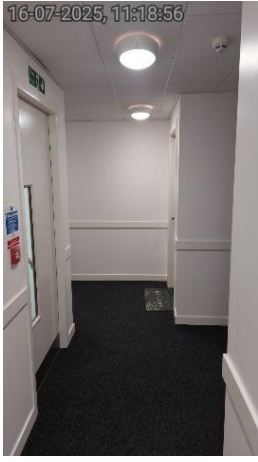
Material Assessment Ref	S010 –	
Building	Main	
Floor	First	
Room	Hallway 3	
Position	Ceiling, Walls & Floor	
Component	Ceiling, Walls & Floor	
Accessibility	N/A	
Lab	In-House Database	
Next Inspection	No further action required	
Material Risk	0 (VL)	
Priority Risk	N/A	
Quantity	Num	
Survey Type	Management	
Action	No further action required	
Product Type	Not Selected	
Asbestos Type	Non suspect material	
Surface Treatment	Not Selected	
Condition	Not Selected	
Recommendations	No further action required	
Comments	Carpet on concrete, plaster walls, non-asbestos ceiling tiles.

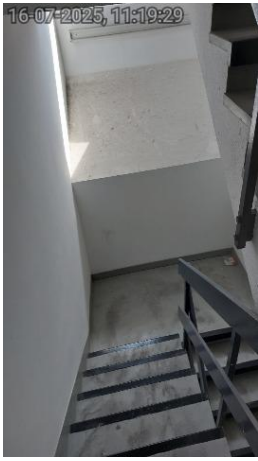
Material Assessment Ref	S011 –	
Building	Main	
Floor	Ground/First	
Room	Landing & Stairs	
Position	Ceiling, Walls & Floor	
Component	Ceiling, Walls & Floor	
Accessibility	N/A	
Lab	In-House Database	
Next Inspection	No further action required	
Material Risk	0 (VL)	
Priority Risk	N/A	
Quantity	Num	
Survey Type	Management	
Action	No further action required	
Product Type	Not Selected	
Asbestos Type	Non suspect material	
Surface Treatment	Not Selected	
Condition	Not Selected	
Recommendations	No further action required	
Comments	Concrete, plaster walls, concrete ceiling, timber hand rail.

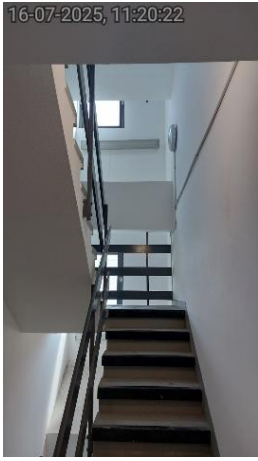
Material Assessment Ref	S012 –	
Building	Main	
Floor	First/Second	
Room	Landing & Stairs	
Position	Ceiling, Walls & Floor	
Component	Ceiling, Walls & Floor	
Accessibility	N/A	
Lab	In-House Database	
Next Inspection	No further action required	
Material Risk	0 (VL)	
Priority Risk	N/A	
Quantity	Num	
Survey Type	Management	
Action	No further action required	
Product Type	Not Selected	
Asbestos Type	Non suspect material	
Surface Treatment	Not Selected	
Condition	Not Selected	
Recommendations	No further action required	
Comments	Concrete, plaster walls, concrete ceiling, timber hand rail.

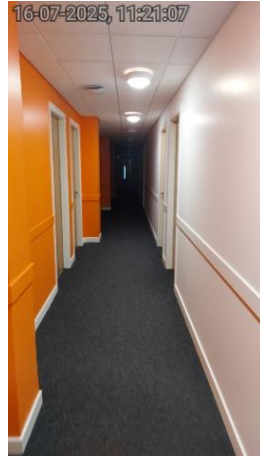
Material Assessment Ref	S013 –	
Building	Main	
Floor	First	
Room	Hallway 4	
Position	Ceiling, Walls & Floor	
Component	Ceiling, Walls & Floor	
Accessibility	N/A	
Lab	In-House Database	
Next Inspection	No further action required	
Material Risk	0 (VL)	
Priority Risk	N/A	
Quantity	Num	
Survey Type	Management	
Action	No further action required	
Product Type	Not Selected	
Asbestos Type	Non suspect material	
Surface Treatment	Not Selected	
Condition	Not Selected	
Recommendations	No further action required	
Comments	Carpet on concrete, plaster walls, non-asbestos ceiling tiles.

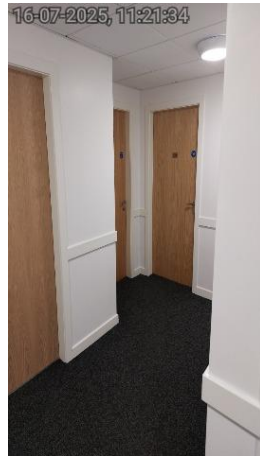
Material Assessment Ref	S014 –	
Building	Main	
Floor	First	
Room	Hallway 5	
Position	Ceiling, Walls & Floor	
Component	Ceiling, Walls & Floor	
Accessibility	N/A	
Lab	In-House Database	
Next Inspection	No further action required	
Material Risk	0 (VL)	
Priority Risk	N/A	
Quantity	Num	
Survey Type	Management	
Action	No further action required	
Product Type	Not Selected	
Asbestos Type	Non suspect material	
Surface Treatment	Not Selected	
Condition	Not Selected	
Recommendations	No further action required	
Comments	Carpet on concrete, plaster walls, non-asbestos ceiling tiles.

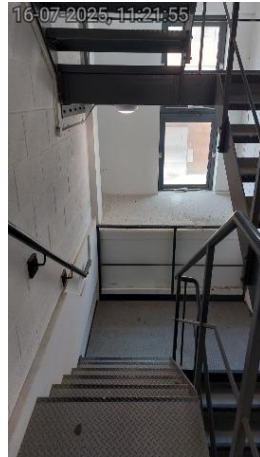
Material Assessment Ref	S015 –	
Building	Main	
Floor	Ground/First	
Room	Landing & Stairs	
Position	Ceiling, Walls & Floor	
Component	Ceiling, Walls & Floor	
Accessibility	N/A	
Lab	In-House Database	
Next Inspection	No further action required	
Material Risk	0 (VL)	
Priority Risk	N/A	
Quantity	Num	
Survey Type	Management	
Action	No further action required	
Product Type	Not Selected	
Asbestos Type	Non suspect material	
Surface Treatment	Not Selected	
Condition	Not Selected	
Recommendations	No further action required	
Comments	Metal stairs, metal floor, brick walls, metal hand rail.

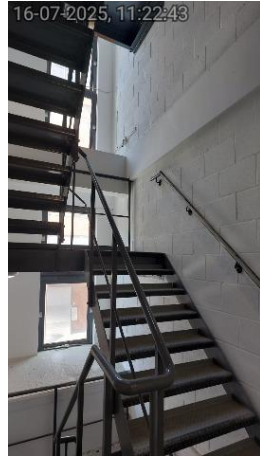
Material Assessment Ref	S016 –	
Building	Main	
Floor	First/Second	
Room	Landing & Stairs	
Position	Ceiling, Walls & Floor	
Component	Ceiling, Walls & Floor	
Accessibility	N/A	
Lab	In-House Database	
Next Inspection	No further action required	
Material Risk	0 (VL)	
Priority Risk	N/A	
Quantity	Num	
Survey Type	Management	
Action	No further action required	
Product Type	Not Selected	
Asbestos Type	Non suspect material	
Surface Treatment	Not Selected	
Condition	Not Selected	
Recommendations	No further action required	
Comments	Metal stairs, metal floor, brick walls, metal hand rail.

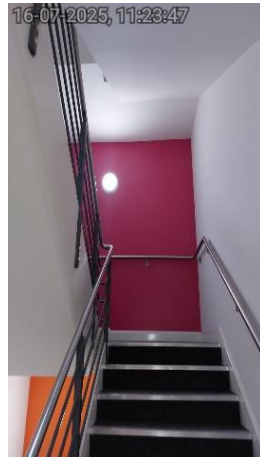
Material Assessment Ref	S017 –	
Building	Main	
Floor	First/Second	
Room	Landing & Stairs	
Position	Ceiling, Walls & Floor	
Component	Ceiling, Walls & Floor	
Accessibility	N/A	
Lab	In-House Database	
Next Inspection	No further action required	
Material Risk	0 (VL)	
Priority Risk	N/A	
Quantity	Num	
Survey Type	Management	
Action	No further action required	
Product Type	Not Selected	
Asbestos Type	Non suspect material	
Surface Treatment	Not Selected	
Condition	Not Selected	
Recommendations	No further action required	
Comments	Carpet on concrete, plaster walls, concrete ceiling, metal hand rail, rubber stair treads.

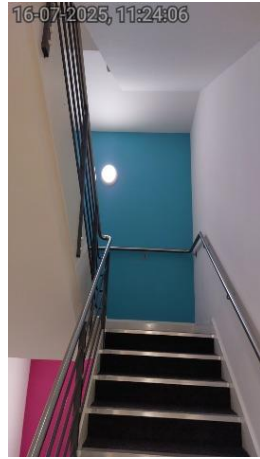
Material Assessment Ref	S018 –	
Building	Main	
Floor	Second/Third	
Room	Landing & Stairs	
Position	Ceiling, Walls & Floor	
Component	Ceiling, Walls & Floor	
Accessibility	N/A	
Lab	In-House Database	
Next Inspection	No further action required	
Material Risk	0 (VL)	
Priority Risk	N/A	
Quantity	Num	
Survey Type	Management	
Action	No further action required	
Product Type	Not Selected	
Asbestos Type	Non suspect material	
Surface Treatment	Not Selected	
Condition	Not Selected	
Recommendations	No further action required	
Comments	Carpet on concrete, plaster walls, concrete ceiling, metal hand rail, rubber stair treads.

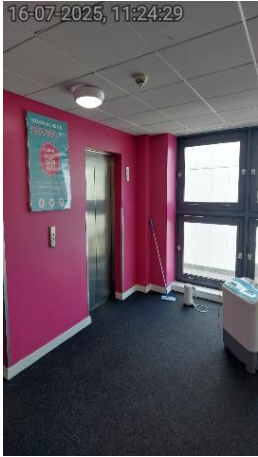
Material Assessment Ref	S019 –	
Building	Main	
Floor	Second	
Room	Lift Lobby	
Position	Ceiling, Walls & Floor	
Component	Ceiling, Walls & Floor	
Accessibility	N/A	
Lab	In-House Database	
Next Inspection	No further action required	
Material Risk	0 (VL)	
Priority Risk	N/A	
Quantity	Num	
Survey Type	Management	
Action	No further action required	
Product Type	Not Selected	
Asbestos Type	Non suspect material	
Surface Treatment	Not Selected	
Condition	Not Selected	
Recommendations	No further action required	
Comments	Carpet on concrete, plaster walls, non-asbestos ceiling tiles, metal lift doors.

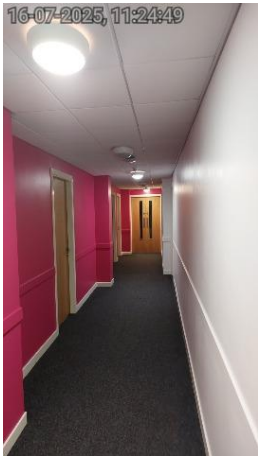
Material Assessment Ref	S020 –	
Building	Main	
Floor	Second	
Room	Hallway 6	
Position	Ceiling, Walls & Floor	
Component	Ceiling, Walls & Floor	
Accessibility	N/A	
Lab	In-House Database	
Next Inspection	No further action required	
Material Risk	0 (VL)	
Priority Risk	N/A	
Quantity	Num	
Survey Type	Management	
Action	No further action required	
Product Type	Not Selected	
Asbestos Type	Non suspect material	
Surface Treatment	Not Selected	
Condition	Not Selected	
Recommendations	No further action required	
Comments	Carpet on concrete, plaster walls, non-asbestos ceiling tiles.

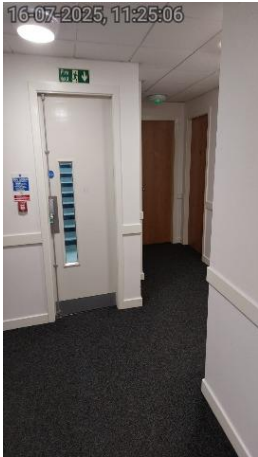
Material Assessment Ref	S021 –	
Building	Main	
Floor	Second	
Room	Hallway 7	
Position	Ceiling, Walls & Floor	
Component	Ceiling, Walls & Floor	
Accessibility	N/A	
Lab	In-House Database	
Next Inspection	No further action required	
Material Risk	0 (VL)	
Priority Risk	N/A	
Quantity	Num	
Survey Type	Management	
Action	No further action required	
Product Type	Not Selected	
Asbestos Type	Non suspect material	
Surface Treatment	Not Selected	
Condition	Not Selected	
Recommendations	No further action required	
Comments	Carpet on concrete, plaster walls, non-asbestos ceiling tiles.

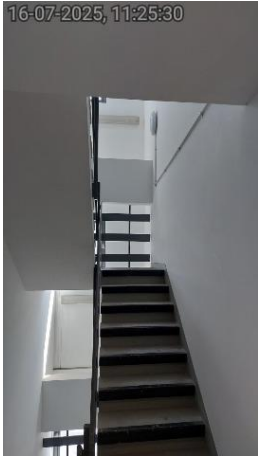
Material Assessment Ref	S022 –	
Building	Main	
Floor	Second/Third	
Room	Landing & Stairs	
Position	Ceiling, Walls & Floor	
Component	Ceiling, Walls & Floor	
Accessibility	N/A	
Lab	In-House Database	
Next Inspection	No further action required	
Material Risk	0 (VL)	
Priority Risk	N/A	
Quantity	Num	
Survey Type	Management	
Action	No further action required	
Product Type	Not Selected	
Asbestos Type	Non suspect material	
Surface Treatment	Not Selected	
Condition	Not Selected	
Recommendations	No further action required	
Comments	Concrete, plaster walls, concrete ceiling, timber hand rail.

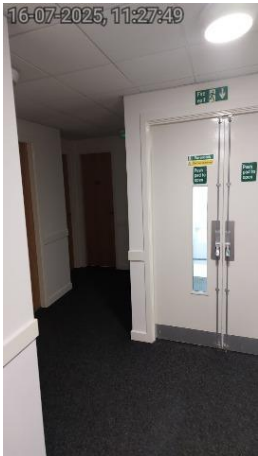
Material Assessment Ref	S023 –	
Building	Main	
Floor	Second	
Room	Hallway 8	
Position	Ceiling, Walls & Floor	
Component	Ceiling, Walls & Floor	
Accessibility	N/A	
Lab	In-House Database	
Next Inspection	No further action required	
Material Risk	0 (VL)	
Priority Risk	N/A	
Quantity	Num	
Survey Type	Management	
Action	No further action required	
Product Type	Not Selected	
Asbestos Type	Non suspect material	
Surface Treatment	Not Selected	
Condition	Not Selected	
Recommendations	No further action required	
Comments	Carpet on concrete, plaster walls, non-asbestos ceiling tiles.

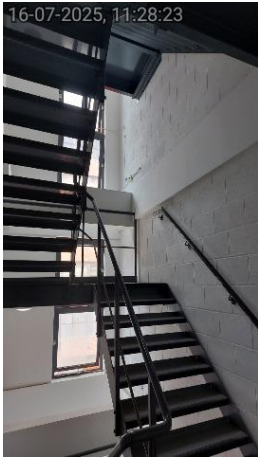
Material Assessment Ref	S024 –	
Building	Main	
Floor	Second/Third	
Room	Landing & Stairs	
Position	Ceiling, Walls & Floor	
Component	Ceiling, Walls & Floor	
Accessibility	N/A	
Lab	In-House Database	
Next Inspection	No further action required	
Material Risk	0 (VL)	
Priority Risk	N/A	
Quantity	Num	
Survey Type	Management	
Action	No further action required	
Product Type	Not Selected	
Asbestos Type	Non suspect material	
Surface Treatment	Not Selected	
Condition	Not Selected	
Recommendations	No further action required	
Comments	Metal stairs, metal floor, brick walls, metal hand rail.

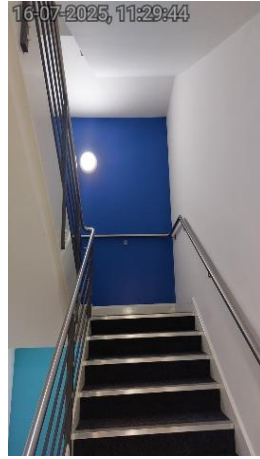
<p>16-07-2025, 11:29:44</p>
Material Assessment Ref	S025 –	
Building	Main	
Floor	Third/Fourth	
Room	Landing & Stairs	
Position	Ceiling, Walls & Floor	
Component	Ceiling, Walls & Floor	
Accessibility	N/A	
Lab	In-House Database	
Next Inspection	No further action required	
Material Risk	0 (VL)	
Priority Risk	N/A	
Quantity	Num	
Survey Type	Management	
Action	No further action required	
Product Type	Not Selected	
Asbestos Type	Non suspect material	
Surface Treatment	Not Selected	
Condition	Not Selected	
Recommendations	No further action required	
Comments	Carpet on concrete, plaster walls, concrete ceiling, metal hand rail, rubber stair treads.

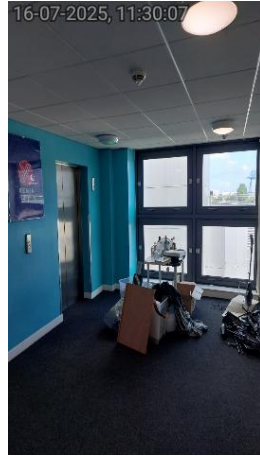
<p>16-07-2025, 11:30:07</p>
Material Assessment Ref	S026 –	
Building	Main	
Floor	Third	
Room	Lift Lobby	
Position	Ceiling, Walls & Floor	
Component	Ceiling, Walls & Floor	
Accessibility	N/A	
Lab	In-House Database	
Next Inspection	No further action required	
Material Risk	0 (VL)	
Priority Risk	N/A	
Quantity	Num	
Survey Type	Management	
Action	No further action required	
Product Type	Not Selected	
Asbestos Type	Non suspect material	
Surface Treatment	Not Selected	
Condition	Not Selected	
Recommendations	No further action required	
Comments	Carpet on concrete, plaster walls, non-asbestos ceiling tiles, metal lift doors.

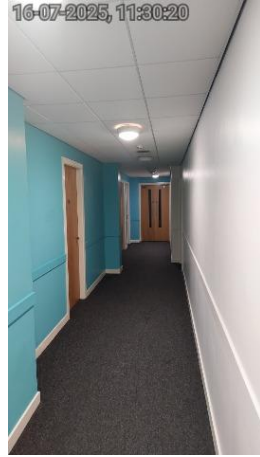
<p>16-07-2025, 11:30:20</p>
Material Assessment Ref	S027 –	
Building	Main	
Floor	Third	
Room	Hallway 9	
Position	Ceiling, Walls & Floor	
Component	Ceiling, Walls & Floor	
Accessibility	N/A	
Lab	In-House Database	
Next Inspection	No further action required	
Material Risk	0 (VL)	
Priority Risk	N/A	
Quantity	Num	
Survey Type	Management	
Action	No further action required	
Product Type	Not Selected	
Asbestos Type	Non suspect material	
Surface Treatment	Not Selected	
Condition	Not Selected	
Recommendations	No further action required	
Comments	Carpet on concrete, plaster walls, non-asbestos ceiling tiles.

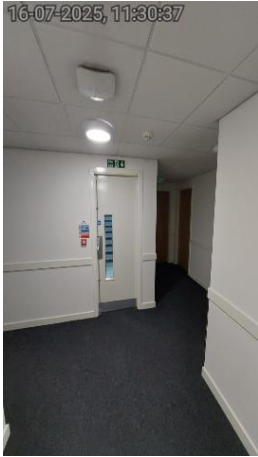
Material Assessment Ref	S028 –	
Building	Main	
Floor	Third	
Room	Hallway 10	
Position	Ceiling, Walls & Floor	
Component	Ceiling, Walls & Floor	
Accessibility	N/A	
Lab	In-House Database	
Next Inspection	No further action required	
Material Risk	0 (VL)	
Priority Risk	N/A	
Quantity	Num	
Survey Type	Management	
Action	No further action required	
Product Type	Not Selected	
Asbestos Type	Non suspect material	
Surface Treatment	Not Selected	
Condition	Not Selected	
Recommendations	No further action required	
Comments	Carpet on concrete, plaster walls, non-asbestos ceiling tiles.

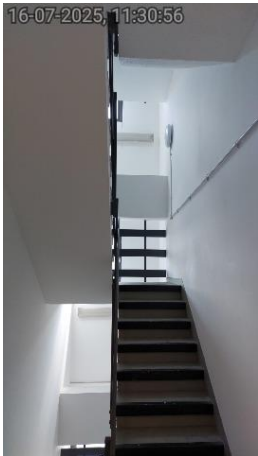
Material Assessment Ref	S029 –	
Building	Main	
Floor	Third/Fourth	
Room	Landing & Stairs	
Position	Ceiling, Walls & Floor	
Component	Ceiling, Walls & Floor	
Accessibility	N/A	
Lab	In-House Database	
Next Inspection	No further action required	
Material Risk	0 (VL)	
Priority Risk	N/A	
Quantity	Num	
Survey Type	Management	
Action	No further action required	
Product Type	Not Selected	
Asbestos Type	Non suspect material	
Surface Treatment	Not Selected	
Condition	Not Selected	
Recommendations	No further action required	
Comments	Concrete, plaster walls, concrete ceiling, timber hand rail.

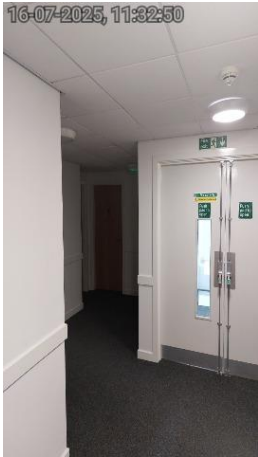
Material Assessment Ref	S030 –	
Building	Main	
Floor	Third	
Room	Hallway 11	
Position	Ceiling, Walls & Floor	
Component	Ceiling, Walls & Floor	
Accessibility	N/A	
Lab	In-House Database	
Next Inspection	No further action required	
Material Risk	0 (VL)	
Priority Risk	N/A	
Quantity	Num	
Survey Type	Management	
Action	No further action required	
Product Type	Not Selected	
Asbestos Type	Non suspect material	
Surface Treatment	Not Selected	
Condition	Not Selected	
Recommendations	No further action required	
Comments	Carpet on concrete, plaster walls, non-asbestos ceiling tiles.

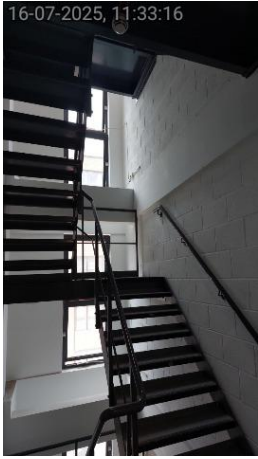
Material Assessment Ref	S031 –	
Building	Main	
Floor	Third/Fourth	
Room	Landing & Stairs	
Position	Ceiling, Walls & Floor	
Component	Ceiling, Walls & Floor	
Accessibility	N/A	
Lab	In-House Database	
Next Inspection	No further action required	
Material Risk	0 (VL)	
Priority Risk	N/A	
Quantity	Num	
Survey Type	Management	
Action	No further action required	
Product Type	Not Selected	
Asbestos Type	Non suspect material	
Surface Treatment	Not Selected	
Condition	Not Selected	
Recommendations	No further action required	
Comments	Metal stairs, metal floor, brick walls, metal hand rail.

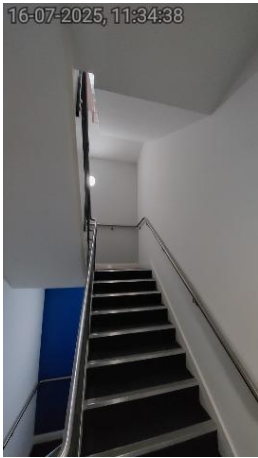
Material Assessment Ref	S032 –	
Building	Main	
Floor	Fourth/Fifth	
Room	Landing & Stairs	
Position	Ceiling, Walls & Floor	
Component	Ceiling, Walls & Floor	
Accessibility	N/A	
Lab	In-House Database	
Next Inspection	No further action required	
Material Risk	0 (VL)	
Priority Risk	N/A	
Quantity	Num	
Survey Type	Management	
Action	No further action required	
Product Type	Not Selected	
Asbestos Type	Non suspect material	
Surface Treatment	Not Selected	
Condition	Not Selected	
Recommendations	No further action required	
Comments	Carpet on concrete, plaster walls, concrete ceiling, metal hand rail, rubber stair treads.

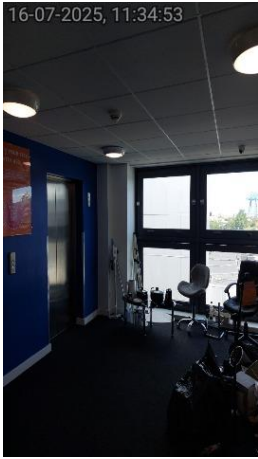
Material Assessment Ref	S033 –	
Building	Main	
Floor	Fourth	
Room	Lift Lobby	
Position	Ceiling, Walls & Floor	
Component	Ceiling, Walls & Floor	
Accessibility	N/A	
Lab	In-House Database	
Next Inspection	No further action required	
Material Risk	0 (VL)	
Priority Risk	N/A	
Quantity	Num	
Survey Type	Management	
Action	No further action required	
Product Type	Not Selected	
Asbestos Type	Non suspect material	
Surface Treatment	Not Selected	
Condition	Not Selected	
Recommendations	No further action required	
Comments	Carpet on concrete, plaster walls, non-asbestos ceiling tiles, metal lift doors.

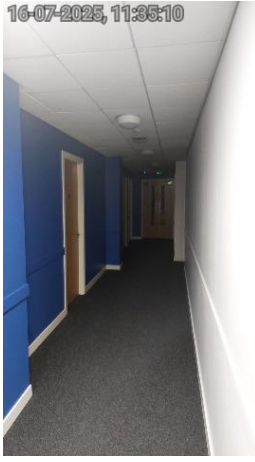
Material Assessment Ref	S034 –	
Building	Main	
Floor	Fourth	
Room	Hallway 12	
Position	Ceiling, Walls & Floor	
Component	Ceiling, Walls & Floor	
Accessibility	N/A	
Lab	In-House Database	
Next Inspection	No further action required	
Material Risk	0 (VL)	
Priority Risk	N/A	
Quantity	Num	
Survey Type	Management	
Action	No further action required	
Product Type	Not Selected	
Asbestos Type	Non suspect material	
Surface Treatment	Not Selected	
Condition	Not Selected	
Recommendations	No further action required	
Comments	Carpet on concrete, plaster walls, non-asbestos ceiling tiles.

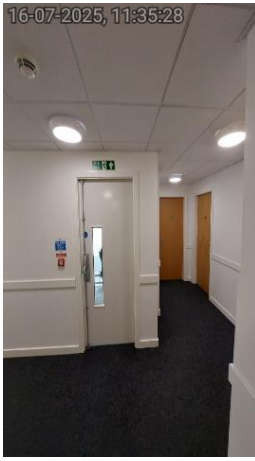
Material Assessment Ref	S035 –	
Building	Main	
Floor	Fourth	
Room	Hallway 13	
Position	Ceiling, Walls & Floor	
Component	Ceiling, Walls & Floor	
Accessibility	N/A	
Lab	In-House Database	
Next Inspection	No further action required	
Material Risk	0 (VL)	
Priority Risk	N/A	
Quantity	Num	
Survey Type	Management	
Action	No further action required	
Product Type	Not Selected	
Asbestos Type	Non suspect material	
Surface Treatment	Not Selected	
Condition	Not Selected	
Recommendations	No further action required	
Comments	Carpet on concrete, plaster walls, non-asbestos ceiling tiles.

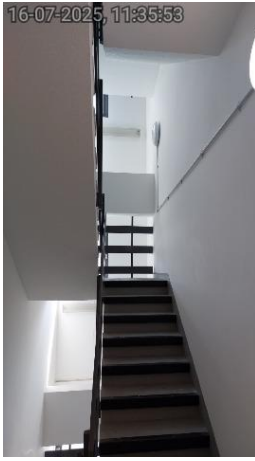
Material Assessment Ref	S036 –	
Building	Main	
Floor	Fourth/Fifth	
Room	Landing & Stairs	
Position	Ceiling, Walls & Floor	
Component	Ceiling, Walls & Floor	
Accessibility	N/A	
Lab	In-House Database	
Next Inspection	No further action required	
Material Risk	0 (VL)	
Priority Risk	N/A	
Quantity	Num	
Survey Type	Management	
Action	No further action required	
Product Type	Not Selected	
Asbestos Type	Non suspect material	
Surface Treatment	Not Selected	
Condition	Not Selected	
Recommendations	No further action required	
Comments	Concrete, plaster walls, concrete ceiling, timber hand rail.

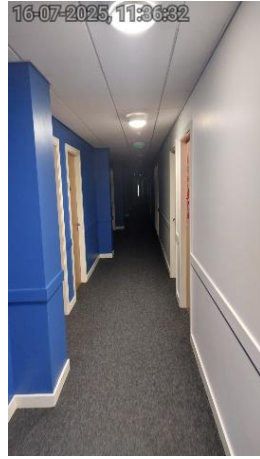
Material Assessment Ref	S037 –	
Building	Main	
Floor	Fourth	
Room	Hallway 14	
Position	Ceiling, Walls & Floor	
Component	Ceiling, Walls & Floor	
Accessibility	N/A	
Lab	In-House Database	
Next Inspection	No further action required	
Material Risk	0 (VL)	
Priority Risk	N/A	
Quantity	Num	
Survey Type	Management	
Action	No further action required	
Product Type	Not Selected	
Asbestos Type	Non suspect material	
Surface Treatment	Not Selected	
Condition	Not Selected	
Recommendations	No further action required	
Comments	Carpet on concrete, plaster walls, non-asbestos ceiling tiles.

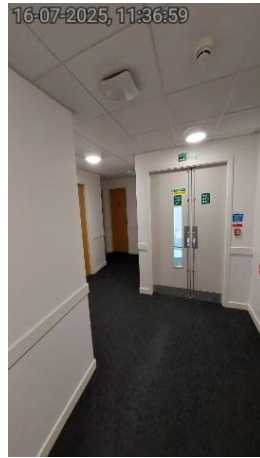
Material Assessment Ref	S038 –	
Building	Main	
Floor	Fourth	
Room	Hallway 15	
Position	Ceiling, Walls & Floor	
Component	Ceiling, Walls & Floor	
Accessibility	N/A	
Lab	In-House Database	
Next Inspection	No further action required	
Material Risk	0 (VL)	
Priority Risk	N/A	
Quantity	Num	
Survey Type	Management	
Action	No further action required	
Product Type	Not Selected	
Asbestos Type	Non suspect material	
Surface Treatment	Not Selected	
Condition	Not Selected	
Recommendations	No further action required	
Comments	Carpet on concrete, plaster walls, non-asbestos ceiling tiles.

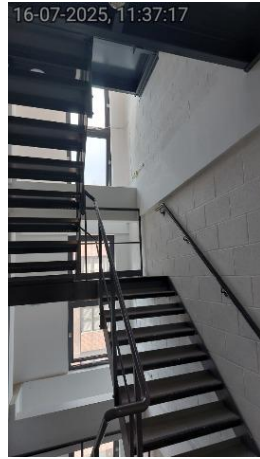
Material Assessment Ref	S039 –	
Building	Main	
Floor	Fourth/Fifth	
Room	Landing & Stairs	
Position	Ceiling, Walls & Floor	
Component	Ceiling, Walls & Floor	
Accessibility	N/A	
Lab	In-House Database	
Next Inspection	No further action required	
Material Risk	0 (VL)	
Priority Risk	N/A	
Quantity	Num	
Survey Type	Management	
Action	No further action required	
Product Type	Not Selected	
Asbestos Type	Non suspect material	
Surface Treatment	Not Selected	
Condition	Not Selected	
Recommendations	No further action required	
Comments	Metal stairs, metal floor, brick walls, metal hand rail.

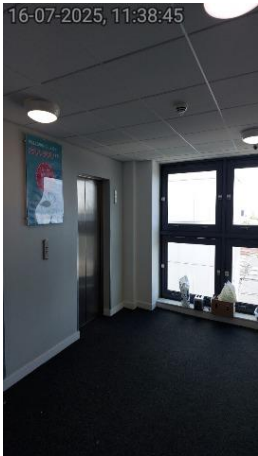
Material Assessment Ref	S041 –	
Building	Main	
Floor	Fifth	
Room	Lift Lobby	
Position	Ceiling, Walls & Floor	
Component	Ceiling, Walls & Floor	
Accessibility	N/A	
Lab	In-House Database	
Next Inspection	No further action required	
Material Risk	0 (VL)	
Priority Risk	N/A	
Quantity	Num	
Survey Type	Management	
Action	No further action required	
Product Type	Not Selected	
Asbestos Type	Non suspect material	
Surface Treatment	Not Selected	
Condition	Not Selected	
Recommendations	No further action required	
Comments	Carpet on concrete, plaster walls, non-asbestos ceiling tiles, metal lift doors.

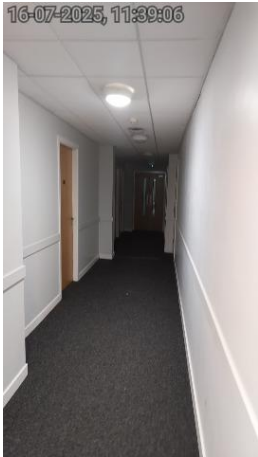
Material Assessment Ref	S042 –	
Building	Main	
Floor	Fifth	
Room	Hallway 16	
Position	Ceiling, Walls & Floor	
Component	Ceiling, Walls & Floor	
Accessibility	N/A	
Lab	In-House Database	
Next Inspection	No further action required	
Material Risk	0 (VL)	
Priority Risk	N/A	
Quantity	Num	
Survey Type	Management	
Action	No further action required	
Product Type	Not Selected	
Asbestos Type	Non suspect material	
Surface Treatment	Not Selected	
Condition	Not Selected	
Recommendations	No further action required	
Comments	Carpet on concrete, plaster walls, non-asbestos ceiling tiles.

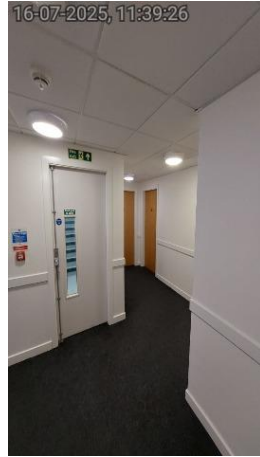
Material Assessment Ref	S043 –	
Building	Main	
Floor	Fifth	
Room	Hallway 17	
Position	Ceiling, Walls & Floor	
Component	Ceiling, Walls & Floor	
Accessibility	N/A	
Lab	In-House Database	
Next Inspection	No further action required	
Material Risk	0 (VL)	
Priority Risk	N/A	
Quantity	Num	
Survey Type	Management	
Action	No further action required	
Product Type	Not Selected	
Asbestos Type	Non suspect material	
Surface Treatment	Not Selected	
Condition	Not Selected	
Recommendations	No further action required	
Comments	Carpet on concrete, plaster walls, non-asbestos ceiling tiles.

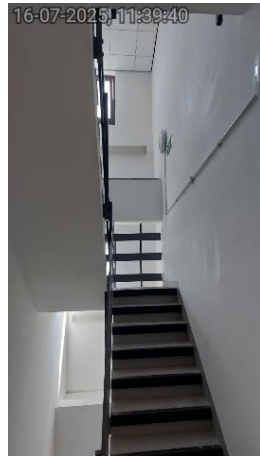
Material Assessment Ref	S044 –	
Building	Main	
Floor	Fifth/Sixth	
Room	Landing & Stairs	
Position	Ceiling, Walls & Floor	
Component	Ceiling, Walls & Floor	
Accessibility	N/A	
Lab	In-House Database	
Next Inspection	No further action required	
Material Risk	0 (VL)	
Priority Risk	N/A	
Quantity	Num	
Survey Type	Management	
Action	No further action required	
Product Type	Not Selected	
Asbestos Type	Non suspect material	
Surface Treatment	Not Selected	
Condition	Not Selected	
Recommendations	No further action required	
Comments	Concrete, plaster walls, concrete ceiling, timber hand rail.

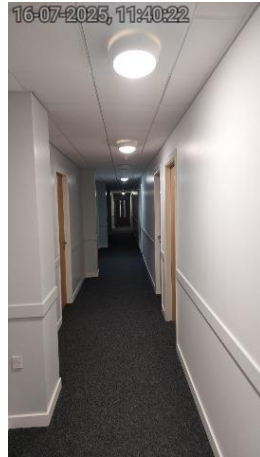
Material Assessment Ref	S045 –	
Building	Main	
Floor	Fifth	
Room	Hallway 18	
Position	Ceiling, Walls & Floor	
Component	Ceiling, Walls & Floor	
Accessibility	N/A	
Lab	In-House Database	
Next Inspection	No further action required	
Material Risk	0 (VL)	
Priority Risk	N/A	
Quantity	Num	
Survey Type	Management	
Action	No further action required	
Product Type	Not Selected	
Asbestos Type	Non suspect material	
Surface Treatment	Not Selected	
Condition	Not Selected	
Recommendations	No further action required	
Comments	Carpet on concrete, plaster walls, non-asbestos ceiling tiles.

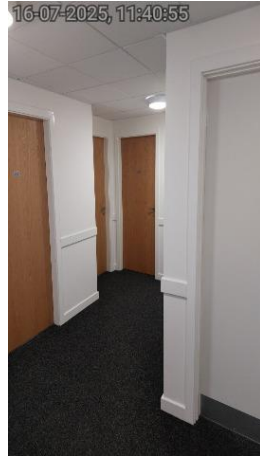
Material Assessment Ref	S046 –	
Building	Main	
Floor	Fifth	
Room	Hallway 19	
Position	Ceiling, Walls & Floor	
Component	Ceiling, Walls & Floor	
Accessibility	N/A	
Lab	In-House Database	
Next Inspection	No further action required	
Material Risk	0 (VL)	
Priority Risk	N/A	
Quantity	Num	
Survey Type	Management	
Action	No further action required	
Product Type	Not Selected	
Asbestos Type	Non suspect material	
Surface Treatment	Not Selected	
Condition	Not Selected	
Recommendations	No further action required	
Comments	Carpet on concrete, plaster walls, non-asbestos ceiling tiles.

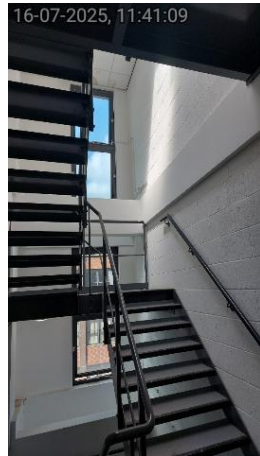
Material Assessment Ref	S047 –	
Building	Main	
Floor	Fifth/Sixth	
Room	Landing & Stairs	
Position	Ceiling, Walls & Floor	
Component	Ceiling, Walls & Floor	
Accessibility	N/A	
Lab	In-House Database	
Next Inspection	No further action required	
Material Risk	0 (VL)	
Priority Risk	N/A	
Quantity	Num	
Survey Type	Management	
Action	No further action required	
Product Type	Not Selected	
Asbestos Type	Non suspect material	
Surface Treatment	Not Selected	
Condition	Not Selected	
Recommendations	No further action required	
Comments	Metal stairs, metal floor, brick walls, metal hand rail.

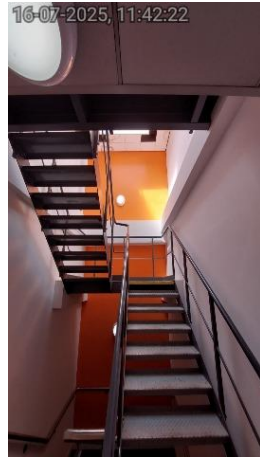
Material Assessment Ref	S048 –	
Building	Main	
Floor	Sixth	
Room	Landing & Stairs	
Position	Ceiling, Walls & Floor	
Component	Ceiling, Walls & Floor	
Accessibility	N/A	
Lab	In-House Database	
Next Inspection	No further action required	
Material Risk	0 (VL)	
Priority Risk	N/A	
Quantity	Num	
Survey Type	Management	
Action	No further action required	
Product Type	Not Selected	
Asbestos Type	Non suspect material	
Surface Treatment	Not Selected	
Condition	Not Selected	
Recommendations	No further action required	
Comments	Metal stairs, plaster walls, non-asbestos ceiling tiles, metal hand rail, carpet on concrete.

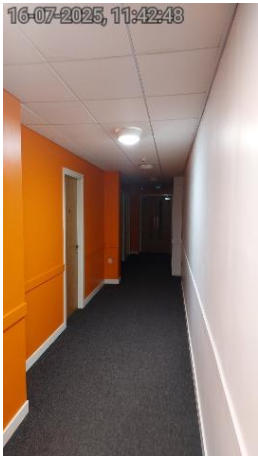
Material Assessment Ref	S050 –	
Building	Main	
Floor	Sixth	
Room	Hallway 20	
Position	Ceiling, Walls & Floor	
Component	Ceiling, Walls & Floor	
Accessibility	N/A	
Lab	In-House Database	
Next Inspection	No further action required	
Material Risk	0 (VL)	
Priority Risk	N/A	
Quantity	Num	
Survey Type	Management	
Action	No further action required	
Product Type	Not Selected	
Asbestos Type	Non suspect material	
Surface Treatment	Not Selected	
Condition	Not Selected	
Recommendations	No further action required	
Comments	Carpet on concrete, plaster walls, non-asbestos ceiling tiles.

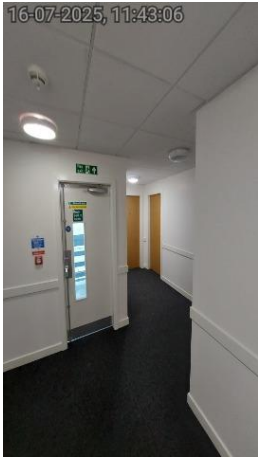
Material Assessment Ref	S051 –	
Building	Main	
Floor	Sixth	
Room	Hallway 21	
Position	Ceiling, Walls & Floor	
Component	Ceiling, Walls & Floor	
Accessibility	N/A	
Lab	In-House Database	
Next Inspection	No further action required	
Material Risk	0 (VL)	
Priority Risk	N/A	
Quantity	Num	
Survey Type	Management	
Action	No further action required	
Product Type	Not Selected	
Asbestos Type	Non suspect material	
Surface Treatment	Not Selected	
Condition	Not Selected	
Recommendations	No further action required	
Comments	Carpet on concrete, plaster walls, non-asbestos ceiling tiles.

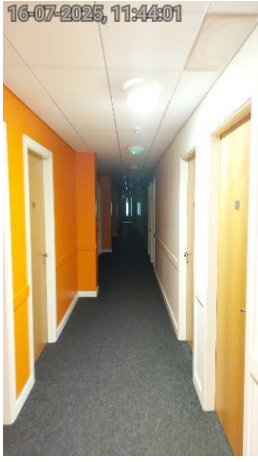
Material Assessment Ref	S052 –	
Building	Main	
Floor	Sixth	
Room	Hallway 22	
Position	Ceiling, Walls & Floor	
Component	Ceiling, Walls & Floor	
Accessibility	N/A	
Lab	In-House Database	
Next Inspection	No further action required	
Material Risk	0 (VL)	
Priority Risk	N/A	
Quantity	Num	
Survey Type	Management	
Action	No further action required	
Product Type	Not Selected	
Asbestos Type	Non suspect material	
Surface Treatment	Not Selected	
Condition	Not Selected	
Recommendations	No further action required	
Comments	Carpet on concrete, plaster walls, non-asbestos ceiling tiles.

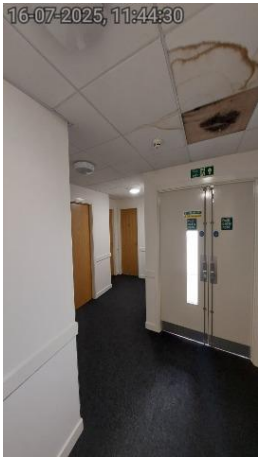
Material Assessment Ref	S053 –	
Building	Main	
Floor	Sixth	
Room	Hallway 23	
Position	Ceiling, Walls & Floor	
Component	Ceiling, Walls & Floor	
Accessibility	N/A	
Lab	In-House Database	
Next Inspection	No further action required	
Material Risk	0 (VL)	
Priority Risk	N/A	
Quantity	Num	
Survey Type	Management	
Action	No further action required	
Product Type	Not Selected	
Asbestos Type	Non suspect material	
Surface Treatment	Not Selected	
Condition	Not Selected	
Recommendations	No further action required	
Comments	Carpet on concrete, plaster walls, non-asbestos ceiling tiles.

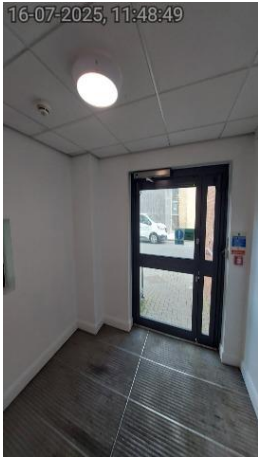
Material Assessment Ref	S054 –	
Building	Main	
Floor	Ground	
Room	Rear Lobby	
Position	Ceiling, Walls & Floor	
Component	Ceiling, Walls & Floor	
Accessibility	N/A	
Lab	In-House Database	
Next Inspection	No further action required	
Material Risk	0 (VL)	
Priority Risk	N/A	
Quantity	Num	
Survey Type	Management	
Action	No further action required	
Product Type	Not Selected	
Asbestos Type	Non suspect material	
Surface Treatment	Not Selected	
Condition	Not Selected	
Recommendations	No further action required	
Comments	Non-asbestos ceiling tiles, carpet with metal treads on concrete, plaster walls, metal door surrounds.
