Home Report

0/1 18 Woodcroft Avenue
Glasgow G11 7HX

Property Address	0/1 18 Woodcroft Avenue Glasgow G11 7HX
Customer	Chris Johnston
Prepared by	Graham + Sibbald Property Consultants Limited
Date of Inspection	01/06/2026

Survey Report & Proposal

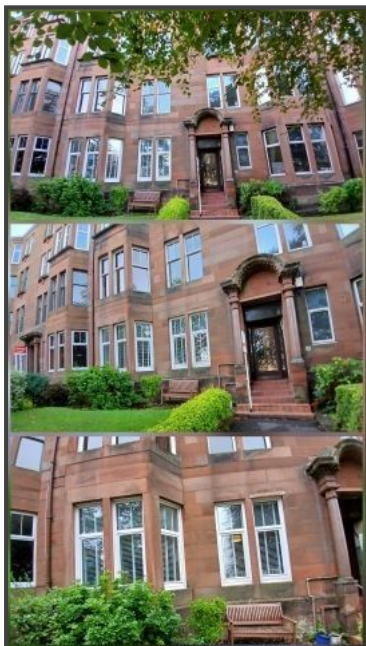
- The external ground level is below the internal floor level of the ground floor flat.

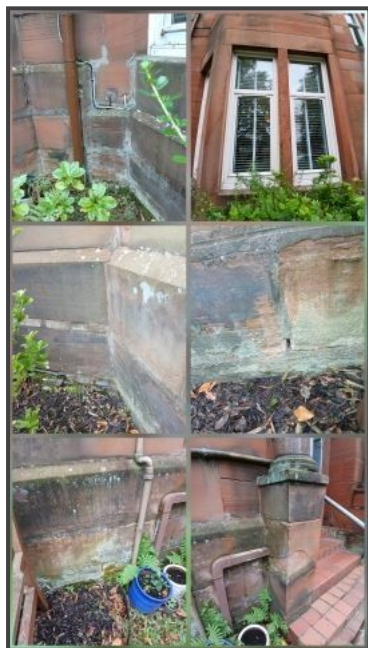
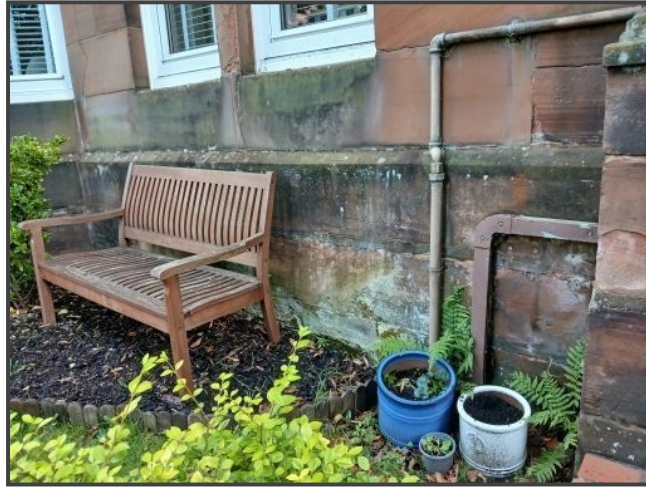
- Find out the root cause of deterioration and fix it before anything else is done to the building.
- If possible, always replace damaged and eroded stone with a matching / compatible stone based on petrographic analysis.
- If there are situations where the use of restoration mortar is deemed necessary, use it properly, ensure it is compatible with the damaged stone, do not use it where the stone is in an exposed / vulnerable location; and avoid covering large areas of wall.
- Understand that this is only a temporary measure and only delaying the inevitable. Eventually, the restoration mortar will deteriorate and will probably take the stone background with it, resulting in the replacement of the stone anyway.

We would highly recommend that the client engages with reputable third-party contractors to fully inspect and undertake remedial repairs to all defects that are noted.

- Reputable third-party contractors should regularly check and maintain / repair as necessary all gutters, down-pipes, masonry, render, painted coatings, external joinery, roof coverings, etc.

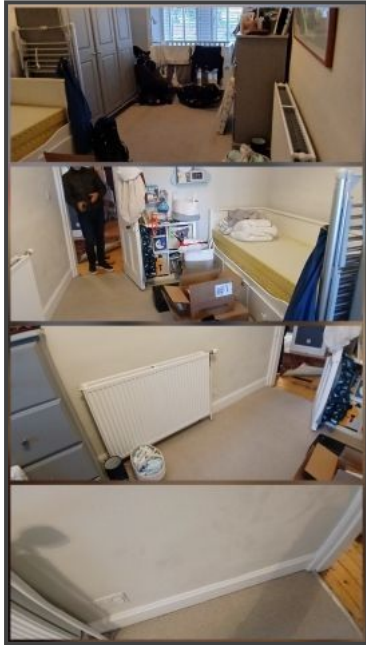
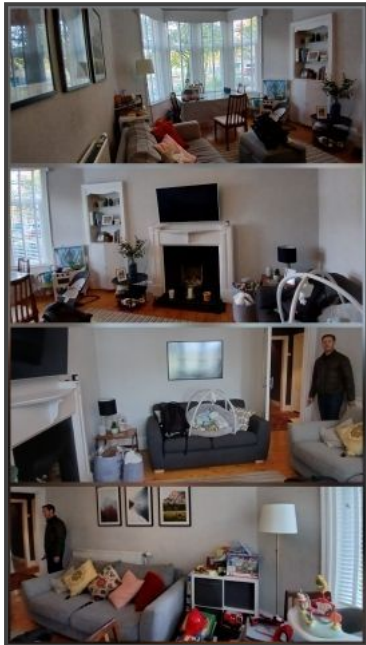
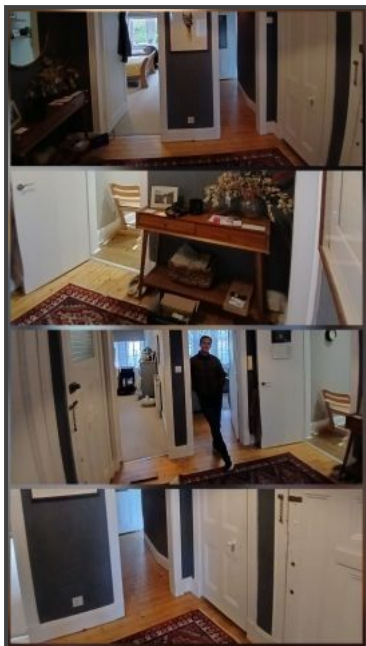
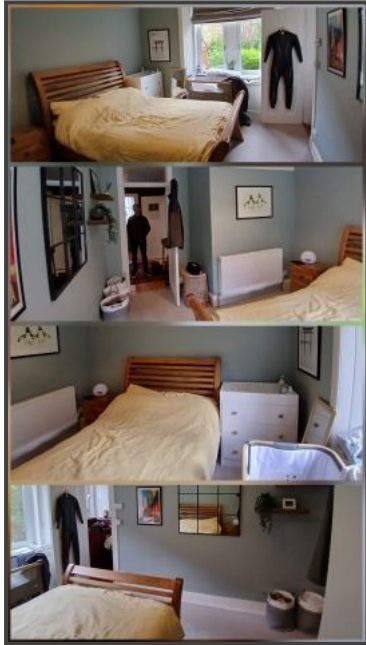
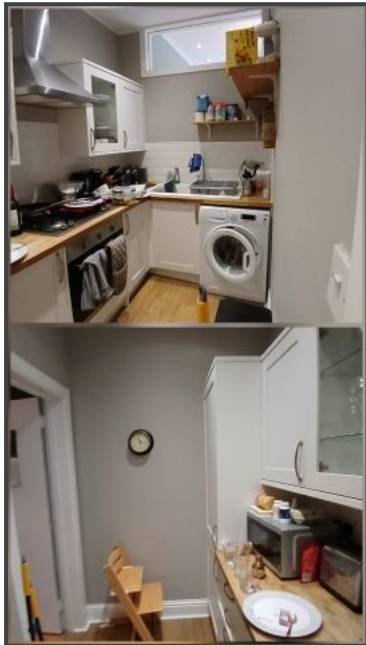
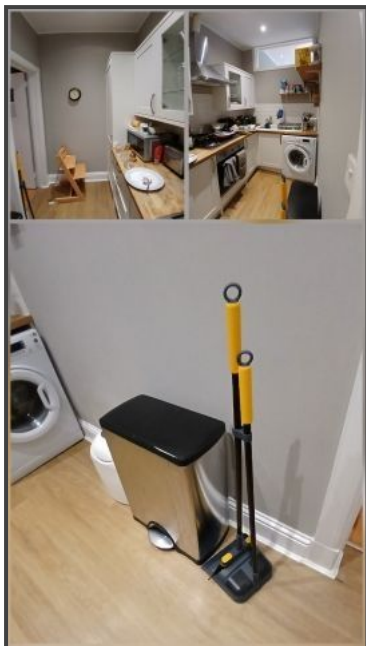
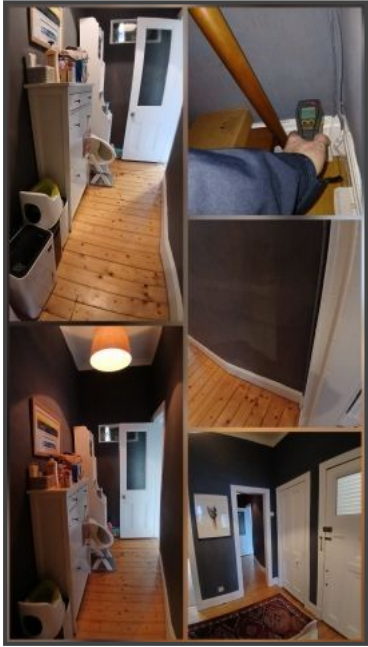
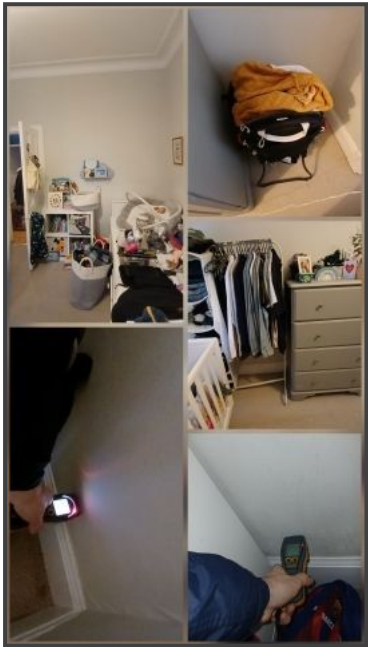
- Moisture bridging: Debris acts as a wick, enabling lateral damp penetration and condensation, leading to staining and salt efflorescence.
- Timber risks: Concealed framing becomes prone to fungal decay if saturation persists.
- Finish damage: Internal linings may delaminate, with potential for mould proliferation in humid conditions.

- Peter Cox is to:

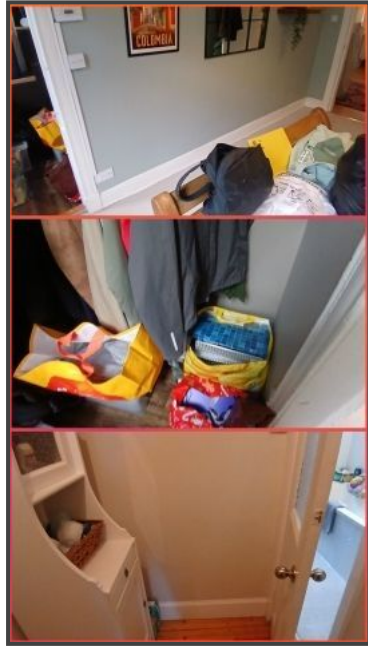
After installing a damp proof course the wall will contain a considerable amount of water that must dry out. The rate at which a wall dries out is dependant on various factors such as the nature, porosity and thickness of the walling material, hygroscopic salts content and the wall finishes. Generally a wall dries out at a rate of one month for every 25mm of thickness. Externally rendered, coated or painted walls may take considerably longer to dry out.

We completed the replastering on 26th February 2026. Currently the wall masonry is in its curing phase.

- No further damp proof course installation work is required in the inspected areas at this time.

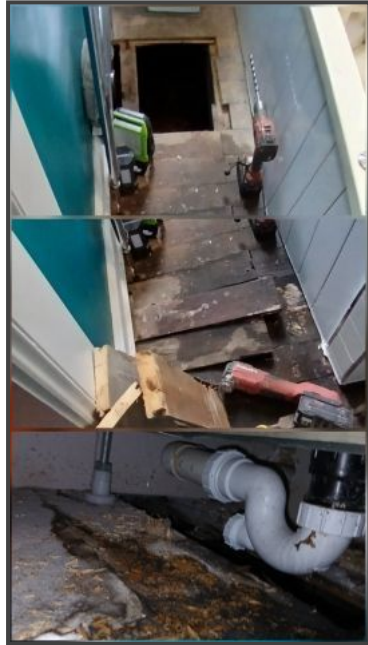
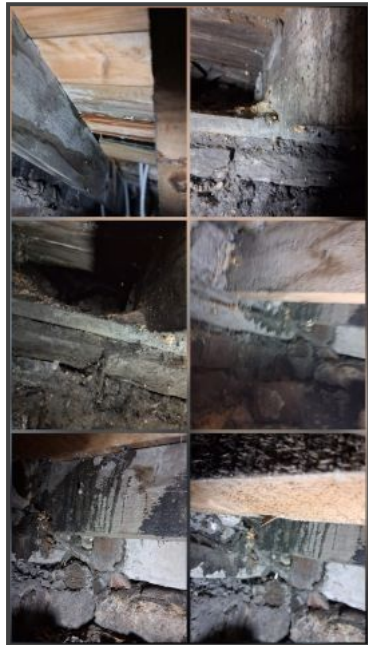
During the sub-floor investigative survey, the joists and wall-plates were treated in-situ using a fungicidal paste.

- No further treatment required to the sub-floor timbers on the basis of this inspection.
