22 Merkland Road,
AYR,
KA7 4UQ

Home Report

Single Survey

Property Address	22 Merkland Road, AYR, KA7 4UQ
Reference	1593462
Customer Name	William Gibson
Date of Inspection	10th June 2026
Surveyor's name, qualifications and office	Mark Rutherford MA (Hons) MRICS DM Hall LLP Chartered Surveyors Eldo House, Monkton Road, Prestwick, KA9 2PB Tel: 01292 286974 email: ayrshireresidential@dmhall.co.uk
Prepared By	DM Hall LLP

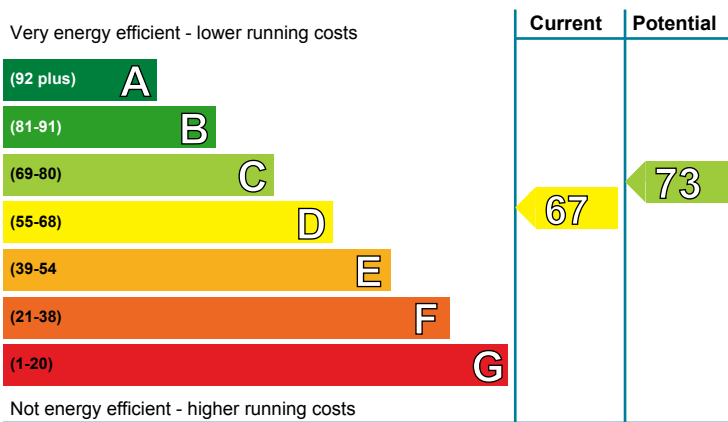
Energy Efficiency Rating

Your current rating is **band D (67)**. The average rating for EPCs in Scotland is **band D (61)**.
