# Home Report

18 Glenapp Quadrant  
Kilmarnock KA1 3LJ

<b>Property Address</b>	18 Glenapp Quadrant Kilmarnock KA1 3LJ
<b>Customer</b>	Mrs Iris Hodgson
<b>Prepared by</b>	Graham + Sibbald Property Consultants Limited
<b>Date of Inspection</b>	01/04/2026

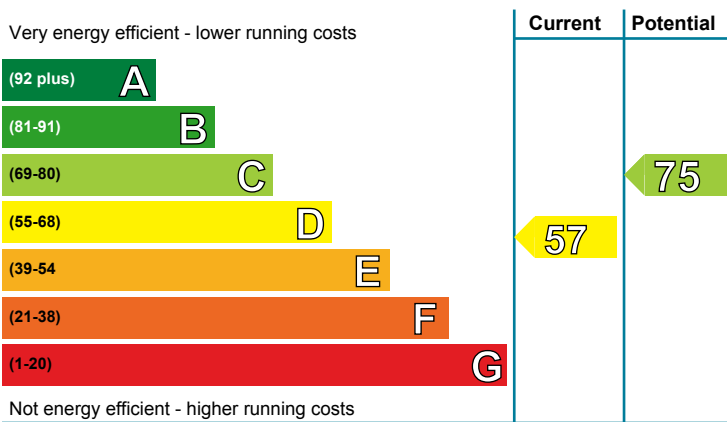
## Energy Efficiency Rating

Your current rating is **band D (57)**. The average rating for EPCs in Scotland is **band D (61)**.
