6 St. Ninian's Avenue,  
Stranraer,  
DG9 7BD

# Home Report

# Single Survey

## Survey Report on:

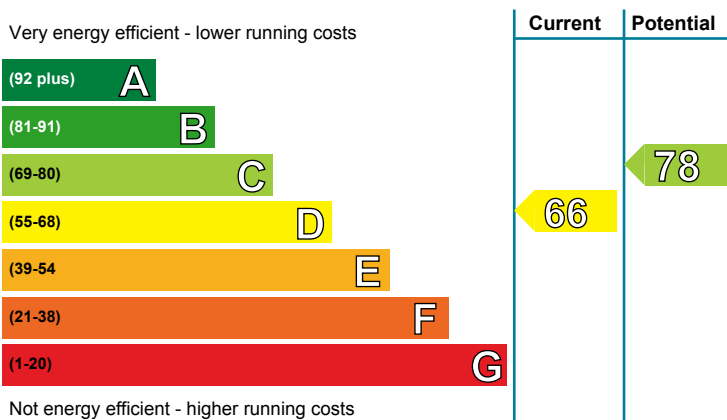
## Energy Efficiency Rating

This graph shows the current efficiency of your home, taking into account both energy efficiency and fuel costs. The higher this rating, the lower your fuel bills are likely to be.

Your current rating is **band D (66)**. The average rating for EPCs in Scotland is **band D (61)**.
