# YOUR ONESURVEY HOME REPORT

8/1  
112 Lancefield Quay  
Glasgow  
G3 8HR

# **Lancefield Quay**

## **Single Building Assessment (SBA)**

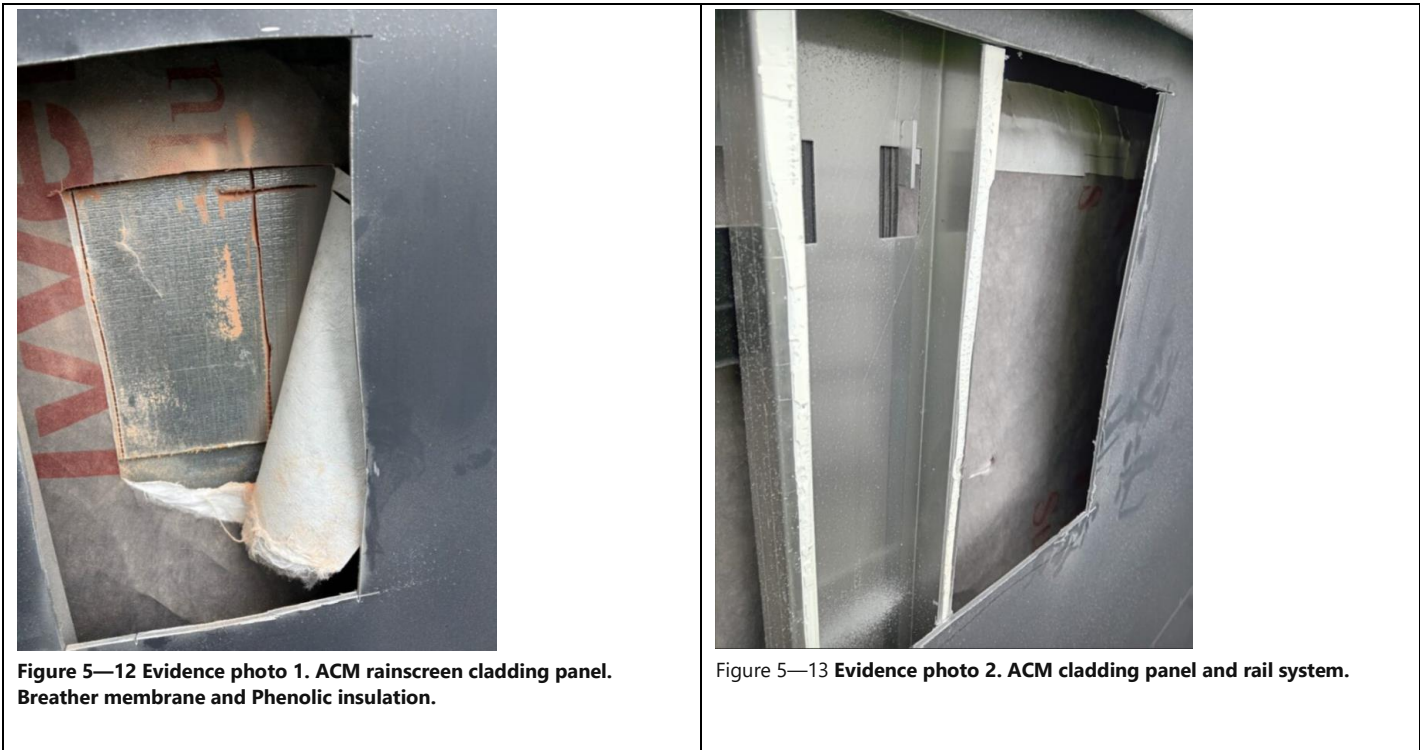
Note: the survey locations completed by BBP did not confirm the presence of horizontal or vertical cavity barriers behind the areas of ACM cladding.

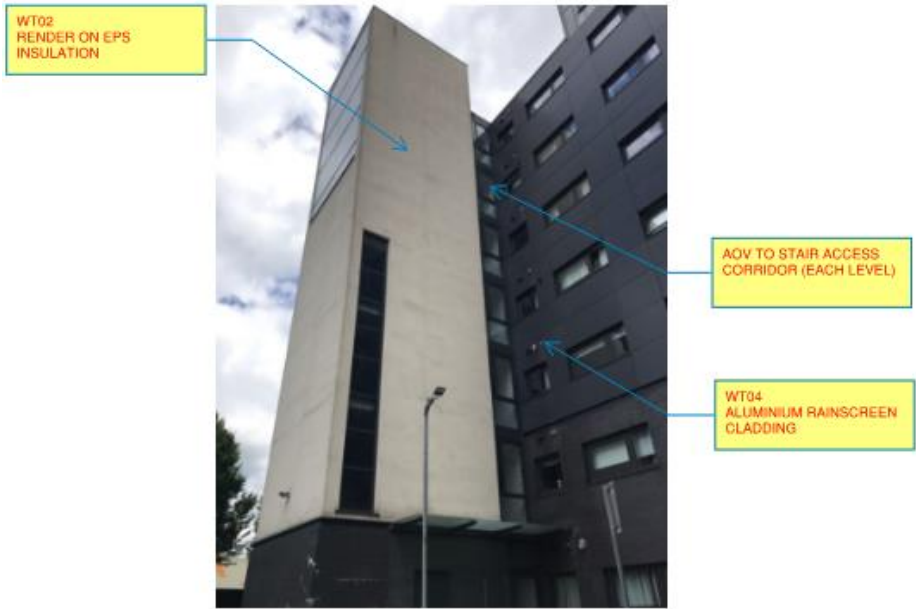
Figure 7—3 Cladding systems adjacent to stair cores

Cladding systems **WT02** and **WT04** are located adjacent to the lobby vent on each stair core. As noted above, both of these systems have combustible elements present within their build up. Refer to Photographs below showing the existing context and proximity of both cladding systems to the lobby vent

In order to mitigate potential smoke logging of the escape corridor in this situation, it is recommended that a second AoV is installed to the stair lobby (each floor) where there is currently a fixed pane. This would provide a secondary vent in order to clear any smoke should the first vent become compromised due to proximity to the flat windows.

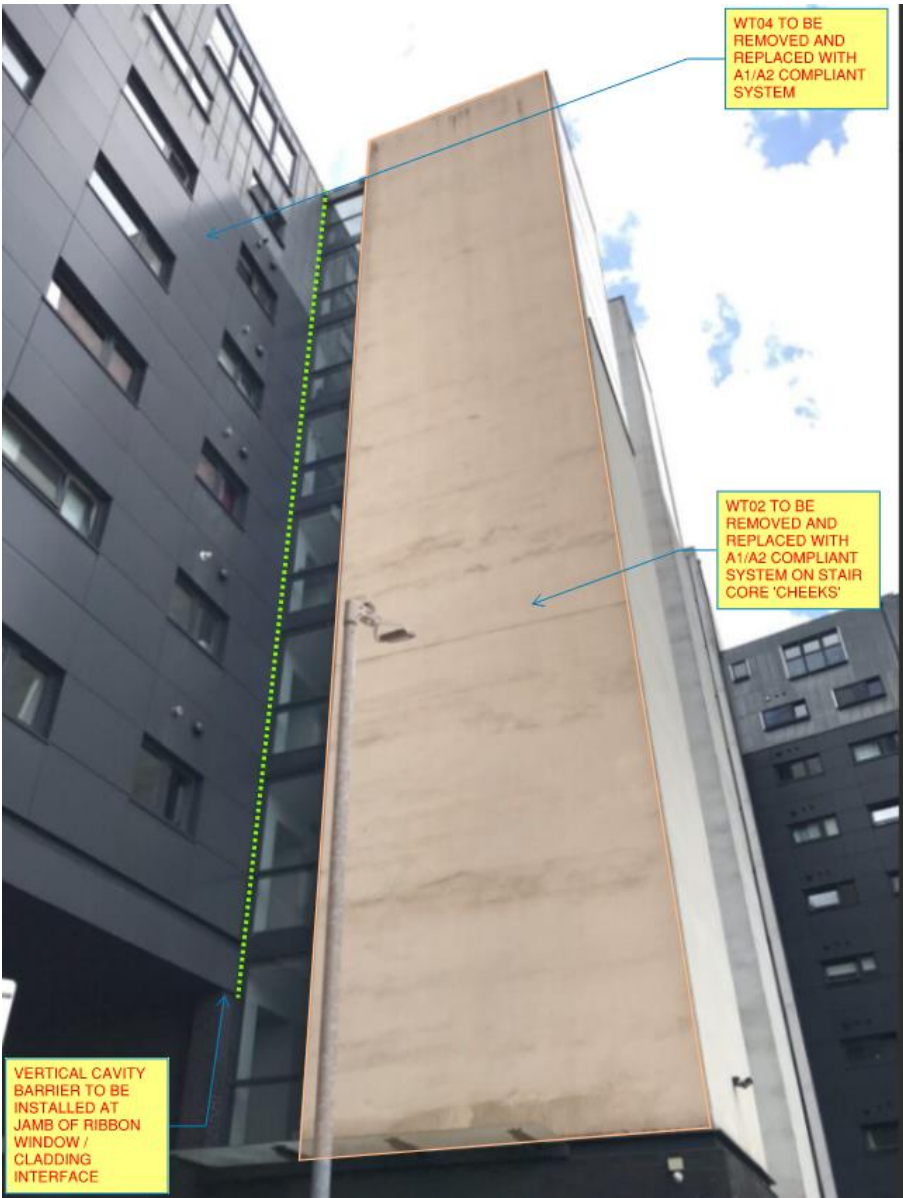
Figure 7—5 Typical Stair Core

Investigations completed on site have also confirmed that there is no vertical cavity barrier is installed at the junction of the vertical ribbon windows and WT04 – it is recommended that this is addressed as part of remediation works

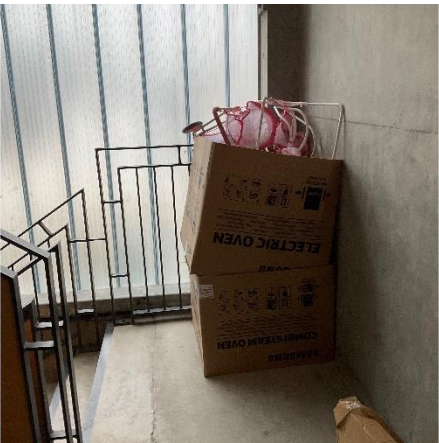
Figure 9—1 Combustibles stored within stairwells

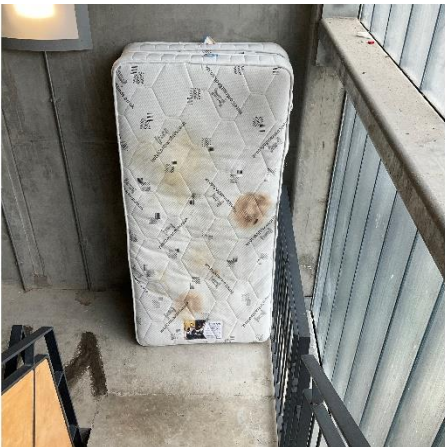
Figure 9—2 Combustibles stored within stairwells

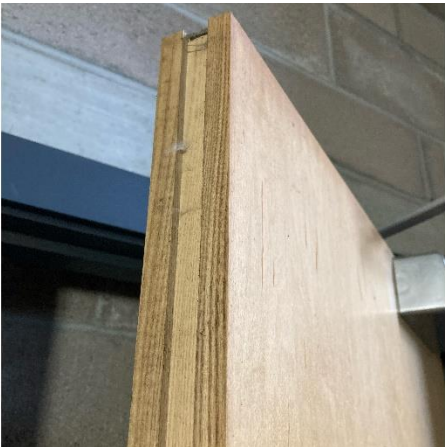
Figure 9—3 Seals missing from fire doors

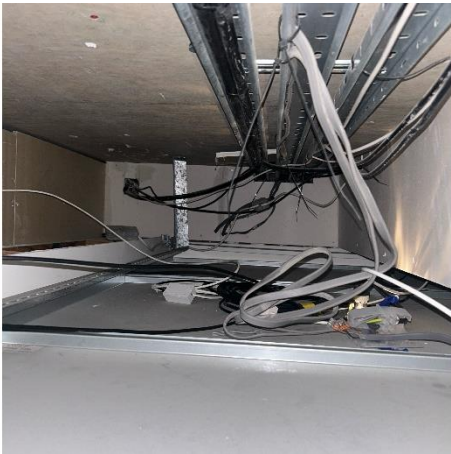
Figure 9—4 Firestopping required

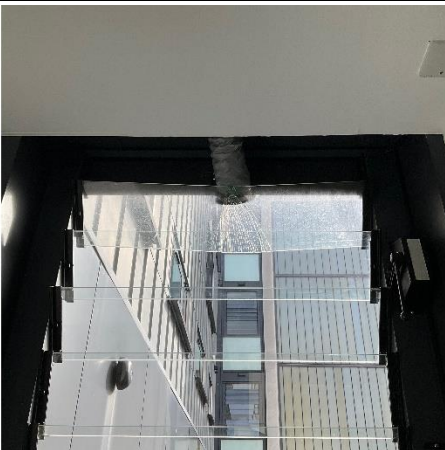
Figure 9—5 Automatic vents to stair lobby jammed open

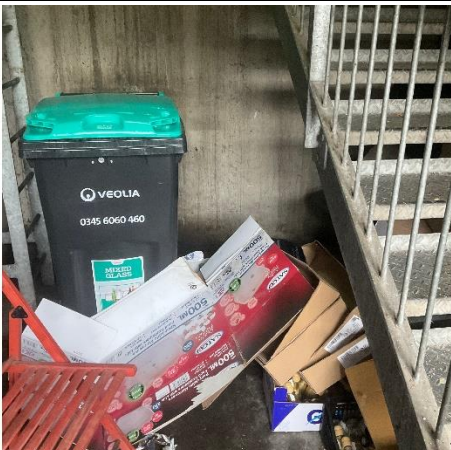
Figure 9—6 India Quay Restaurant: Combustibles on escape route
