22 Montgomery Street,  
GRANGEMOUTH,  
FK3 8QN

# Home Report

## Survey Report on:

<b>Property Address</b>	22 Montgomery Street, GRANGEMOUTH, FK3 8QN
<b>Reference</b>	1610412
<b>Customer Name</b>	Hazel Ross
<b>Date of Inspection</b>	3rd June 2026
<b>Surveyor's name, qualifications and office</b>	David Telford  DM Hall LLP Chartered Surveyors Unit 6A, The Courtyard Callendar Business Park Falkirk FK1 1XR  Tel: 01324 628321  email: centralresidential@dmhall.co.uk
<b>Prepared By</b>	DM Hall LLP

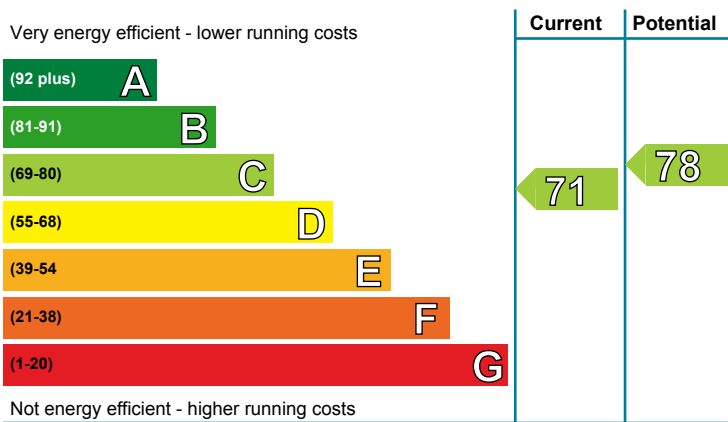
This graph shows the current efficiency of your home, taking into account both energy efficiency and fuel costs. The higher this rating, the lower your fuel bills are likely to be.

Your current rating is **band C (71)**. The average rating for EPCs in Scotland is **band D (61)**.
