Home Report

10 Aitken Street
Kirkcaldy KY1 3DR

Date of Valuation: 01/06/2026

Single Survey

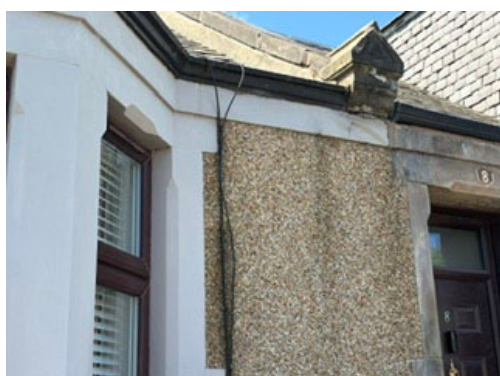
- Staining to roughcast to front elevation, possibly due to defective rainwater goods.
- Slightly limited/restricted ventilation to the sub floor.

Staining to roughcast below gutter to front elevation

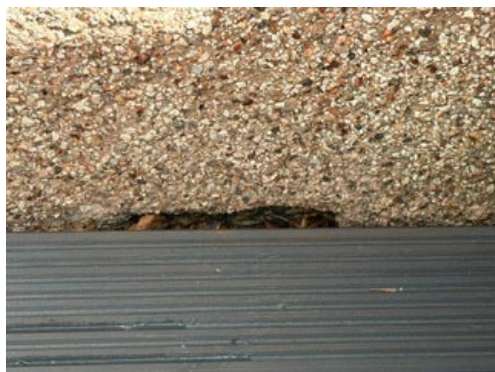
Partially restricted sub-floor vent to rear elevation

Please note that no allowance has been made at this stage for rectifying the above defects, or any other external repairs considered or found to be necessary unless directly specified otherwise within the body of this report. Failure to carry out essential repair and maintenance works to the external fabric may result in water ingress to the property and increase the risk of dampness and timber decay.

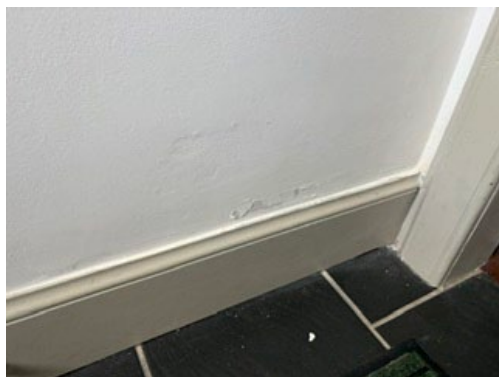
Small area of dampness
noted within front entrance
vestibule

NB. Where internal wall, ceiling and floor surfaces are affected by raised moisture levels, any joists/rafters/wallplates or concealed wall strapping/framing/lintels or other timbers meeting these areas could be affected by fungal decay. As such, and where possible, we recommend a sub-floor and/or invasive wall surface investigation be undertaken to ascertain whether any additional works are required to areas out-with the scope of our current inspection and any further works in this respect will be the subject of a supplementary report/quotation. Where we are instructed to proceed with specified strip/repair works we will, as a matter of course, inspect any newly exposed timbers for signs of decay and report accordingly.

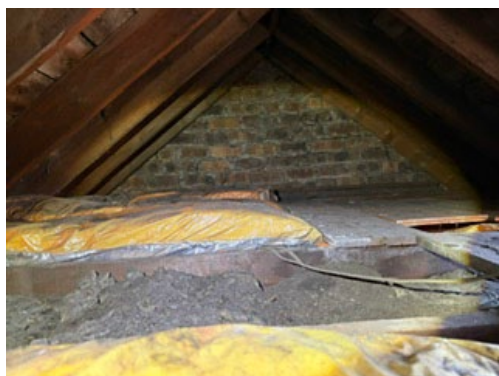
Our inspection of the roof timbers was restricted by the presence of quilt insulation material, stored goods and the addition of dry-lining and floor coverings due to the attic conversion.

Restricted inspection of apex void due to insulation

Whilst evidence of past attack by the common furniture beetle was noted to a section of floorboard within the apex void, there was no indication of any recent activity where inspection was possible and is considered dormant. If treatments have been carried out by others previously, it is important that you check the validity of any available guarantees.
