24 Skelmorlie Castle Road,
SKELMORLIE,
PA17 5AL

Home Report

Single Survey

Property Address	24 Skelmorlie Castle Road, SKELMORLIE, PA17 5AL
Reference	1480633
Customer Name	Helen Ridley
Date of Inspection	16th March 2026
Surveyor's name, qualifications and office	Claudia Balmforth BSc (Hons) MRICS DM Hall LLP Chartered Surveyors Eldo House, Monkton Road, Prestwick, KA9 2PB Tel: 01292 286974 email: ayrshireresidential@dmhall.co.uk
Prepared By	DM Hall LLP

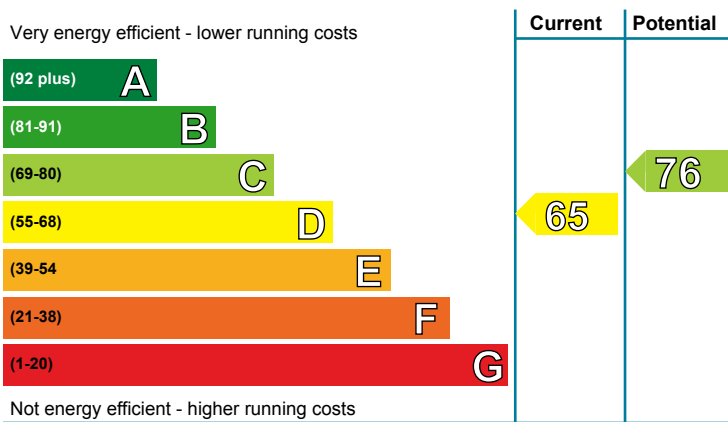
Energy Efficiency Rating

Your current rating is **band D (65)**. The average rating for EPCs in Scotland is **band D (61)**.
