# YOUR ONESURVEY HOME REPORT

Flat 5  
20 Haggswood Avenue  
Glasgow  
G41 4RE

# SINGLE SURVEY

**Asbestos Management Survey**  
**Of**  
**Flat 0/5 20 Haggswood Ave, Glasgow**  
**For**

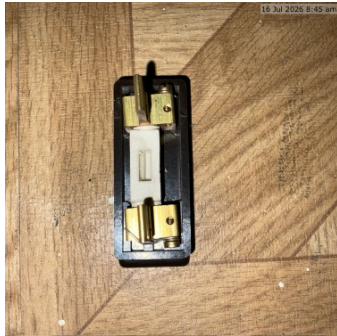
## Fuse Liner in old fuse box, Electrical Cupboard

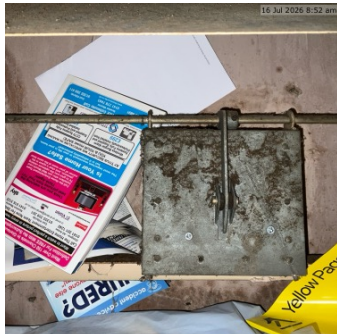
## Sample 2 Gasket to old vents in drying cupboard
