Home Report

43 Turnberry Drive
Kirkcaldy KY2 6SU

Property Address	43 Turnberry Drive Kirkcaldy KY2 6SU
Customer	Carrie Annabi
Prepared by	Graham + Sibbald Property Consultants Limited
Date of Inspection	22/01/2026

Bulk Sample Report

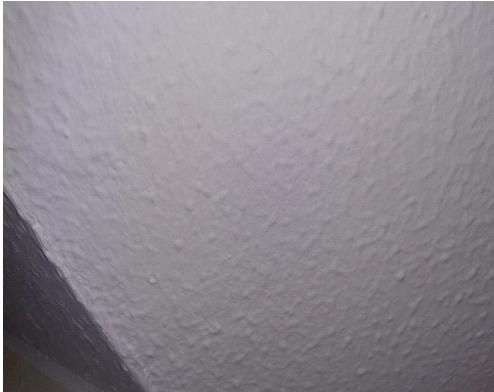
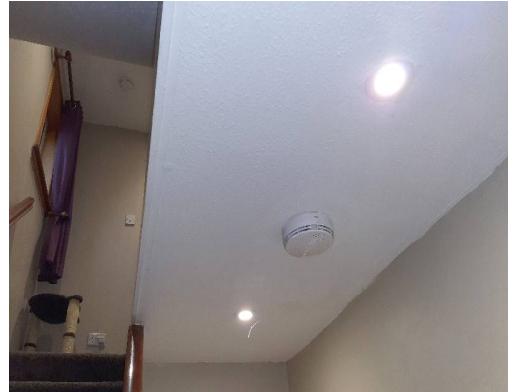
Item No / Sample No: 1 / ED005360

Building ID: 43 Turnberry Drive		
Location: Hallway, G/01		
Fibre Identification: Chrysotile		
Item Description: Textured coating over plasterboard Ceiling		
Sample Comments:		
Room Notes:		
Item No / Sample No: 2 / ED005361

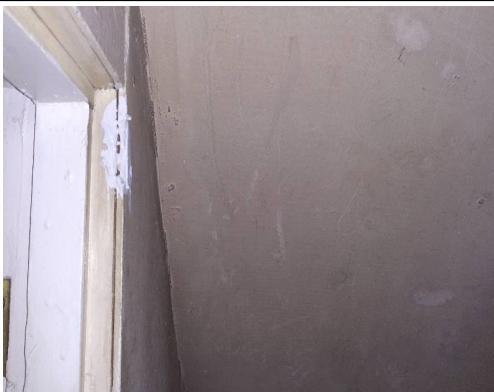
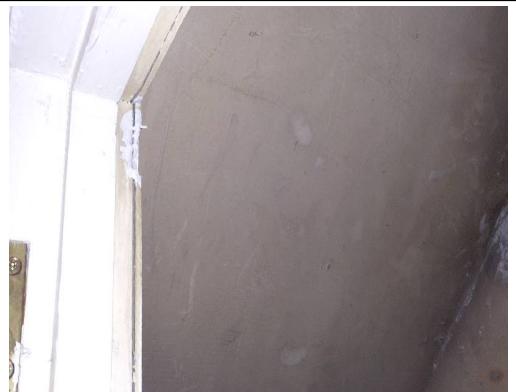
Building ID: 43 Turnberry Drive		
Location: Understairs Cupboard, G/02		
Fibre Identification: Chrysotile + Amosite		
Item Description: Insulating board lining Ceiling and walls 1 & 2		
Sample Comments:		
Room Notes:
