Your survey and valuation report

112 Stonemere Drive, Radcliffe,
Manchester, M26 1QX

16th February 2026

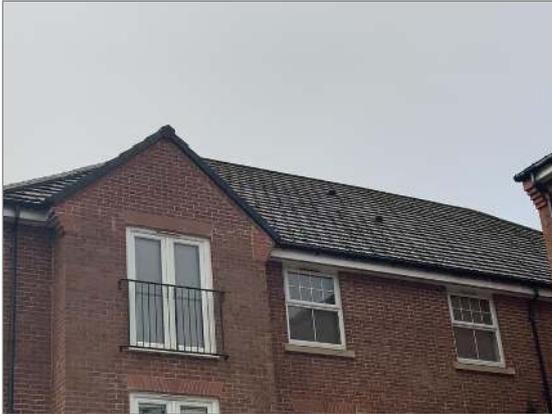
Photo - 2

The visible areas of the roof covering appear generally serviceable, however as with most roofs it will require annual maintenance to clear the areas of vegetation. Any loose or slipped tiles should be reset or replaced. If rainwater travels underneath the tiles, it could rot the wooden components of the roof, threatening structural integrity and leading to costly repairs. Broken tiles and debris can fall into gutters or downpipes, blocking your drainage system. If this issue is not spotted, it could potentially lead to parts of your drainage system requiring replacement.

There are valleys installed to the gable(s). Where valleys intersect the main roof slopes, these areas are considered to be weak points and the flashings lining them may fail, allowing damp penetration to occur. Water ingress may cause consequential damage to structural elements and decorative finishings, however no water ingress was noted internally to the subject property at time of inspection.

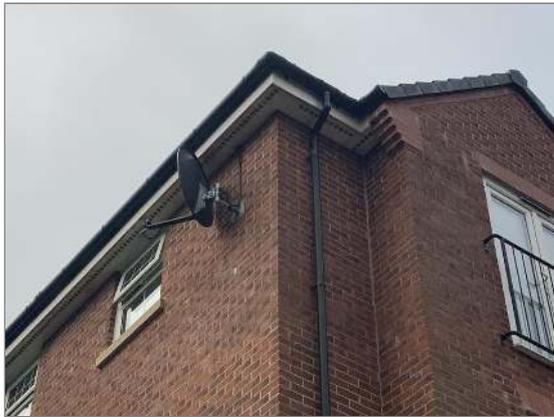
Photo - 3

The rainwater pipes are plastic and appeared in fair condition. It was not raining at the time of the inspection and it was not possible to determine whether the rainwater goods are performing adequately. As such it would be prudent to observe the goods during/just after a period of rainfall, identify any areas of vulnerability and carry out repairs/replacements, if necessary.

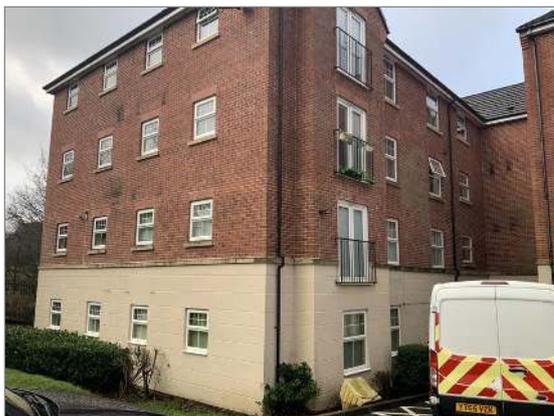
Photo - 6

Inspection from ground level indicated no evidence of significant bulging, distortion or structural cracking to the main walls of the property. A visual inspection indicated no evidence of significant distortion over openings, which would suggest that the lintel support is adequate to carry the imposed loads above. If non-galvanised metal lintels have been used, they may corrode over time, leading to expansion and cracking of the surrounding brickwork. Even where lintels do exist, we cannot assess their long-term performance or effectiveness without specialist investigation.

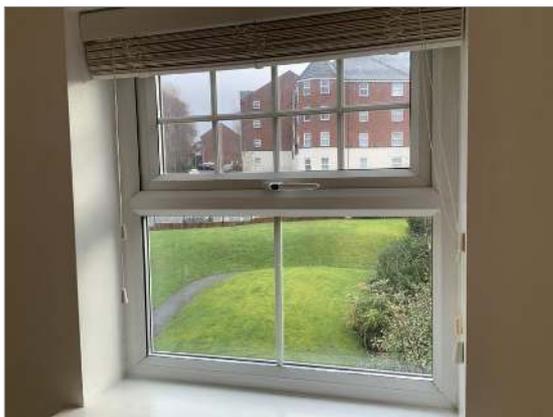
Photo - 10

Windows are uPVC framed top openings with double glazing and appeared in fair condition at the time of inspection. Some windows were opened on both elevations and no significant defects were noted to their operation at the time of inspection.

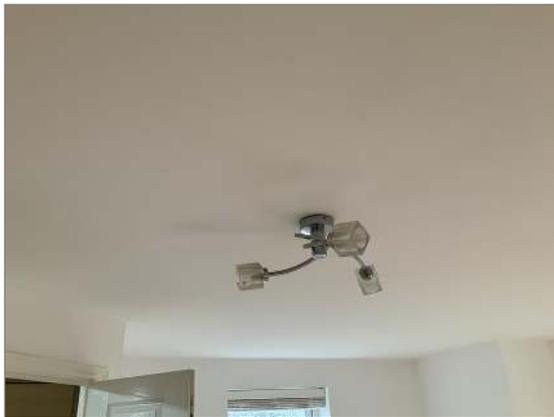
Photo - 17

All ceilings appeared generally free from deflection and in fair condition. As with the majority of plastered ceilings, minor areas of deterioration to the plaster do exist, in particular where surfaces meet. This is to be expected and can be rectified when attending to redecoration.

We did not observe significant cracking damage and/or deviation(s) to the ceilings other than hairline cracking which can be filled and redecorated during routine maintenance.

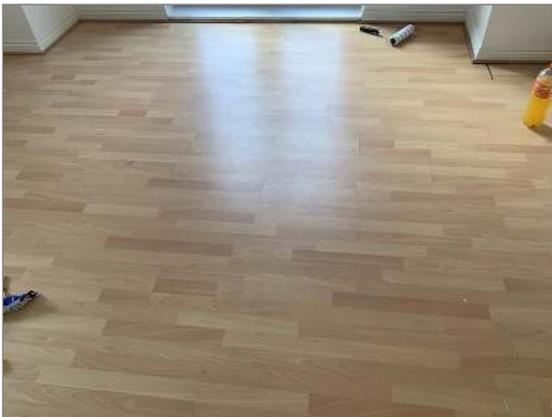
Photo - 24

The floors are of suspended concrete construction. Owing to the conditions of the survey, no fixed coverings were lifted.

The floor finishes comprise of timber laminate, close fitted carpet and linoleum. The floor finishes were now suffering from general deterioration and future replacement will no doubt be required in the medium term at the time of redecoration.

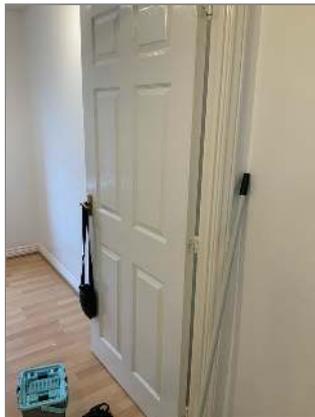
Photo - 31

The internal doors and skirtings and other joinery were reasonably well decorated and in a fair condition, however a programme of general maintenance/redecoration will no doubt be required in the medium term.

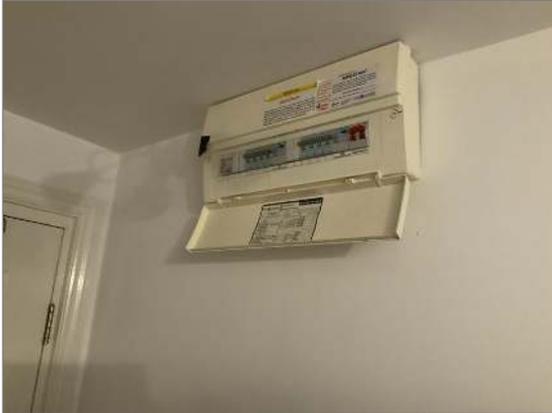
Photo - 35

In the absence of a current test certificate, we must designate a level three risk. If certification is available, please ask your legal advisor to check the validity of this evidence. Electrical installations

to be checked and certified by an NICEIC qualified engineer prior to purchase, unless evidence of recent testing is provided and verified.

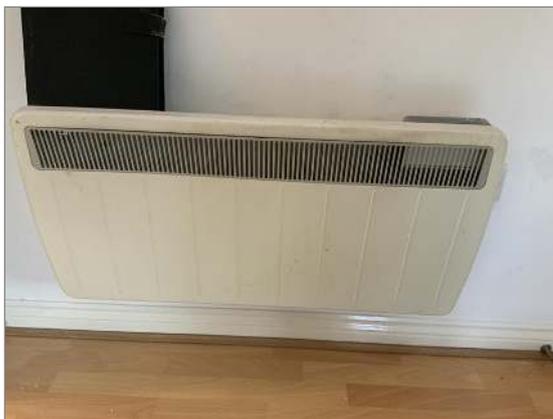
Photo - 37

In the absence of a current test certificate, we must designate a level three risk. If certification is available, please ask your legal advisor to check the validity of this evidence.

You should instruct a suitable qualified heating engineer to carry out a thorough inspection and functional test of the heating system and to advise on any improvements and/or upgrading required prior to exchange so that you are aware of the likely cost.

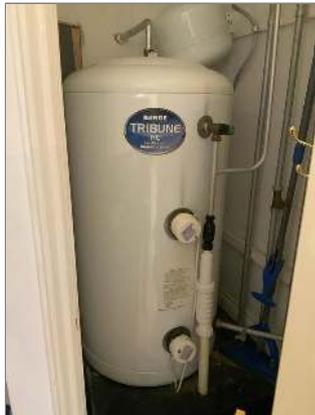
Photo - 39

The hot water is provided by a heating boiler combined with the hot water storage in the same appliance (sometimes called a combined primary storage unit).

In the absence of a current test certificate, we must designate a level three risk. If certification is available, please ask your legal advisor to check the validity of this evidence. All gas installations to be checked and certified by a Gas Safe engineer prior to purchase, unless evidence of recent testing can be provided. Please ensure you have a carbon monoxide alarm near all fuel burning appliances.

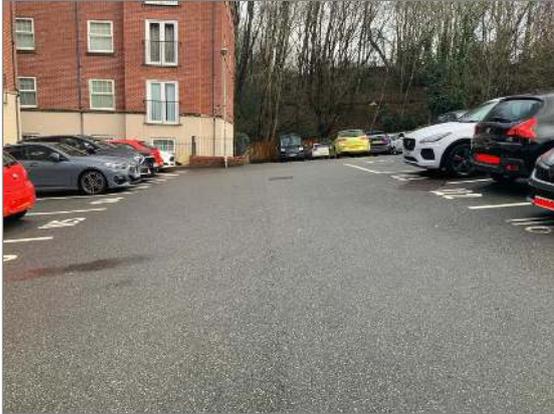
Photo - 40

There are communal garden / lawned areas. The grounds appear reasonably well maintained.
