# YOUR ONESURVEY HOME REPORT

25 Elm Street  
Glasgow  
G14 9PX

# SINGLE SURVEY

# Survey Report & Proposal

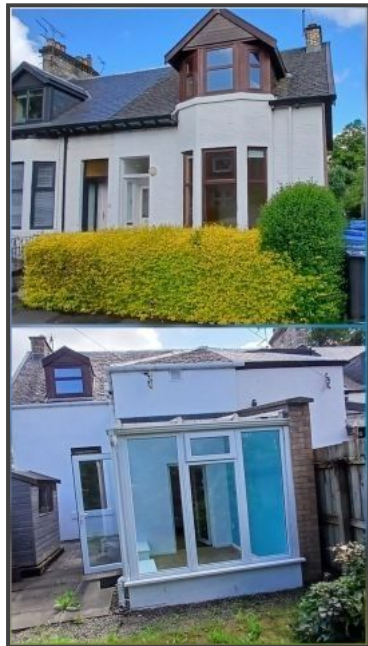
- **PROPERTY DESCRIPTION:** The property is a stone-built two-storey end-terraced house (domestic).
- **OCCUPIED STATUS:** At the time of the survey inspection, the property was unoccupied.
- **WEATHER CONDITIONS:** The weather conditions at the time of the inspection were mild, light cloud cover, and dry; Temperature: 13.5 °c.

- The external ground level is above internal floor level.

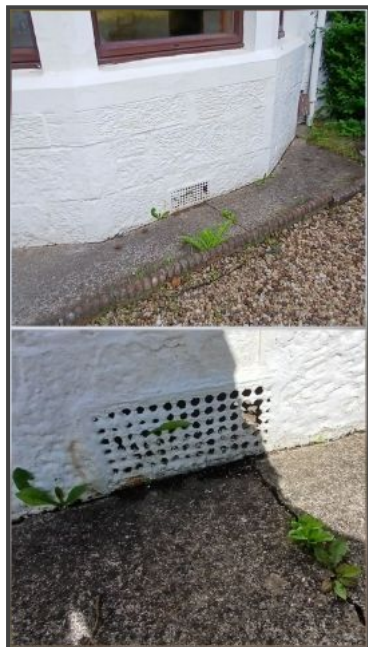
- Sub-floor Ventilation

We would recommend that the client give serious consideration to the renewal of the air ventilators. We would recommend that new 9" by 6" louvre air ventilators are installed.

We recommend, as essential regular maintenance, that the client arranges for air vents to the property to be cleaned out in order to maintain air flow to the sub-floor to extend the life span of the timbers.

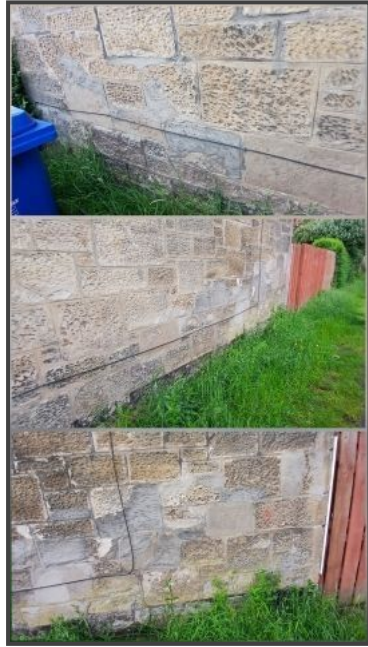
- Reduced thermal resistance of damp masonry causing heat loss and condensation;
- Moss and mould growth;
- Frost damage;
- Rotting of embedded timbers;
- Disfiguring carbonate deposits.

We would highly recommend that the client engages with reputable third-party contractors to fully inspect and undertake remedial repairs to all defects that are noted.

- Reputable third-party contractors should regularly check and maintain / repair as necessary all gutters, down-pipes, masonry, render, painted coatings, external joinery, roof coverings, etc.

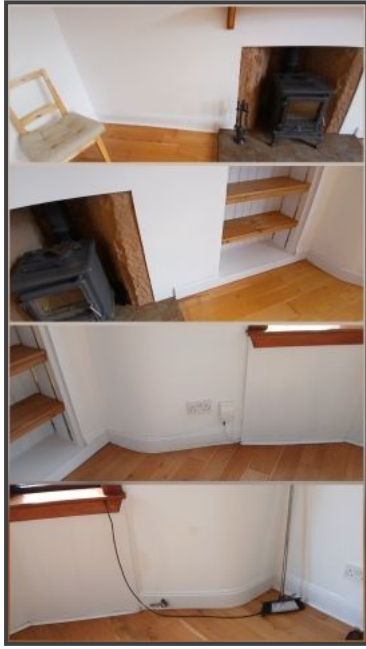
Where inspection was possible, the moisture levels in the remaining walls were below the threshold that would warrant recommending the installation of a remedial damp proof course.
