56 Glenurquhart Road,  
Inverness,  
IV3 5PA

# Home Report

## Survey Report on:

<b>Property Address</b>	56 Glenurquhart Road, Inverness, IV3 5PA
<b>Reference</b>	1350651
<b>Customer Name</b>	Rosemary Watters
<b>Date of Inspection</b>	1st June 2026
<b>Surveyor's name, qualifications and office</b>	Colin MacGregor BSc (Hons) MRICS  DM Hall LLP Chartered Surveyors Hope House, Cradlehall Business Park, Castlehill Drive Cradlehall Inverness IV2 5GH  Tel: 01463 241077  email: invernessresidential@dmhall.co.uk
<b>Prepared By</b>	DM Hall LLP

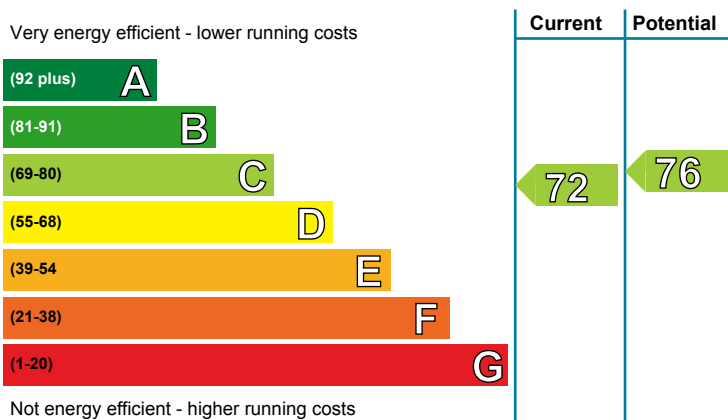
## Energy Efficiency Rating

This graph shows the current efficiency of your home, taking into account both energy efficiency and fuel costs. The higher this rating, the lower your fuel bills are likely to be.

Your current rating is **band C (72)**. The average rating for EPCs in Scotland is **band D (61)**.

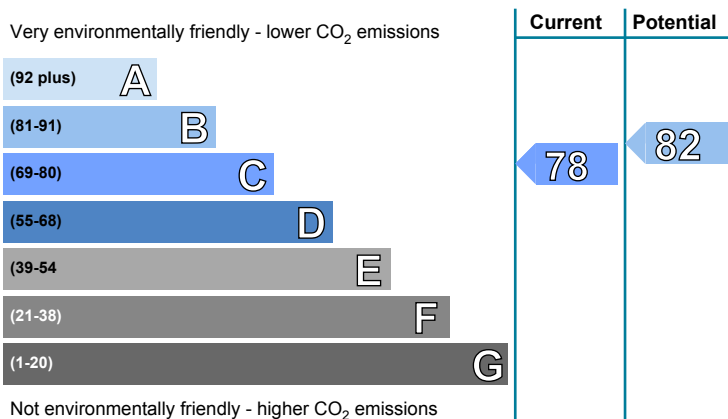
## Environmental Impact (CO<sub>2</sub>) Rating

This graph shows the effect of your home on the environment in terms of carbon dioxide (CO<sub>2</sub>) emissions. The higher the rating, the less impact it has on the environment.
