# Home Report

3 Novar Crescent  
Kirkcaldy KY1 1PT

Date of Valuation: 03/02/2026

## Property Owner's Completion Pack

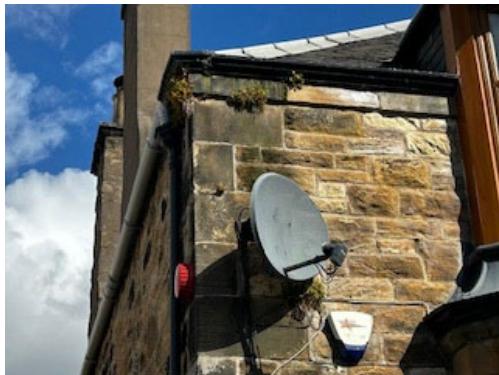
Vegetation growth to stonework below gutter to front left hand corner of property

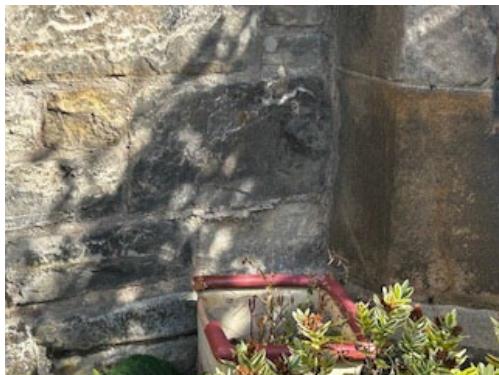
Weathered stonework to front elevation

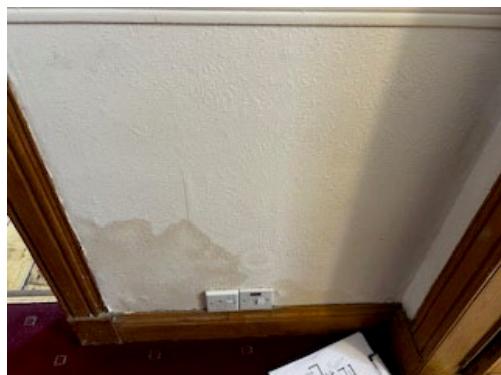
Dampness to wall plaster within hall, outside bathroom door

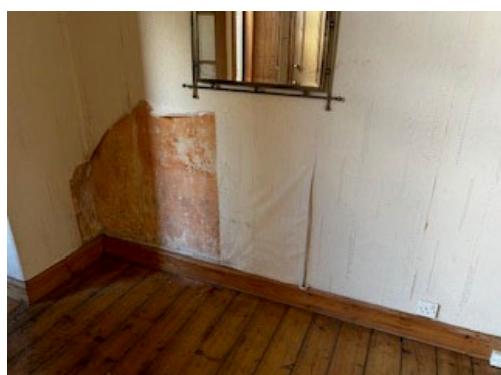
Dampness to wall plaster to ground floor room rear left - bathroom located on opposite side of wall

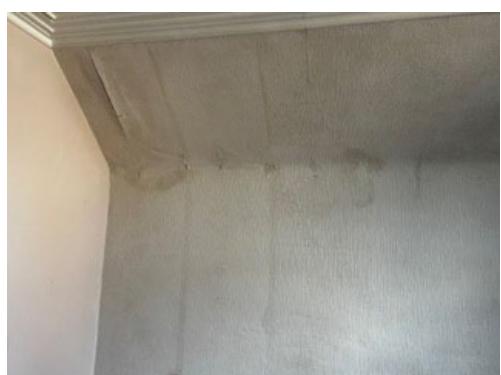
Dampness to wall and coomed ceiling fabric to 1<sup>st</sup> floor room rear left

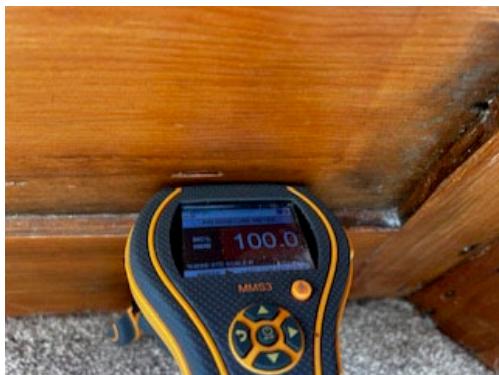
Elevated moisture readings to plywood linings below window to ground floor room front

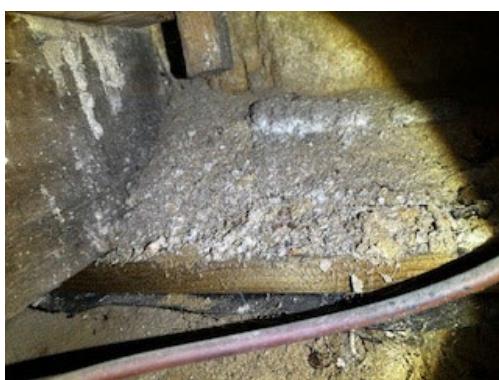
- Wet rot (Coniophora Puteana) to the floor joist within the press recess to the front left hand corner of room front. Significant debris build up was noted to the wallplate to this area also.
- The floor within the ground floor bathroom was noted to be significantly wet and partially collapsing. It is assumed that there is a plumbing leak below the floor and the whole floor will need to be removed and renewed.

Significant debris build-up on wallplate to front left hand corner of ground floor room front

Uplift floorboards, remove joist within press and renew. Clear debris from wallplate and clear exposed solum surface of timber offcuts and debris. Reinstate floorboards.

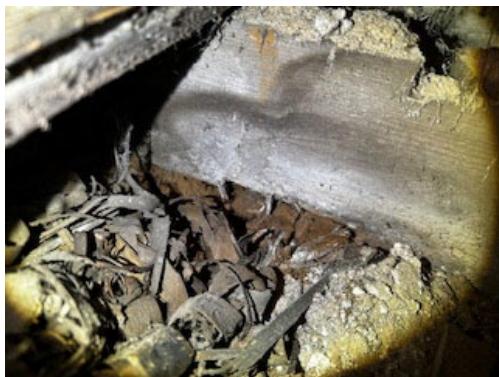
Decay to floor joist within press recess to ground floor room front

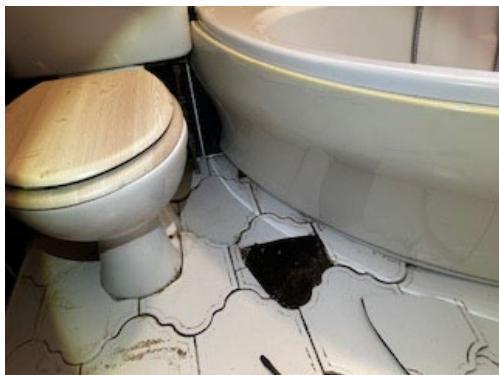
Saturated floor timbers to ground floor room rear right (bathroom)

Remove floorboards, floor joists and wallplates in entirety. Clear solum, lay polythene DPM and concrete mix. Renew all floor timbers with pre-treated timber and lay new T+G floorboards to match existing.

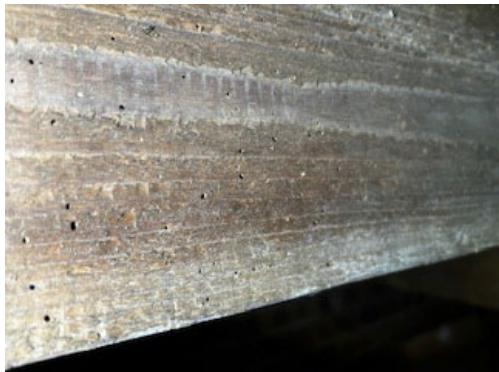
A slight infestation of wood borer (*Anobium punctatum*) was noted to the accessible timbers which was active.

Active woodworm to roof timbers within main roof void

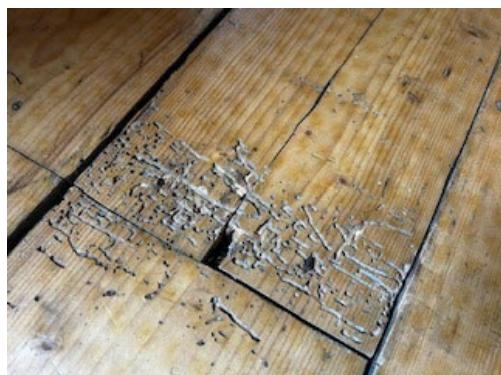
Whilst evidence of past attack by the common furniture beetle was noted to exposed floorboards and exposed timbers within the under stair cupboard, there was no indication of any recent activity where inspection was possible and is considered dormant. If treatments have been carried out by others previously, it is important that you check the validity of any available guarantees.

Historic woodworm to floorboards to ground floor room rear left
