Survey Report

Property Surveyed: 6 Battery Terrace, Oban, PA34 5DN

Date of Survey: 20th January 2026

Our Ref: CW/KM/S26/00073

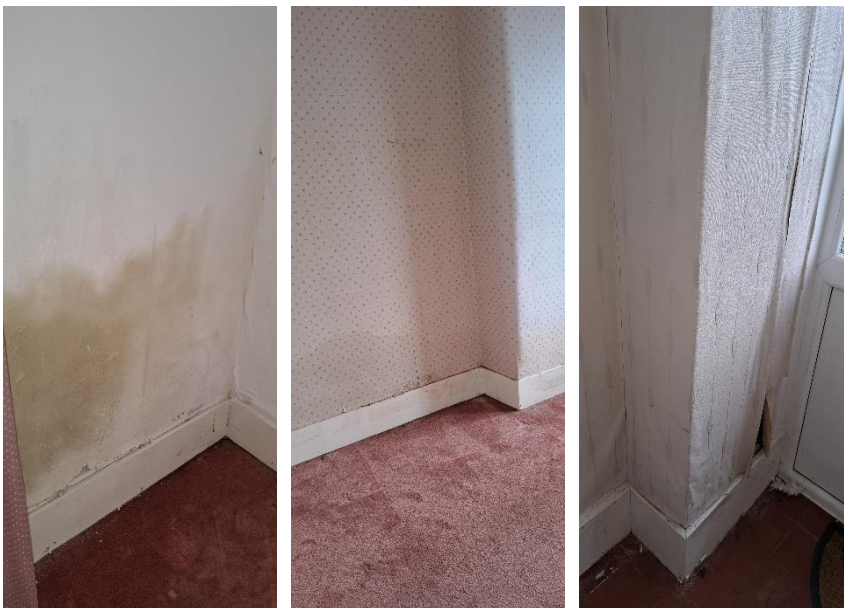
Using instrumental analysis in conjunction with physical observations we have formed the conclusion that dampness in the form of penetrating damp exists on the external walls of these rooms.

It should be noted that, due to the survey being carried out on a dry day, we were unable to observe the effectiveness of the rainwater goods of the property, therefore we were unable to determine the precise points of entry for the moisture ingress to the building. We recommend that the external fabric of the property is appropriately inspected and that any necessary repairs are carried out.

It should be further noted that some areas of walls appear to be plastered on the hard on external walls. This may contribute to moisture penetration due lack of cavity between the porous stone and the wall linings.

In view of the above we recommend the removal of the contaminated wall fabrics, apply a damp proofing membrane to the exposed wall areas and reinstate wall fabrics using a renovating type plaster or dot and dab plasterboard, finishing with a skim of plaster, we would advise that a budget cost of £14,000 + VAT should be considered.
