YOUR ONESURVEY  
**HOME REPORT**

0/1  
11 Montague Street  
Woodlands Glasgow  
G4 9HU

# SINGLE SURVEY

<b>Surveyor Reference</b>	GG/3364
<b>Customer</b>	Mr. Martyn Nicholson
<b>Selling address</b>	0/1 11 Montague Street Woodlands Glasgow G4 9HU
<b>Date of Inspection</b>	08/06/2026
<b>Prepared by</b>	A E MacDonald, BSc (Hons) MRICS Glasgow North - Allied Surveyors Scotland Ltd

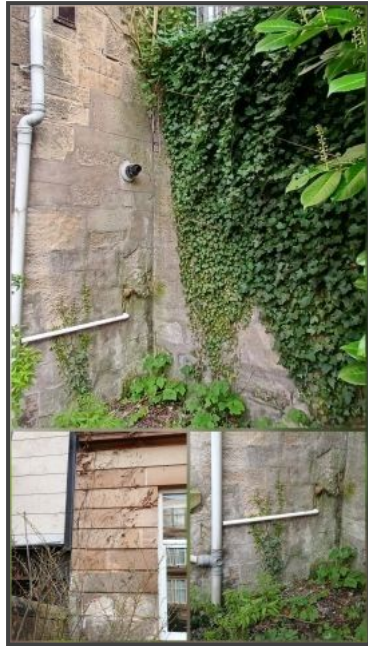
Mortar joint pointing to the property was noted to be perished in instances and in need of attention from a reputable third-party party stonemason contractor.

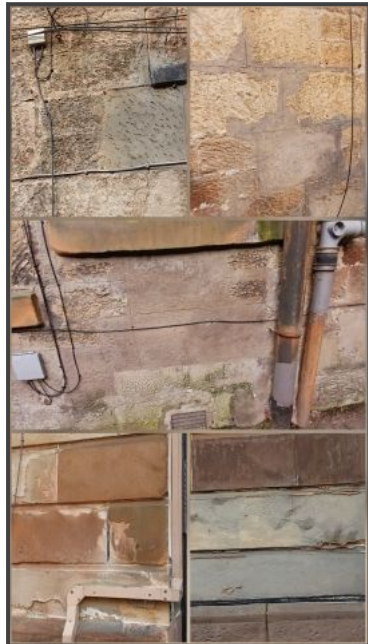
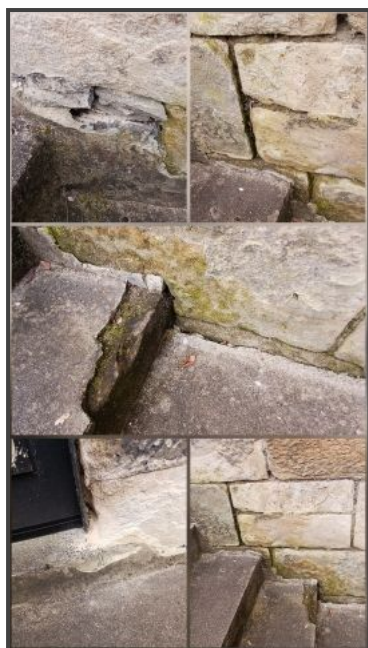
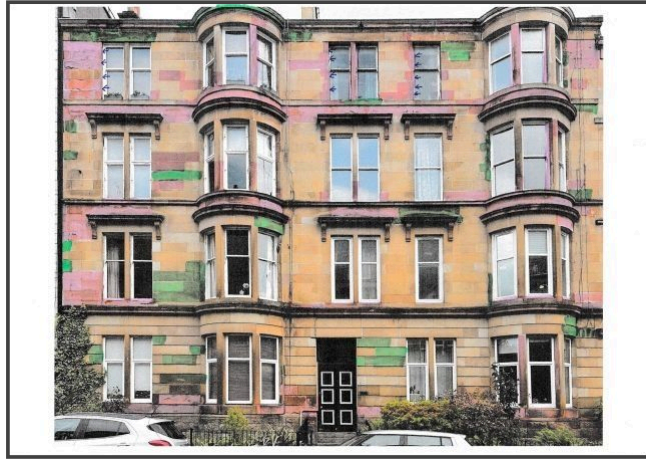
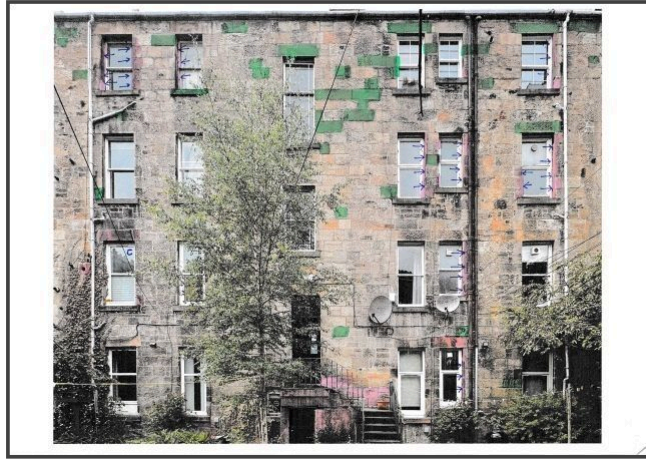
We understand that masonry repairs by a third-party contractor, 'The Sandstone Specialists Limited', have been agreed by the owners. Please see the images highlighting the areas of repair in red and green.

- Reputable third-party contractors should regularly check and maintain / repair as necessary all gutters, down-pipes, masonry, render, painted coatings, external joinery, roof coverings, etc.
