LEVEL 2

Your survey and valuation report...

34 Longacre, Hindley Green, Wigan,
WN2 4LL

07/05/2026

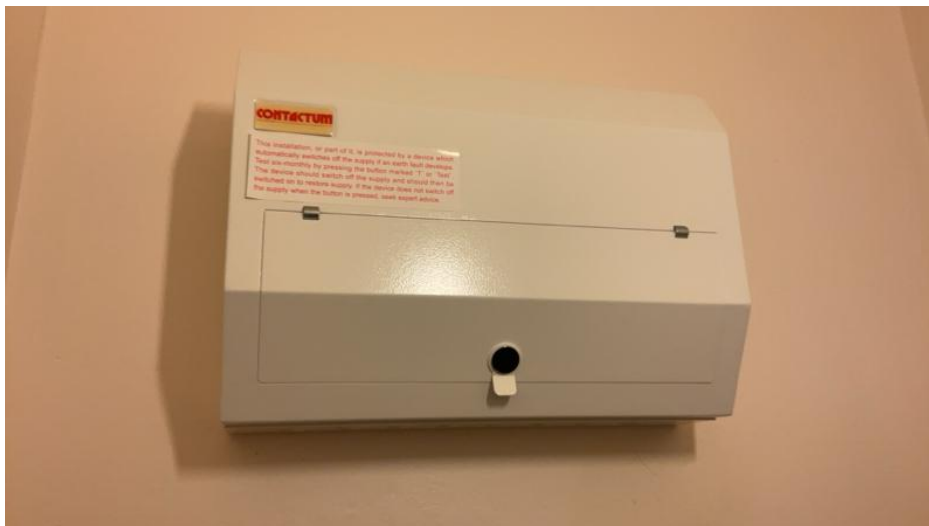
Consumer unit

Our visual inspection revealed no significant faults. Electrical Safety First advises that you engage a registered electrician to conduct a thorough inspection of the property and its electrical fittings at a minimum interval of every ten years, or upon change of occupancy. Consequently, it is recommended that prior to purchase, you obtain a NICEIC safety inspection certificate.
