26-6486 – 6 Hazeldean Crescent, Oban – Structural Inspection

Further to your recent request, we confirm that we visited 6 Hazeldean Crescent, Oban on Wednesday 25th March 2026. The purpose of the visit was to inspect the condition of the existing dwelling and identify any visible structural defects or repairs that may be required. At the time of the inspection, the weather conditions were bright and wet.

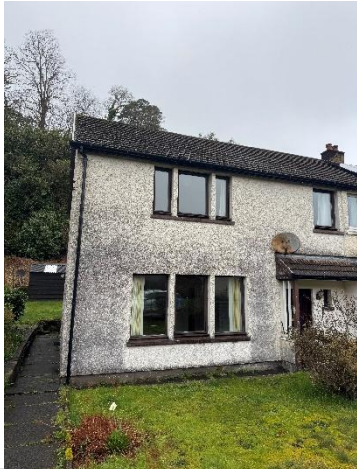
The front elevation of the property was noted to have been subjected to weathering with areas of paint spalling and significant discolouration across the rendered façade (See photo 1). The concrete window piers on both the first floor and ground floor appeared to be in a state of disrepair with deep cracks noted. The middle window into the living room on the ground floor was noted to have a crack that had propagated vertically through the render on the inside face of the pier from the underside of the lintel downwards towards the window cill where it returns towards the windowpane (See photo 2). Similar defects were also noted on the bedroom window piers directly above the living room (See photo 3). A notable crack was identified to have propagated vertically down the centre of the right-hand side window pier and curves at the base around the window cill. To assess the extent of the cracking, the render would need to be removed to expose the condition of the concrete. Furthermore, significant deterioration of the kitchen window pier on the rear elevation was also noted with an area of corroded reinforcement exposed (See photo 4). Corrosion of embedded steel reinforcement within concrete can be significantly accelerated in the presence of elevated chloride ion concentrations. This is particularly relevant in structures constructed before modern standards were implemented, as chloride-based admixtures were commonly used in concrete mixes up until the late 1960's. These admixtures, while once considered beneficial for workability and curing, are now known to contribute to long-term durability issues due to their role in initiating corrosion of reinforcement. Additionally, the depth of the concrete between the reinforcement and the elements (referred to as concrete cover) is essential for protecting the reinforcement from external contaminants such as chlorides and carbon dioxide. From the exposed area at the kitchen window, it appeared as though there was insufficient cover to the reinforcement which is likely to have contributed to the deterioration.

Photo 1 – Discolouration on the front elevation

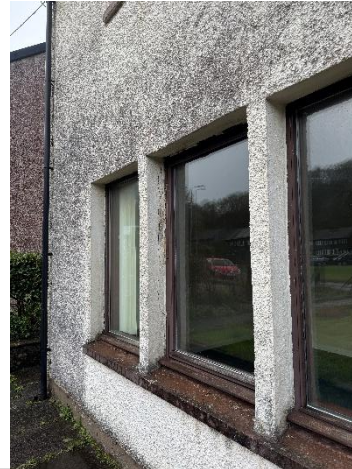
Photo 2 – Cracking noted on living room window pier

1. Replacing the rotted timbers on the front entrance porch with timbers treated with an approved preservative recommended by the British Wood Preservative Association to prevent deterioration from exposure to the elements.
2. Replacing the SHS post supporting the front entrance canopy with a galvanised steel SHS post to prevent deterioration from exposure to the elements.
3. Remove all loose or cracked render from affected window piers to assess the condition of the concrete behind. See appendix A for details on the specification for remedial works.

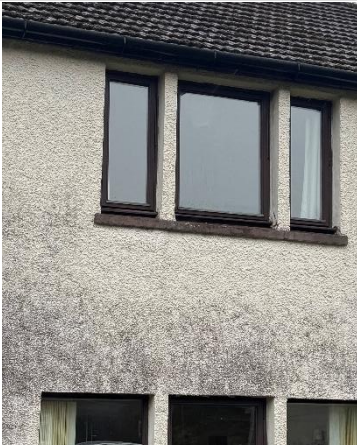
Photo 3 – Cracking noted at base of first floor bedroom window piers on front elevation

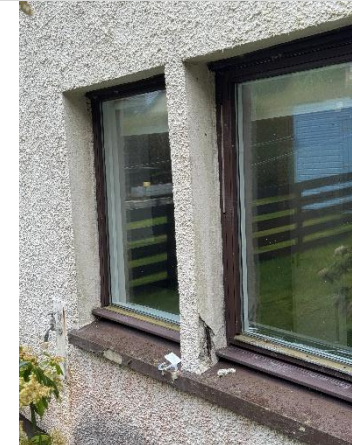
Photo 4 – Exposed reinforcement at base of kitchen window pier on the rear elevation

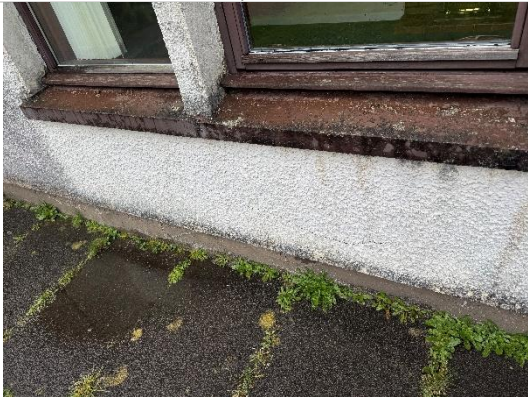
Directly below the living room window a long, horizontal crack (less than 5mm wide) had propagated through the render (See photo 5). From the visual inspection, this crack appears to be the result of weathering and poor maintenance over a prolonged period of time therefore cosmetic in nature.

Photo 5 – Hairline crack noted in render under living room window on front elevation

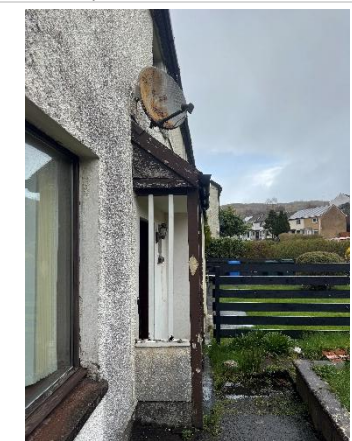
The canopy located over the front entrance is formed of a slate tiled roof supported on a steel SHS post and a masonry wall with vertical timber posts supported on a half-height masonry wall (See photo 6). The SHS post was

Photo 6 – Front entrance canopy structure

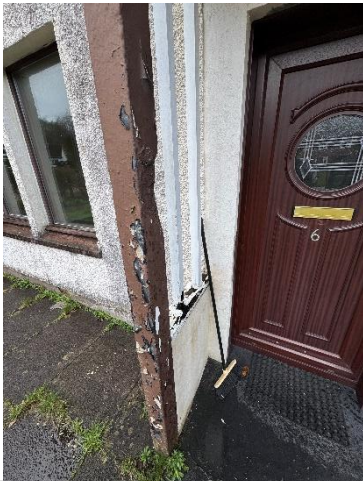
noted to be in a state of disrepair with significant spalling of paint and on the SHS post and timber elements along with areas of corrosion and deformed at the mid-section (See photo 7-8). Additionally, the timber members have rotted at the base causing the timber to disintegrate and separate from the timber cope (See photo 9). The masonry wall which supports the eaves beam between both properties was in reasonable condition however areas of render have disintegrated, and concrete has been exposed on the front face of the adjoining wall with the neighbouring property (See photo 10). Furthermore, the canopy roof appeared to be level, and no depressions were noted across the face of the roof (See photo 11).

Photo 7 – Deformation of SHS post and weathering of structure

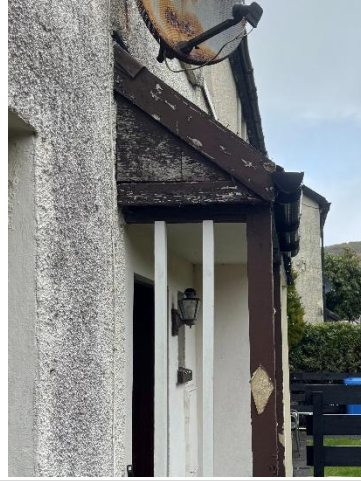
Photo 8 – Weathering of timber elements

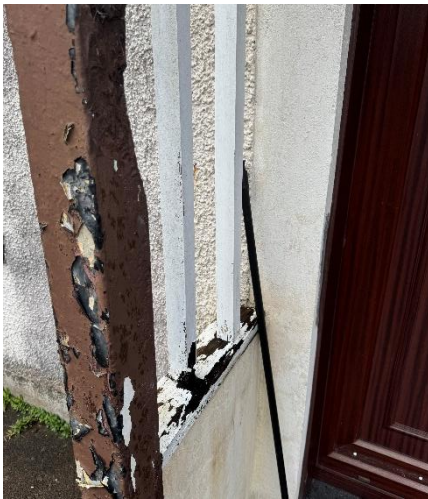
Photo 9 – Timber posts and cope rotted

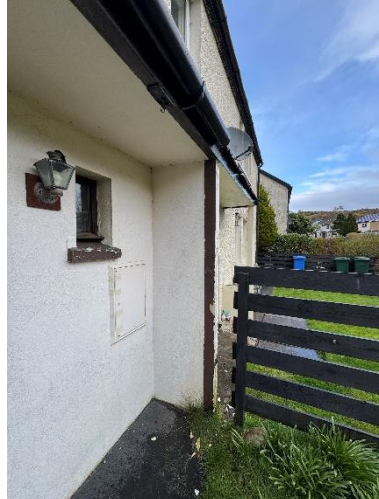
Photo 10 – Paint spalling and concrete exposed on shared wall

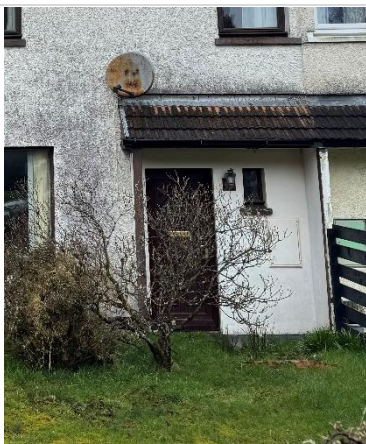
Photo 11 – Canopy roof structure

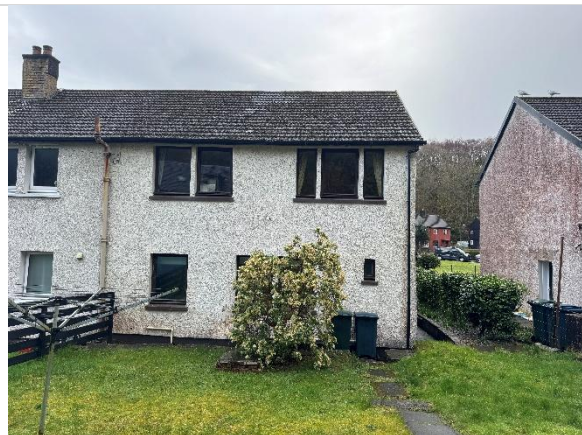
The rear elevation of the property was also noted to have been subject to weathering with discolouration of the render noted below the ground floor windows and behind the rainwater down pipe which suggests that these areas have had excessive moisture exposure causing algae to develop (See photo 12).

Photo 12 – Discolouration below rear windows and behind RWP

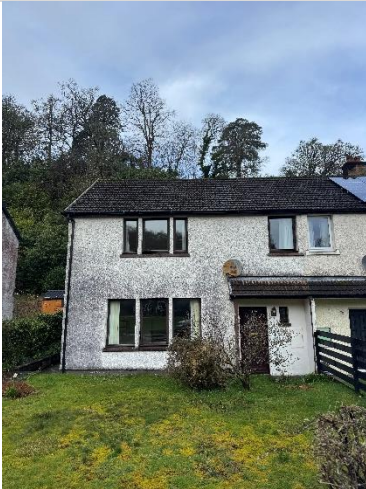
The roof profile of the property was noted to be finished with concrete tiles with notable algae growth across the extent of the roof. The ridge line of the dwelling appeared to be plumb with no notable depressions identified across the roof profile (See photos 13-14). The gable end of the property was noted to have notable discolouration, and algae growth however had no significant structural defects were noted at the time of inspection (See photo 15).

Photo 13 – Roof profile on front elevation

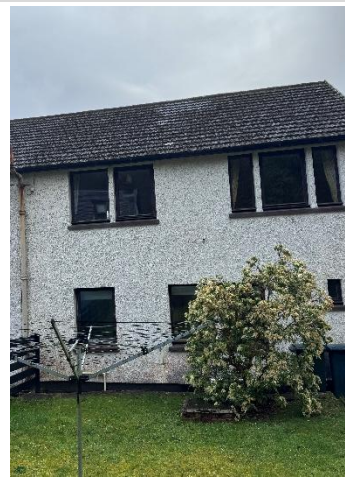
Photo 14 – Roof profile on rear elevation

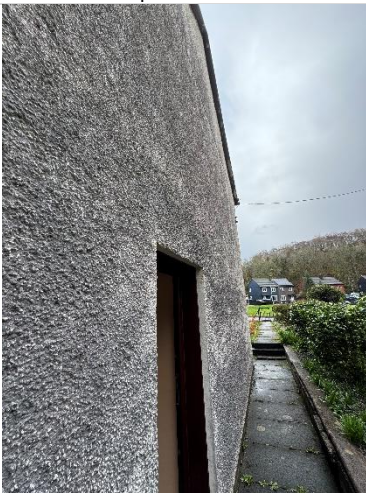
Photo 15 – Condition of gable end

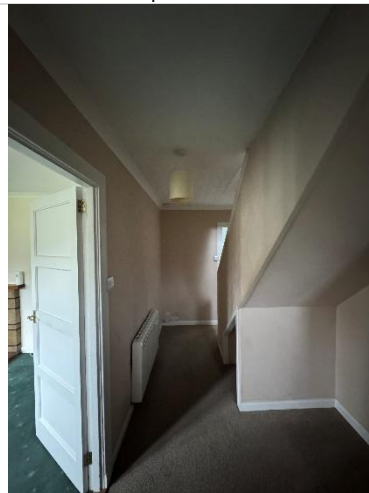
Upon entry into the property, the first area of inspection was the ground floor hallway which was in sound condition with no cracking or defects noted within the space (See photos 16-17). The living room space was inspected next which was also in sound condition with no structural cracking identified at the time of inspection. A small, localised area of discolouration was noted on the ceiling within the living room which appeared to follow a linear pattern approximately 1m from the gable wall (See photo 18). An additional area of discolouration was also noted on the internal wall to the left of the electric fireplace (See photo 19). The cause of the discolouration could not be confirmed at the time of inspection due to finishes being present therefore intrusive investigations would be required to assess the condition of the structure. The ground floor bathroom also appeared to be in sound condition with no notable defects identified in the finishes (See photo 20). The kitchen space was also in good condition with no visible cracking or deformations noted at the time of inspection (See photo 21). The floor space within the kitchen pantry had no finishes present which confirmed that the ground floor is constructed of concrete slab (See photo 22). All ground floor door and window openings appeared to be level and opened with ease.

Photo 16 – Ground floor hallway

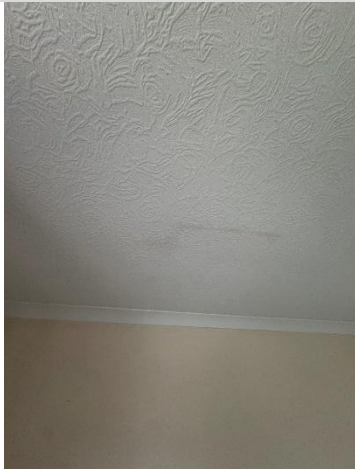
Photo 18 – location of discolouration on living room ceiling

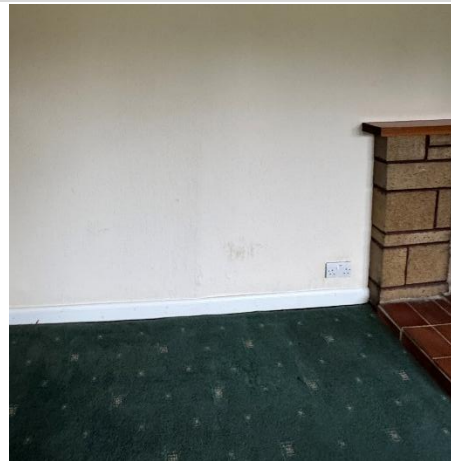
Photo 19 – Discolouration noted on internal wall in living room

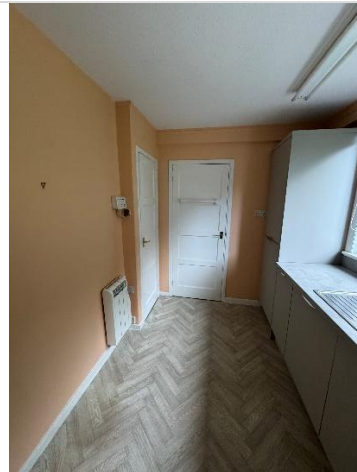
Photo 21 – Kitchen in good condition

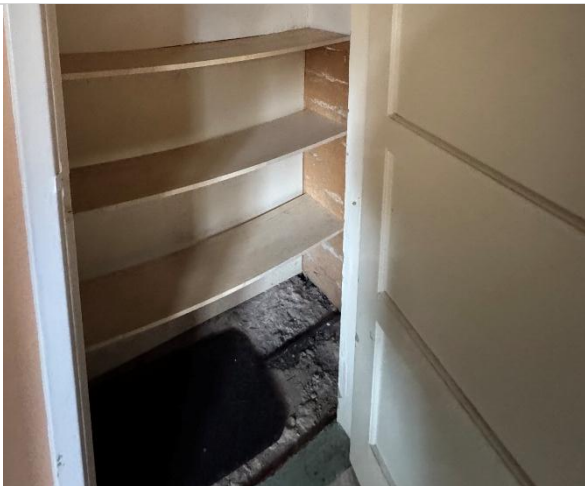
Photo 22 – Exposed ground floor slab

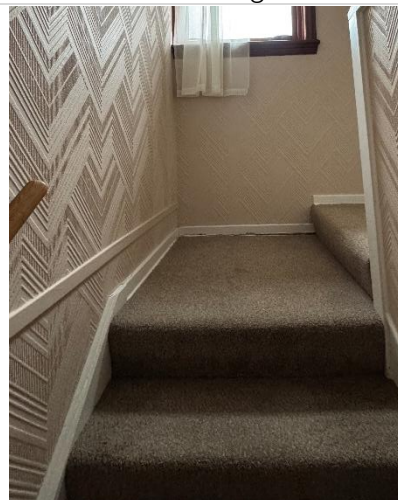
The top landing of the stairs up to the first floor appeared to slope from the party wall towards the gable wall which has caused separation between the landing and the skirting (See photo 23). There was no cracking identified on the underside of the stair trimmer or on the wall below to suggest that there had been any significant structural movements. The floor was noted to slope in this direction throughout the first-floor level of the property however no signs of structural movement were noted which would have been related to this at the time of inspection (See photo 24). All window and door openings were plumb and level at the time of inspection. The attic hatch was noted to be located within the hallway however due to no ladder access provided the attic space could not be inspected therefore we are unable to comment on the condition of the attic structure (See photo 25).

Photo 23 – Separation at skirting on landing

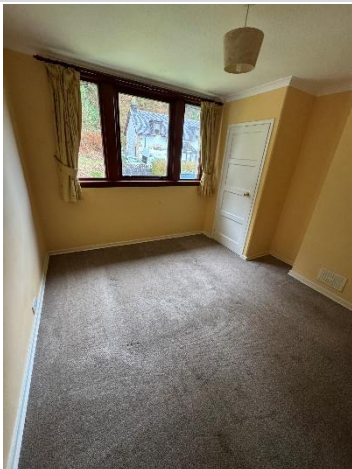
Following the recent visual inspection, we conclude that the property is in good structural condition however it has been subject to weathering and consequential deterioration as a result of poor maintenance. The visual inspection of the first-floor area found that there was a notable slope in the floor which is likely to have caused the separation noted between the finishes at the landing. We are of the opinion that this is the result of settlement over time as there are no signs of subsidence or resultant cracking in other parts of the property. The ground floor area was also found to be in good condition with no imminent structural defects noted. It would be recommended that additional investigation is carried out to assess the cause of discoloured locations within the living room space to prevent any deterioration. The visual inspection of the external façade highlighted a number of defects including the deterioration of several window piers on the front and rear elevation which appear to be the result of corroded reinforcement. If left unaddressed, these defects could lead to structural failure therefore we recommend that intrusive investigations should be carried out to assess the condition of the concrete behind the affected render on the window piers and relevant remedial works should be carried out by a qualified professional. Additionally, the front entrance canopy was noted to be in a state of significant disrepair with numerous members damaged from water ingress and poor maintenance. Despite the notable defects, the structure was stable at the time of inspection however we would recommend that the timber elements and steel SHS post were replaced to prevent further deterioration which could lead to failure of the structure.

Photo 24 – Floor sloping in first floor

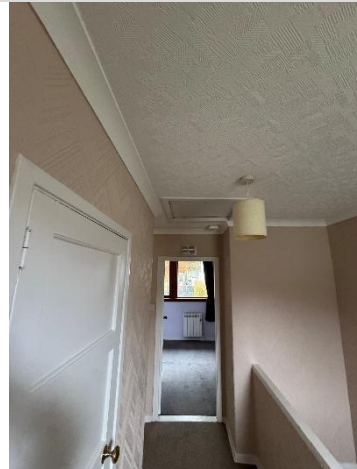
Photo 25 – First floor hallway and attic hatch
